# ENERGY REHABILITATION OF VENTILATED FAÇADES USING PHENOLIC PANELLING AT THE UNIVERSITY OF ALICANTE MUSEUM: THERMAL CHARACTERISATION AND ENERGY DEMAND

VÍCTOR ECHARRI IRIBARREN<sup>1</sup>, ANTONIO GALIANO GARRIGÓS<sup>1</sup>  
& ALMUDENA ESPINOSA FERNÁNDEZ<sup>2</sup>

<sup>1</sup>Department of Building Construction, University of Alicante, Spain

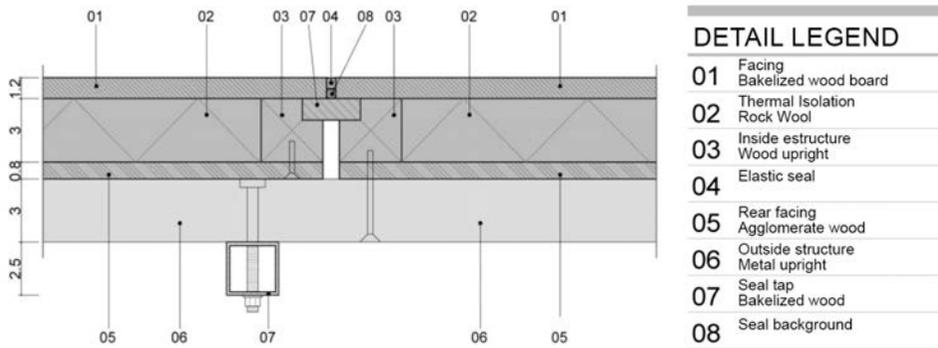
The envelope was a sandwich structure, in which the phenolic panels and the MDF were anchored to a wooden frame and the spaces in between were filled with rock wool. Insulation of the façade was therefore discontinuous and there were thermal bridges (Fig. 2).

Figure 2: Section of the external envelope. Original project.

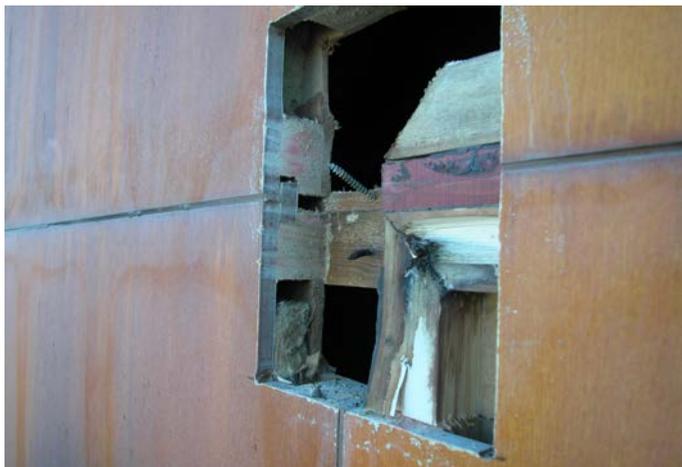
Simple observation of the resin-coated panels revealed a general deterioration. Lack of accessibility hindered examination of the condition of some elements. Consequently, we took some samples (Fig. 3). The damage detected on the façade was as follows:

1. Staining on the panels corresponding to the subframe onto which they were mounted. Darkening on the south and west façades.
2. Warping on the exterior resin-coated panels.
3. Absence or disintegration of sealant seams. Peeling and cracking of joints between boards. Water penetration of the sandwich via these joints.
4. Drip marks and irregular stains on parts of the north and east façades.
5. Hazy white stains, more pronounced at the edges.
6. Fungal colonies on the inner surface of the façade, on the MDF panel.
7. Piecemeal repair of screws. The coating had lost its elastic properties, and was discoloured and flaking.
8. Some glass in the lower façade was cracked due to deterioration of the sealant.

Figure 3: Aspect of the samples taken from the main façade.

Besides being the result of insufficient protection of the first-generation resin-coated wood panels, the general deterioration of the façade also bore a direct relationship to the original construction system. Several degradation processes had occurred simultaneously. The main factor that had accelerated the process was the absence of sealing at the panel joints, due to insufficient thickness, lack of initial adhesion and weathering at the joints and panel edges. Rain had penetrated the sandwich panel and the moisture was retained due to lack of natural ventilation, causing the damage described. The process of deterioration and its causes has been described in previous publications [2].

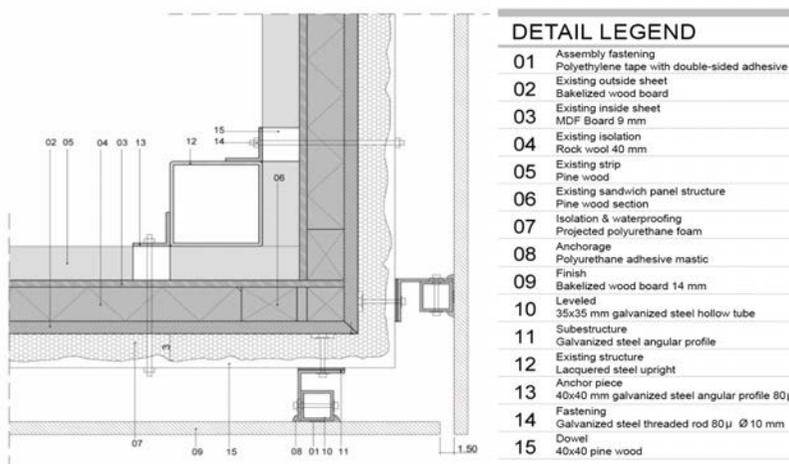
Figure 4: Section of the external envelope. Intervention project.

The existing panels were maintained for economic reasons, and a new wooden subframe was added, anchored by rods screwed into the existing metal structure. Polyurethane foam was sprayed continuously over the entire surface, and latest generation resin-coated wood panels [5] were mounted onto galvanized steel elements anchored onto the wooden battens, thus creating a double-skin façade [6] without seals between panels (Fig. 4). Below, we describe the interventions in the order they were implemented (Figs 5 and 6):

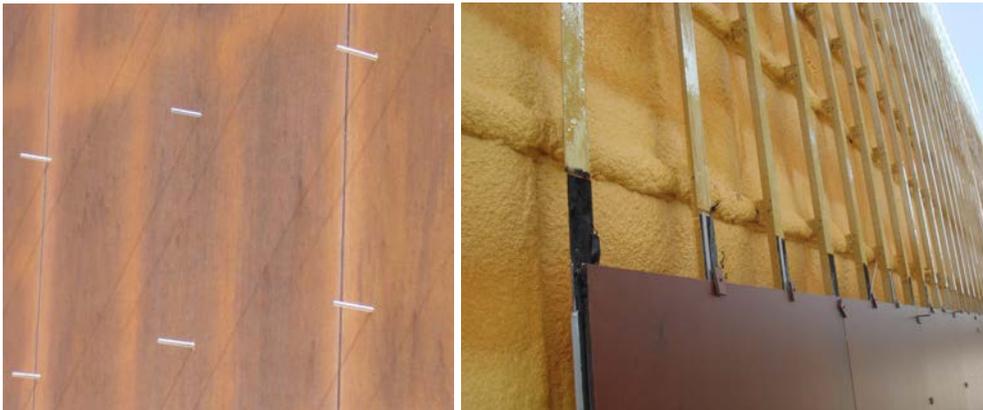
Figure 5: Execution phases of the new envelope mounted over the existing one.

1. The original boards were preserved, and these served to anchor the new subframe supporting the new layers of the repaired façade.
2. A subframe of galvanized 40 × 40 mm steel tubes was mounted onto these panels, and attached to the existing metal structure by means of galvanized threaded steel rods.
3. Then, a structure consisting of 60 × 50 mm galvanized steel H beam uprights measuring 60 × 50 mm and placed 60 cm apart was screwed onto these battens (Figure 5). A band of neoprene was placed at the anchor points to prevent thermal bridges.
4. The H beams were protected with a polyethylene film and adhesive tape.
5. Then, the entire surface was sprayed with polyurethane foam to a mean depth of 3 cm. The polyurethane serves as thermal insulation and render the boards waterproof.

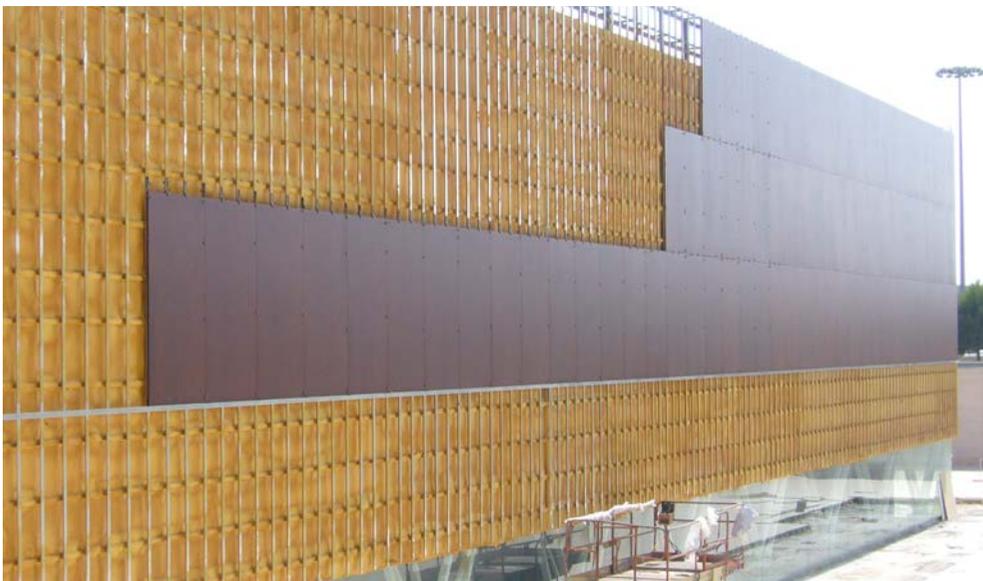
Figure 6: Placement of panels mounted onto a galvanized steel subframe.

Once the adhesive tape had been peeled off the metal uprights, the elements to be joined were cleaned. Subsequently, latest generation resin-coated wood panels measuring  $2.440 \times 1.220$  mm and 13 mm thick were mounted onto the uprights using a structural monocomponent polyurethane adhesive, reinforced with double-sided adhesive tape to stabilise them while the polyurethane adhesive was drying (Figs 6 and 7).

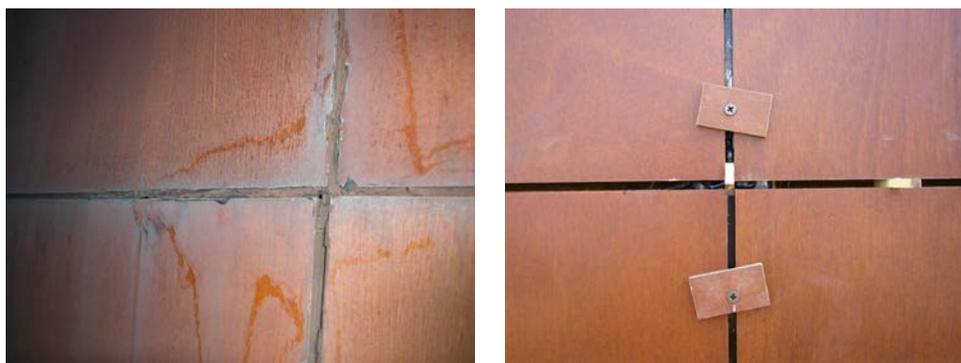
Figure 7: Details of the old and new phenolic panels.

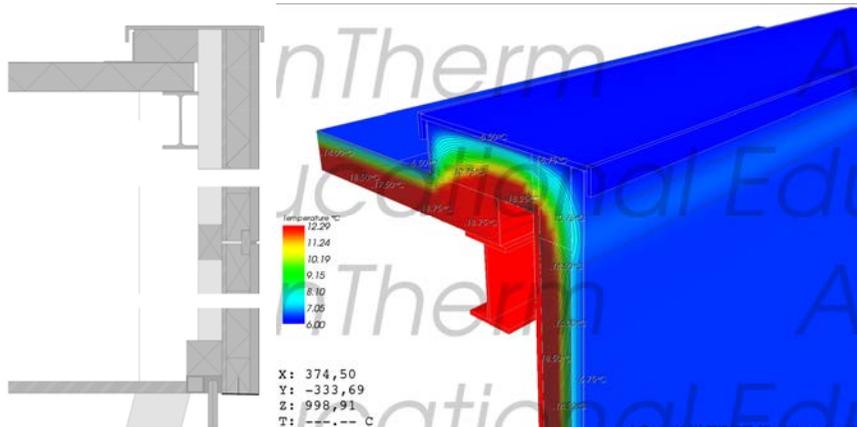
To thermally characterise the envelopes [7], the thermal transmittance values  $U$  of the envelopes were obtained in situ according to the thermal conductivity values given in the TBC database [8]. Thermal bridges were also quantified [9] using the AnTherm simulation tool (Figs 10–12). Values were obtained for the coupling coefficient  $L^{2D}$  and linear thermal transmittance  $\Psi$  of the thermal bridges in MUA 1 and MUA 2 (Table 1). A 43% reduction in transmittance was obtained at the façade-roof point of union, and a 32% reduction in the same at the thermal bridges created by the wooden frame [3]. Figs 10–12 show the thermal gradients where the walls meet the roof and the mezzanines 1.4 m wide, for MUA 1 and MUA 2.

Figure 10: Temperature gradient. Façade-roof point of union. AnTherm.

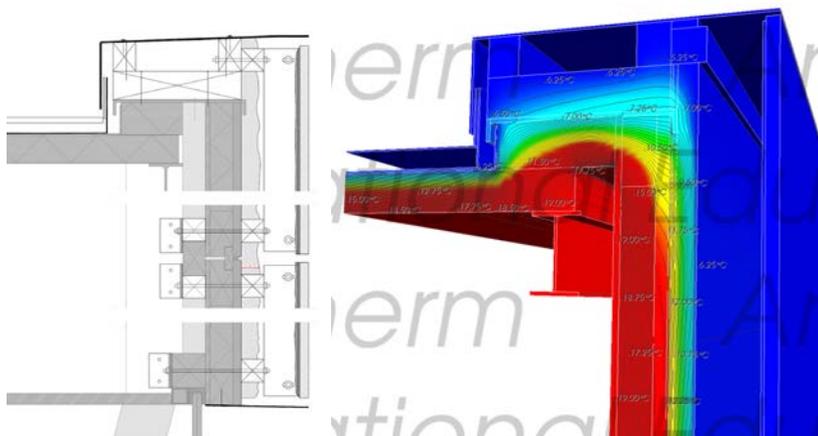
Figure 11: Temperature gradient after the intervention project. Thermal bridge. AnTherm.

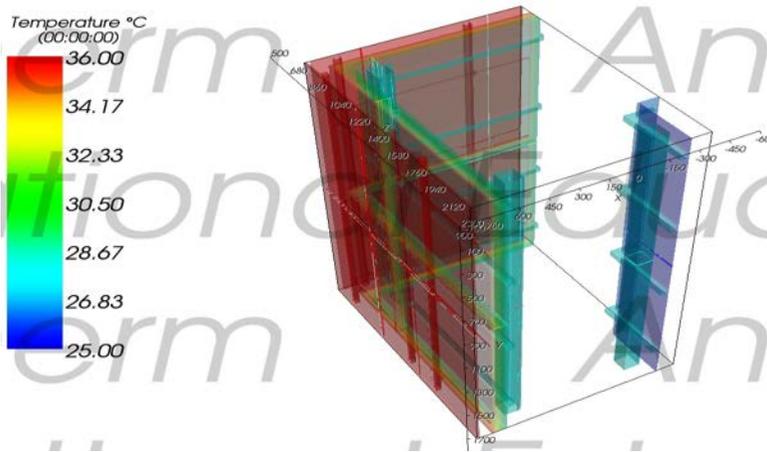
Figure 12: Temperature gradient. Double skin of the mezzanines. AnTherm.
