Internal characterization of embankment dams using ground penetrating radar (GPR) and thermographic analysis: A case study of the Medau Zirimilis Dam (Sardinia, Italy)

Internal characterization of embankment dams using ground penetrating radar (GPR) and thermographic analysis: A case study of the Medau Zirimilis Dam (Sardinia, Italy).

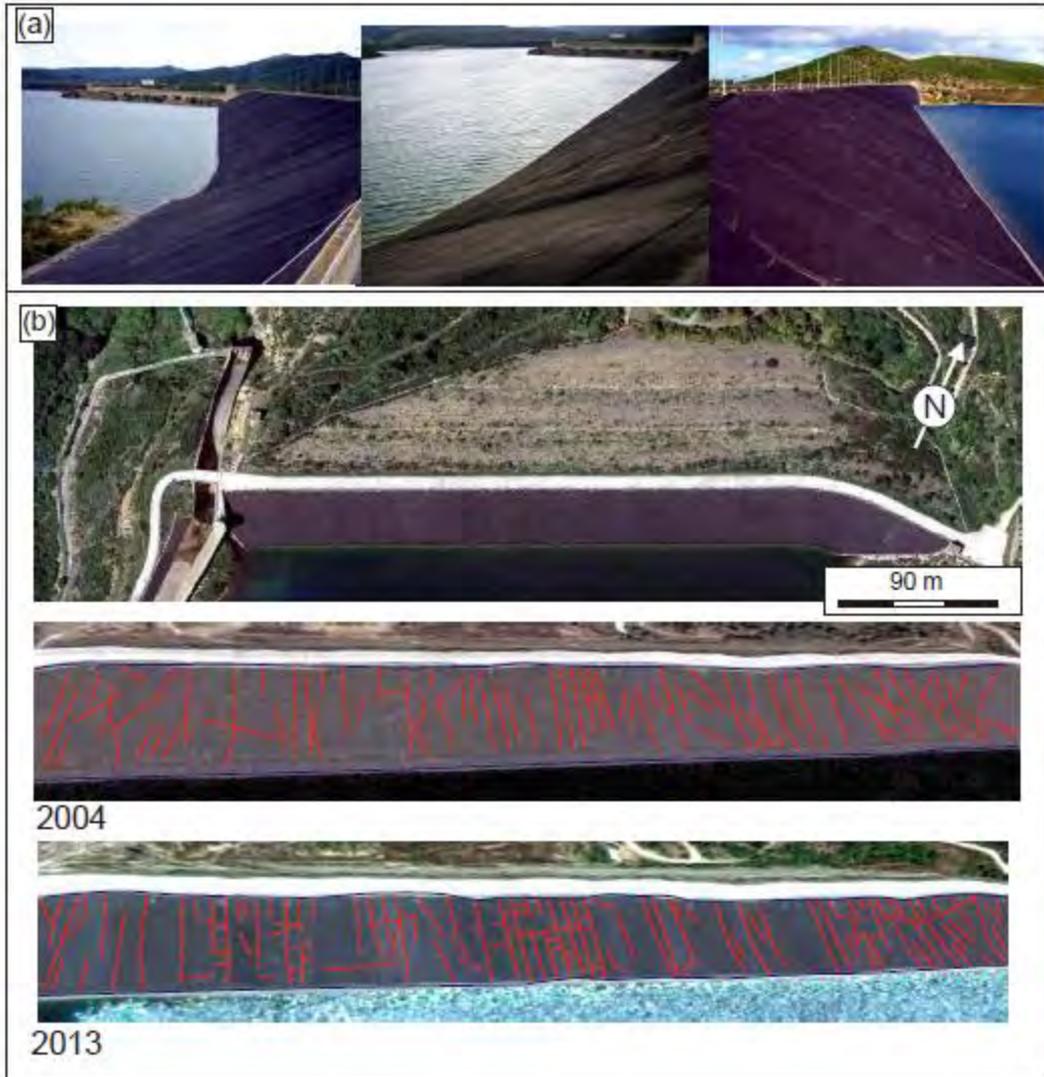
Figure 2

A surficial analysis of the upstream slope shows cracks that can be ascribed to three main groups (Fig. 2a): i) subvertical cracks perpendicular to the upstream slope (normal cracks) related to the limits between asphalt tiles; in general, these have linear traces, or eventually irregular trends between shingles, with differential relative movement (shear cracks: Fig. 2a), ii) subhorizontal cracks, having interruptions or small steps at the intersection between shingles, and defining small bulges or depressions; and iii) transverse cracks, showing a vertical component, that are less representative, usually affecting the asphalt layers and their limits. Deformation of the slab surface can also be expressed without rupture, by means of slope changes along the surface, topographical internal depressions between transverse and irregular cracks, and non-linear trends between different asphalt laminae. Crack distribution highlights the construction limits and indicates apparent differential movement between panels, as shown by shear and transverse cracks pre- and post-dating the reparation of the upstream dam face (see Fig. 2b for a comparative analysis between 2004 and 2013).

Figure 2. a) Photographs from the studied zone showing deformation and cracks along the dam slope. b) Photographs from 2004 and 2013, taken before and after the last reparation, are included where cracks can be identified.

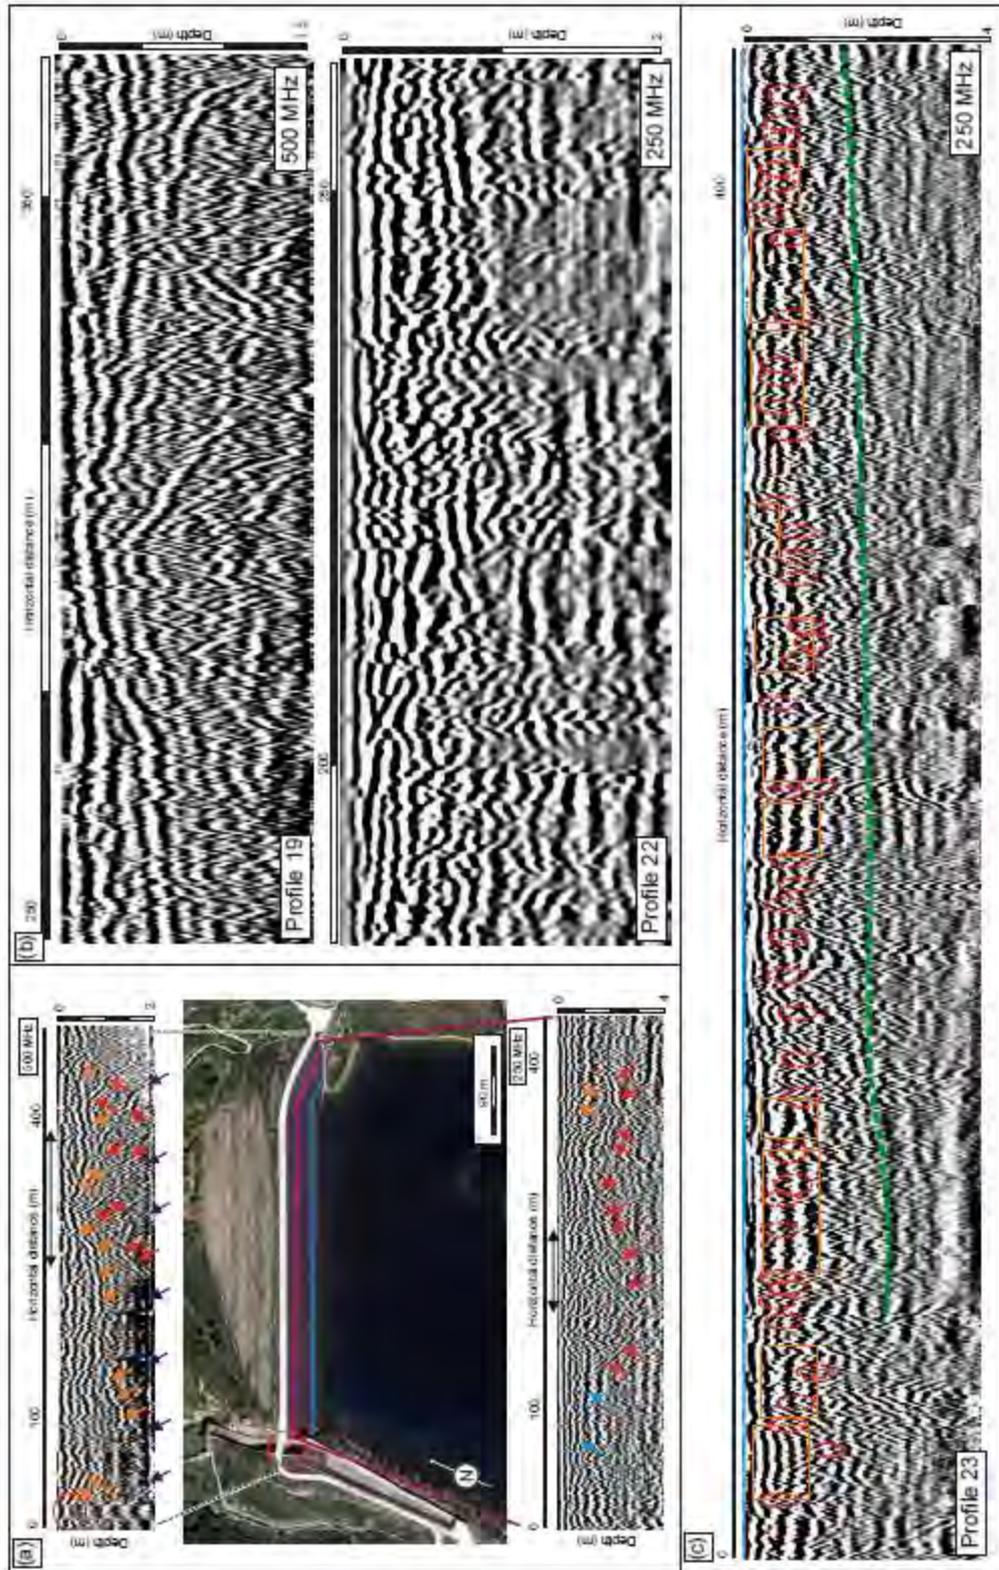
Figure 5

Data obtained in zone 1 (the upper part of Fig. 5a and b: 500 MHz), over the crest of the dam, show irregular reflector trends, with depth variations, tilting and changes in the thickness of the uppermost, more reflective unit. This result differs from the expected structure having homogeneous layers. In some cases, changes in the thickness of the upper units exceeded 1 m (Fig. 5a and b), or tilted reflectors or non-horizontal geometries were identified below this depth. The general trends of these changes along the crest are (i) a progressive increase in thickness of the upper unit in the western abutment (Fig. 5a), showing irregularities at approximately 2 m depth, (ii) a sudden decrease in thickness of the shallowest unit at 275 m (Fig. 5b: 250 MHz), defining a relative high, and again a concave-upwards geometry between this position and 450 m. At approximately 2 m in depth, a subhorizontal reflector, parallel to the surface, was found, indicating that the described structural changes only affect the upper part of the structure. This supports the identification of surficial structural changes that do not respond to propagation from deeper levels of the dam.

Along the upstream slope (zone 2; lower part of Fig. 5, a, b and Fig. 5 c: 250 MHz) different profiles over the asphalt shingles were conducted to identify its structure and the

Figure 5. a) GPR profiles over the crest and upstream zones (see photograph for location). In the profiles, reference to the structural changes, interruption of the expected horizontal distribution and net interruptions are marked by arrows. Coincident profiles for 250 and 500 MHz are shown. b) Detailed view of profiles included in (a) and made with 250- and 500-MHz antennas are shown. Net changes, structural variations, and thickness changes of most surficial units can be identified. Meters reference from (b) is the same as that in (a) where the profile location is marked by an arrow. c) Complete profile along the lower part of the dam where net interruptions related to the construction characteristics and changes of structure, thickness and dip of reflectors can be identified along the 250-MHz profile. The profile location is marked in (a). Note that changes are in many cases limited by net hyperbolic anomalies that present a correlation between profiles and are interpreted in terms of limits between asphalt layers.

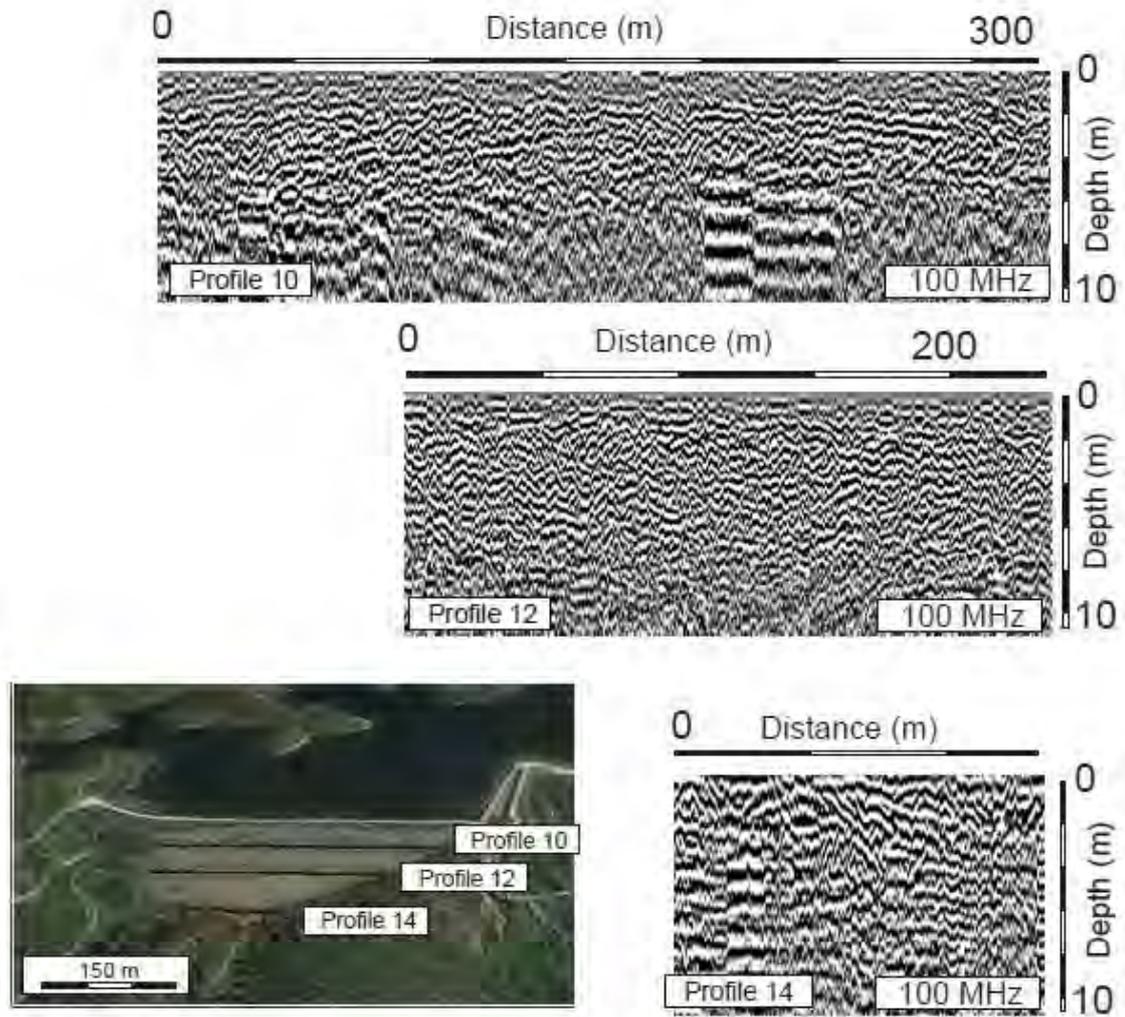
Figure 6

The survey along the downstream face did not show significant changes (Fig. 6; 100 MHz). In general, homogeneous or progressive thickness changes in the reflective upper unit or horizontal and progressive tilted reflectors were identified. A similar thickness, ranging from 6 to 9 m, was interpreted along the upper and intermediate profiles, with a lower penetration occurring when approaching the natural materials below the dam. At the abutments, the upper constructive levels show a more homogeneous pattern and do not define geometries liable to be interpreted in terms of sudden changes in thickness or tilted reflectors.

Figure 6. GPR profiles conducted along the downstream slope at different heights along the construction berms. A photograph with the location of the profiles is also included. All the profiles were conducted using 100-MHz antennas.

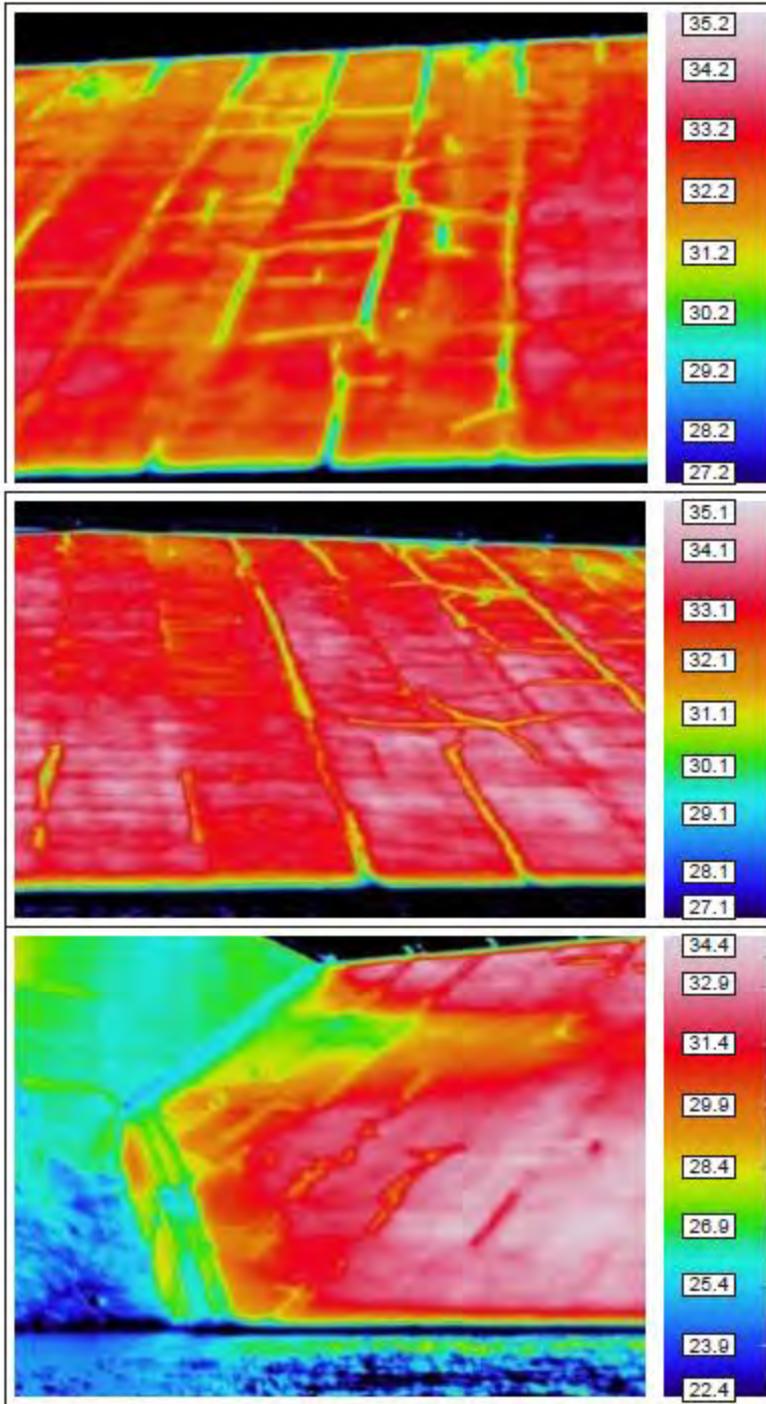
Figure 7

the upstream side of the dam (Fig. 7) to identify thermal changes in the asphalt layers or underlying units. Obtained results permitted us to identify two groups of linear thermal anomalies, one parallel to the main slope of the dam surface and a second that is perpendicular (horizontal). This distribution is interrupted at certain sectors where the parallelism disappears and irregular trends can be identified. These trends correlate in general with the surficial limits identified during the inspection and with the hyperbolic anomalies with a direct correlation between profiles identified using the GPR.

Figure 7. - Thermographic photographs from different sectors of the dam.

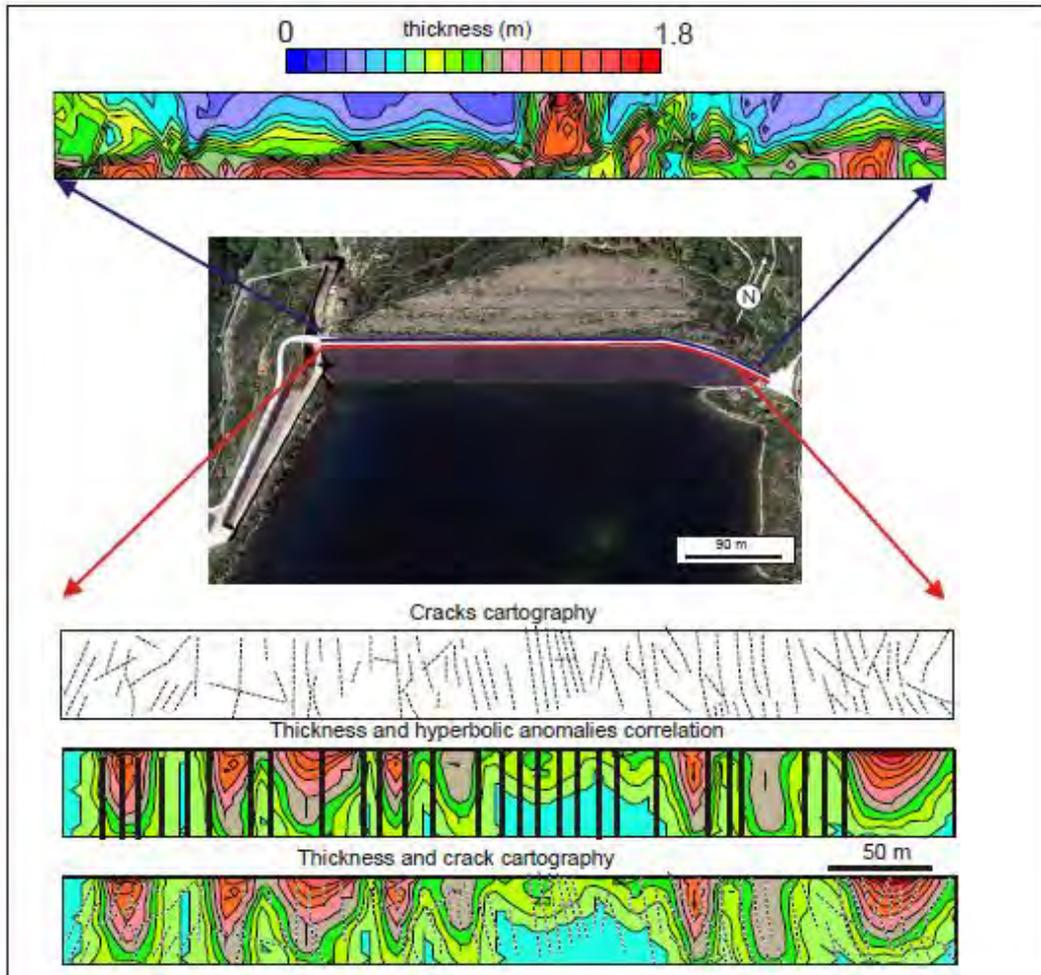
Figure 8

The limits of thickness changes along the southern sector of the dam show a general correlation with the open cracks and relative movements between asphalt laminae. The highest density of cracks indicates the strongest relative movement of asphalt laminae. Sectors with a smaller thickness of the non-horizontal unit identified in the GPR model usually have less

Figure 8. Model of involved thickness of deformed units along the crest and upstream slope of the dam obtained from the integration of the different profiles (a photograph with the location of the studied sectors is also included). In the model developed over the asphalt slab, hyperbolic anomalies with a direct correlation between profiles and the surficial identified cracks are shown.

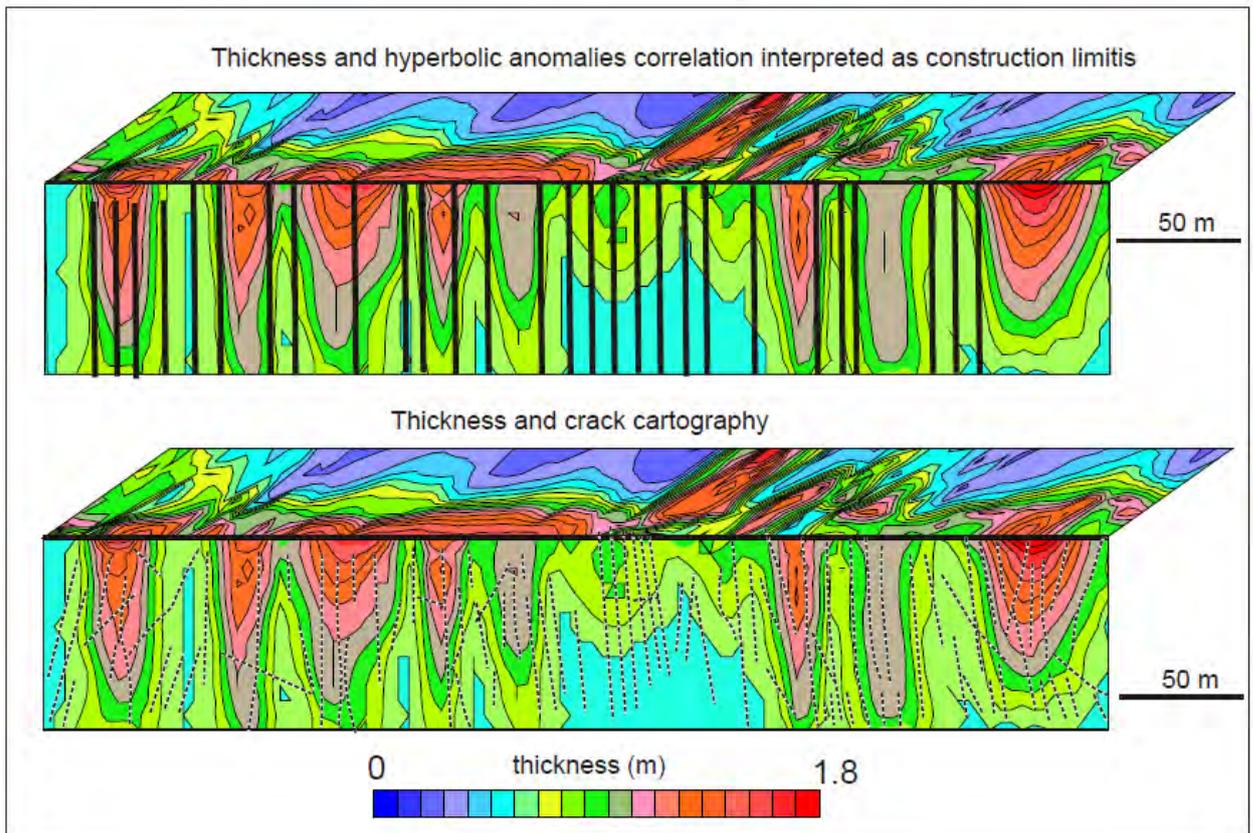
Figure 9

To evaluate the correlation among the identified changes, anomalies and their distribution, an integrated analysis of the different obtained profiles was conducted. The objective of this analysis was to evaluate the position of the lower limit for irregular trends, tilted reflectors or interruption of layers. The analysis was performed by picking up the position of the lower limit of the non-horizontal areas from the different profiles, especially the 250-MHz profiles, that were the most systematically performed. A model of the correlation of the identified limits along the different profiles from survey zones 1 and 3 was completed to evaluate the degree of correlation between the profiles and their potential correlation with the identified cracks and problems affecting the asphalt layers. On the one hand, it seems that the systematic group of the hyperbolic anomalies identified in the radargrams with a direct correlation between profiles can be ascribed to the construction limits of the impervious slabs (Fig. 8) that were also identified during the thermographic analysis (Fig. 7). The comparison between the surficial movements and cracks to the underground structure shows that the sectors showing the strongest structural changes in the GPR profiles (Fig. 9) correlate with the sectors where higher

surficial movements were detected. The thickness distribution of the involved materials and non-horizontal reflectors coincide with a stronger deformation of asphalt laminae. This correlation substantiates that the surficial movements involve a greater thickness than the asphalt layers and include materials of the dam structure itself. The same methodology of correlation between profiles was also applied for the upper part of the dam (crest), although in this sector, there is no evidence of cracks affecting the survey zone. However, this analysis can permit the direct comparison of the underground structure along the crest and the upstream face (Fig. 9).

Figure 9. Oblique models showing a correlation of deformed sectors identified in the GPR profiles at the crest and upstream slope. Isolated anomalies with lateral correlation and cracks identified in the asphalt are also included. Note that the cracks are drawn using the most recent aerial photograph in the area (2013) after repairing and reconstruction.
