## Case study

## Evaluation thermal of the building envelope: Rehabilitated building versus non-rehabilitated

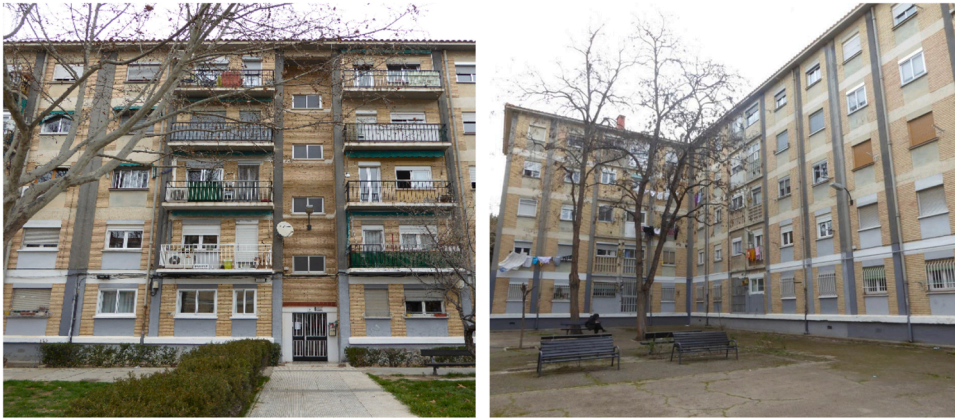
Fig. 2. View of the building (Oroel n°2) before rehabilitation. South (left) and North (right) facades.

In its initial state (Fig. 2), it is a property that has a ground floor plus four floors, all of them for residential use. In the central axis of the ground floor is the access that leads to the staircase, from which you can access the different floors. Initially, the building did not have an elevator.

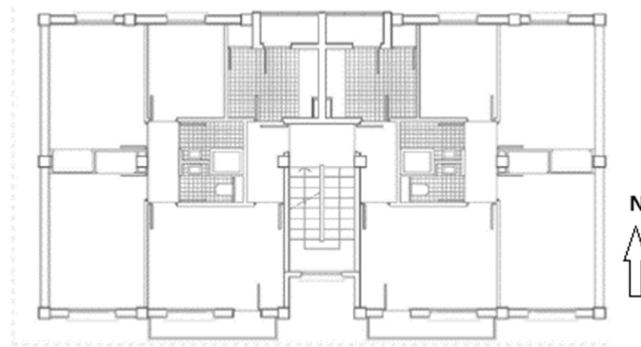
Fig. 3. Type floor of the building non-rehabilitated.

Two symmetrical apartments are located on each of the floors. Each of the apartment has a living room, three bedrooms, kitchen, bathroom and/or cloakroom, entrance and hallway (Fig. 3).

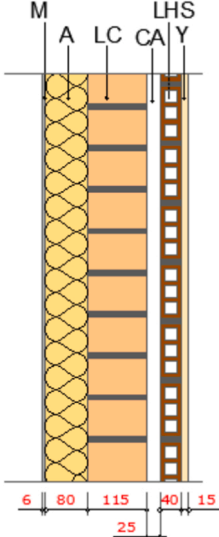
(LC) Facing brick (5 × 11.50 × 25 cm) (CA) Air chamber (2.50 cm) (LHS) Hollow brick (4 cm) (Y) Gypsum plaster (1.50 cm)	(T) Ceramic tile (M) Cement mortar (3 cm) (TC) Ceramic Slab (4 cm) (CA) Air chamber (2.50 cm) (FU) One-way slab (Y) Gypsum plaster (1.50 cm)	(M+A) (EIFS) using the REDArt system. RockSATE Duo insulation consists of 80 mm rock wool with a thermal conductivity of 0.04 W/mK. (LC) Facing brick (5 × 11.50 × 25 cm) (CA) Air chamber (2.50 cm) (LHS) Hollow brick (4 cm) (Y) Gypsum plaster (1.50 cm)	(T) Ceramic tile (M) Cement mortar (3 cm) (TC) Ceramic Slab (4 cm) (CA) Air chamber (2.50 cm) (A) 120 mm. rock wool with thermal conductivity 0.04 W/mK. (FU) One-way slab (Y) Gypsum plaster (1.50 cm)

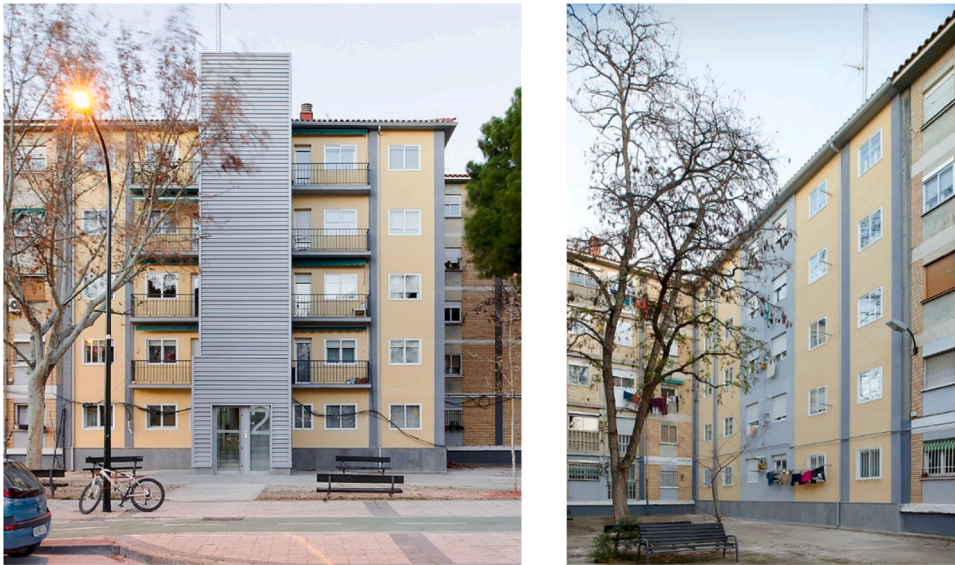
Fig. 4. View of the building (Oroel 2) after rehabilitation. South (left) and North (right) facades (Photo: Iñaki Bergara).

The Fig. 4 shows some images of the renovated building.

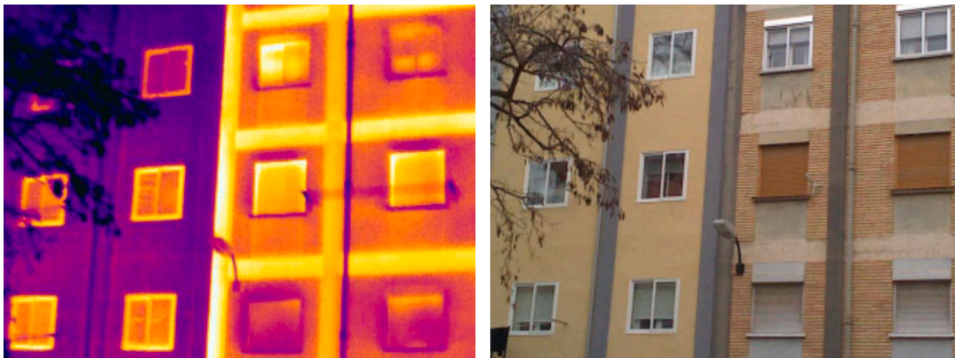
Fig. 5. Comparative thermographic and optical images of the north façade of a rehabilitated and non-rehabilitated building.

A complete thermographic study of the building was carried out to verify the correct execution of the EIFS installation on the envelopes [52]. Fig. 5 shows the optimum result in the thermal insulation achieved in the façade compared to the building non-rehabilitated, the thermal bridges have been removed.

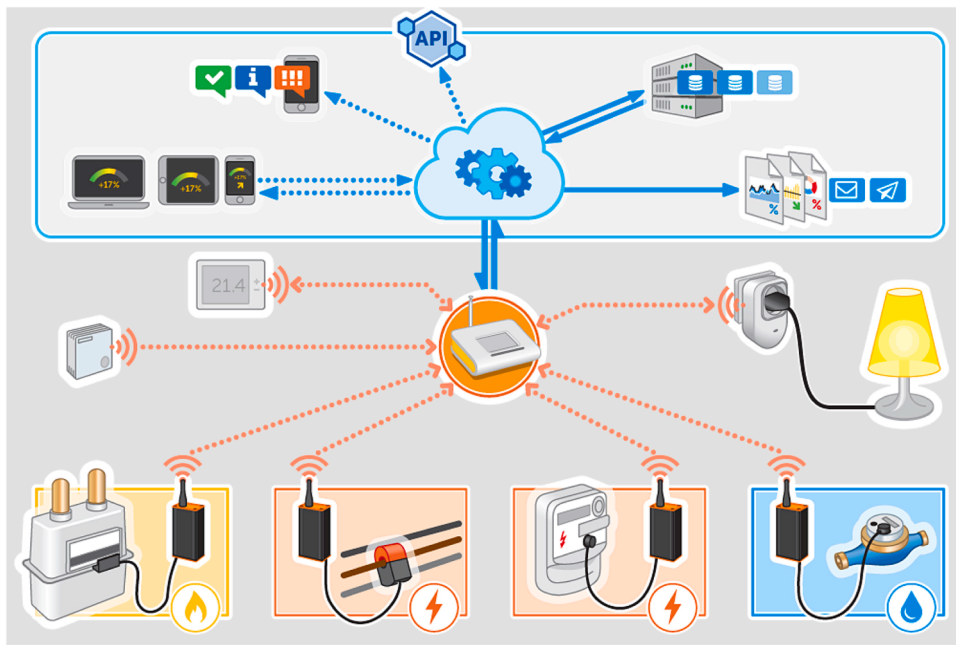
Fig. 6. Monitoring system operating diagram [59].

Once the type of gas metre to be monitored and the electrical consumption communication system were determined, different combinations of sensors were studied to monitor all the variables required for this work. After evaluating different solutions taking into account the economic cost and technical characteristics (scope, autonomy, precision, etc.), the complete solution offered by the distributor Cliensol Energy S.L. was chosen [59]. Since it covers all the technical needs related to monitoring and at the same time, by obtaining all the devices from the same supplier, delivery times and costs associated with transport are reduced. This, in addition to centralizing access to the measured data from a single platform, facilitating its management and avoiding additional costs due to the subscription to different data management platforms. The operating diagram of the monitoring system is shown in Fig. 6.

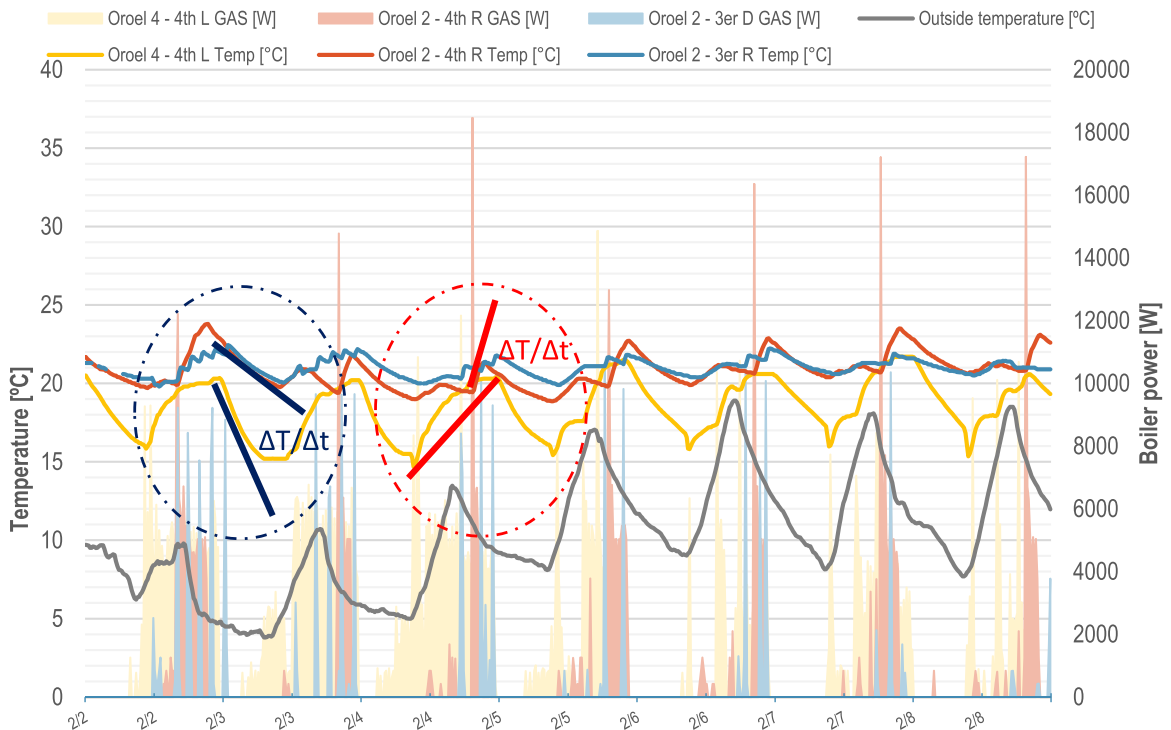
Fig. 7. Evolution of the temperatures and the power supplied by the boiler for a cold week.

Fig. 7 represents the temporal evolution of the exterior temperature, as well as the interior and gas consumption for three characteristic apartments (Oroel 2–4th R, Oroel 2–3rd R, and Oroel 4–4th L). The temperature values [°C] are represented as a line, whose

scale is represented on the left vertical axis. The power supplied by the boiler [W] is associated with the bars represented in the lower zone, whose scale is associated with the right vertical axis. The area contained under the bar graphs corresponds to the energy consumed in the form of natural gas. This type of graph will be used in the following points:

In this period, the two rehabilitated buildings (Oroel 2–4th R, Oroel 2–3rd R) maintained a relatively constant temperature, while the non-rehabilitated house (Oroel 4–4th L) had greater temperature fluctuations during the day-night cycle. This greater oscillation is accompanied by higher heating consumption in nonrenovated homes. This shows the benefit of exterior insulation on the stability of the interior temperature.

The cooling or heating rate ( $\Delta T/\Delta t$ ) of the apartments can be evaluated considering the variation in the ambient temperature ( $\Delta T$ ) of the same in a certain period of time ( $\Delta t$ ) (Fig. 7).

In this case, the average nighttime cooling rate ( $\Delta T/\Delta t$ ) of the building (from 1 to 7 am) is 0.23 °C/hour for the renovated dwelling, while for the nonrenovated dwelling, it is 0.51 °C/hour. Therefore, the renovated building cools 2.21 times faster than the renovated building for the same outdoor temperature.

During the day, when a lack of comfort is detected in the home, the heating system is switched on. The heating of the rehabilitated buildings is 70 % faster than that of the non-rehabilitated buildings, with a heating rate of 0.93 °C/hour for the former and 0.64 °C/hour for the latter.

In addition, there is a small increase in thermal losses on the fourth floor compared to the third, since at the beginning of the period without heating (00:00 h), the apartment located under cover (last floor) is at a higher temperature than that located between floors, and at the end of the period without heating (7:00 h), its temperature is lower, so it has a slightly higher cooling rate. The behaviour that has just been mentioned is associated with a specific day, but it has been verified that it is fulfilled during the entire period studied and is caused both by the influence of the thermal bridges of the roof and by the greater surface exposed to the outside-temperature conditions.

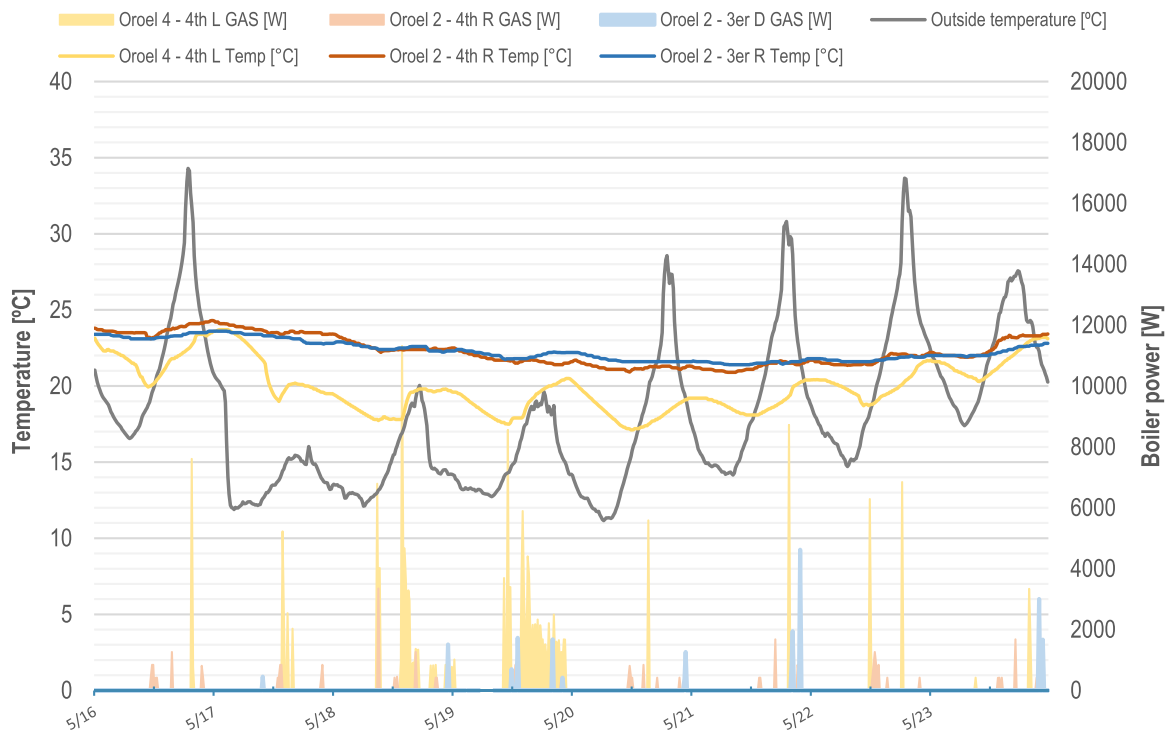
Fig. 8. Effect of thermal inertia (05/16 to 05/22).

A sample of the effect of thermal inertia is the week of May 16 to 22, 2019 (Fig. 8). From May 16 to 17, the outdoor temperature dropped sharply (a difference of 18.5 °C between the daily maximums), and the low temperatures were maintained for three days, recovering later. In the three days, the interior temperature of the rehabilitated building barely fell 3 °C. The apartment did not need to

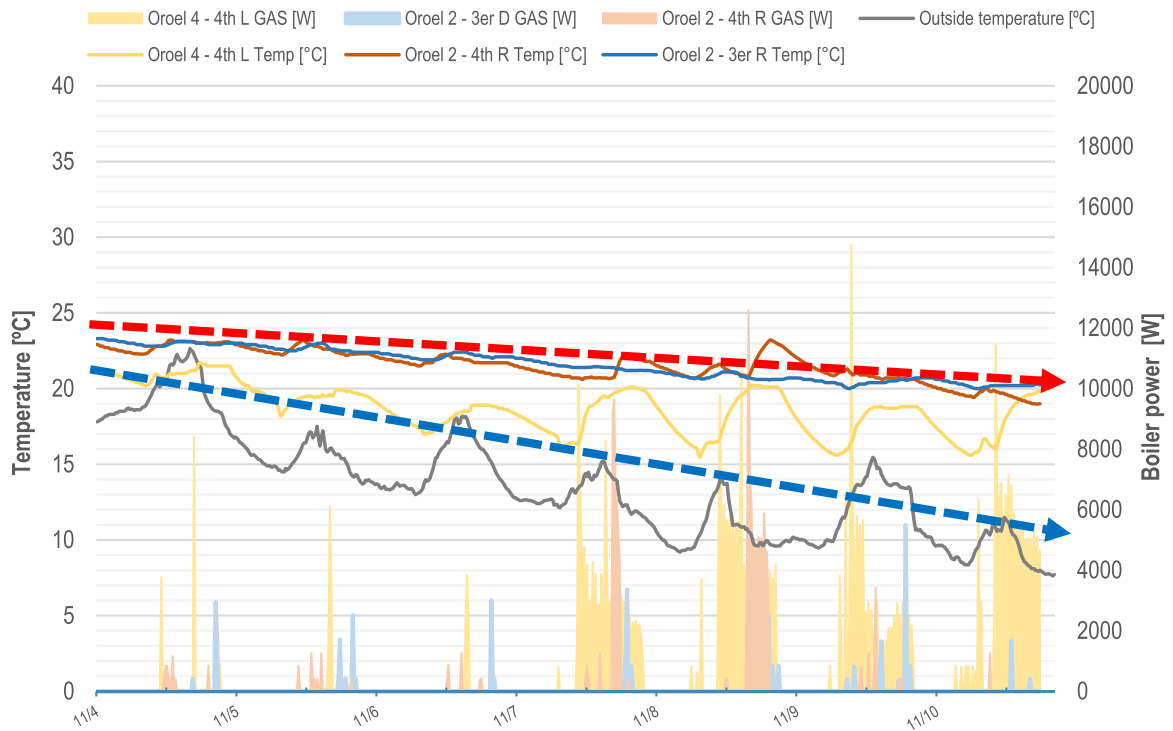
**Fig. 9.** Effect of thermal inertia change towards winter (11/4 to 11/11). The dashed red line shows the trend of indoor temperatures, the dashed blue line the trend of outdoor temperatures.

In periods of time in which the temperature variation is continuous, as is the case of the change of season towards winter, the effect of the exterior insulation is also important (thermal inertia), as shown in Fig. 9.

From November 4 to 11, 2019, the tendency of the outdoor temperature decreased due to the onset of winter, with an average drop of approximately 10 °C on those days. It is observed that the trend of the interior temperature of the renovated homes tends to decrease, but in a more buffered way (Fig. 9 red line), with a drop of only 4 °C, without having the need to connect the heating system.

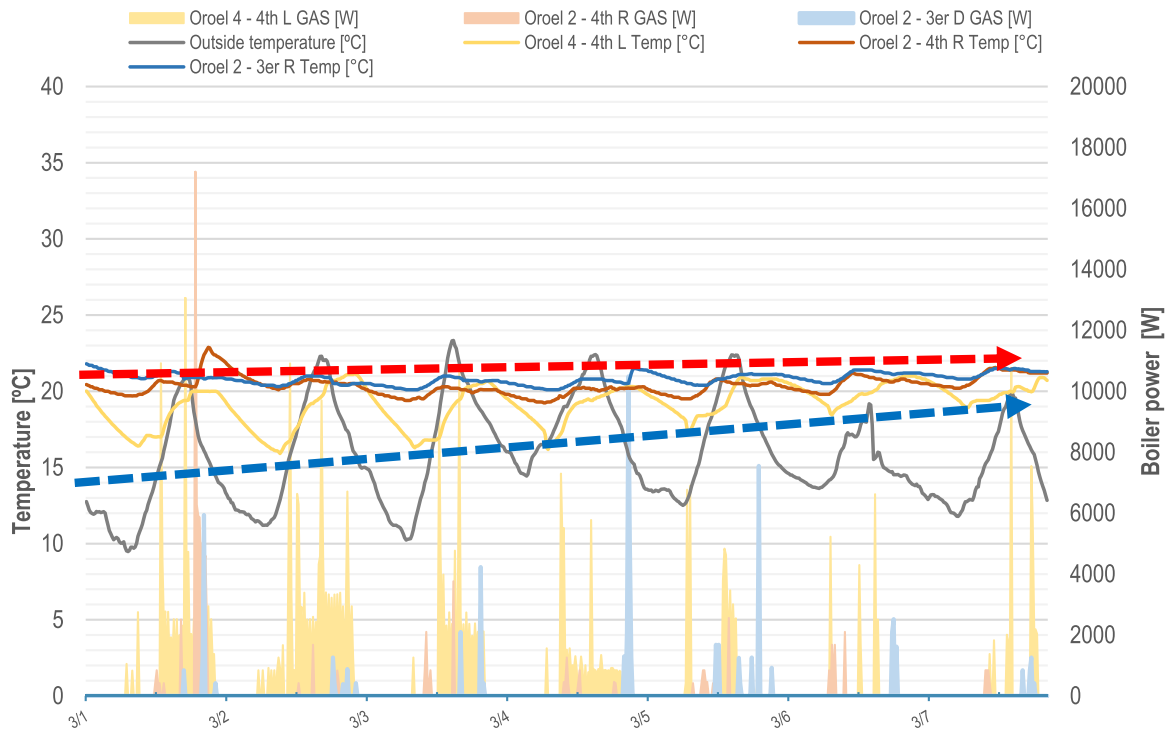
**Fig. 10.** Effect of thermal inertia change towards summer (3/1 to 3/7). The dashed red line shows the trend of indoor temperatures, the dashed blue line the trend of outdoor temperatures.
