Article

Influence of the Arrangement of the Cells/Modules of a Traction Battery on the Spread of Fire in Case of Thermal Runaway

Citation: Olona, A.; Castejón, L. Influence of the Arrangement of the Cells/Modules of a Traction Battery on the Spread of Fire in Case of Thermal Runaway. *Batteries* **2024**, *10*, 55. <https://doi.org/10.3390/batteries10020055>

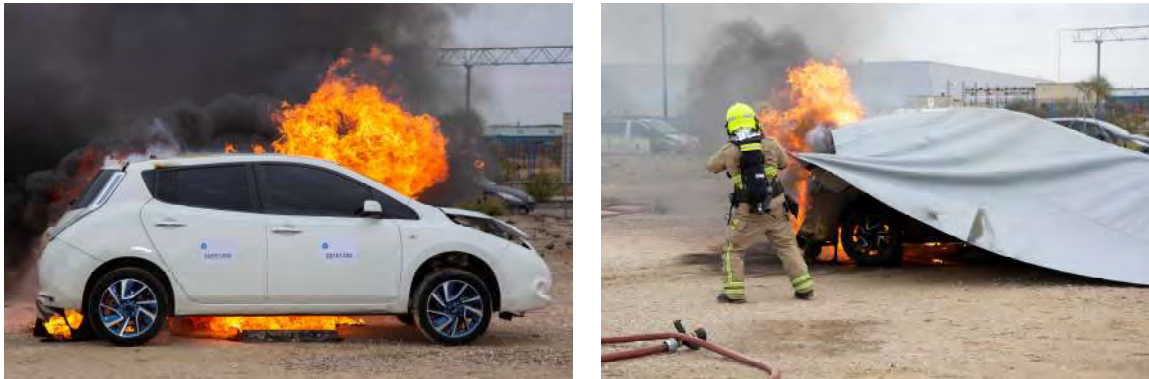
Figure 2. Zaragoza City Council firefighters covering the burnt vehicle with the fire blanket.

Initially, the fire was extinguished using a fire blanket (Figure 2). After just over ten minutes from the beginning of the test, the temperature in the battery area exceeded 1000 °C. It was at this point that the firefighters proceeded to cover the vehicle with the blanket. Immediately after the vehicle had been covered by the blanket, the surface temperature of the vehicle dropped from approximately 850 °C to about 350 °C. From this moment on, the blanket insulates the vehicle from the radiation emitted by the fire, preventing any element from spreading into the environment and, at the same time, cooling the vehicle. In addition, the blanket prevents the oxygen supply, preventing the fire from continuing when all the oxygen confined under the blanket is consumed.

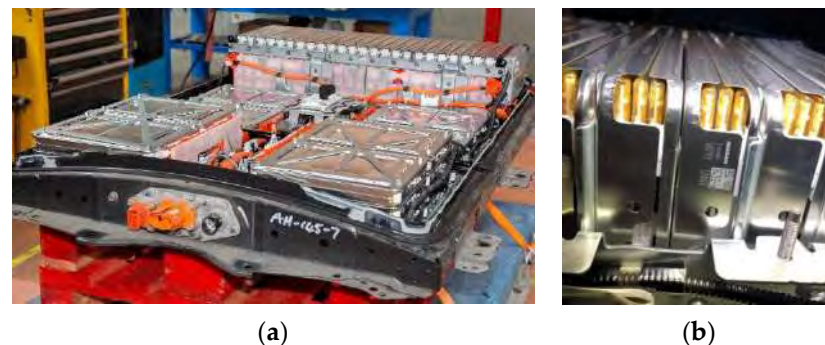
Figure 3. (a) Battery pack before fire test. (b) Detail of a battery module constructed with a 4-cell configuration).

The following shows the state of the battery pack (Figure 3a) and a detailed view of the battery modules (Figure 3b) before the fire test:

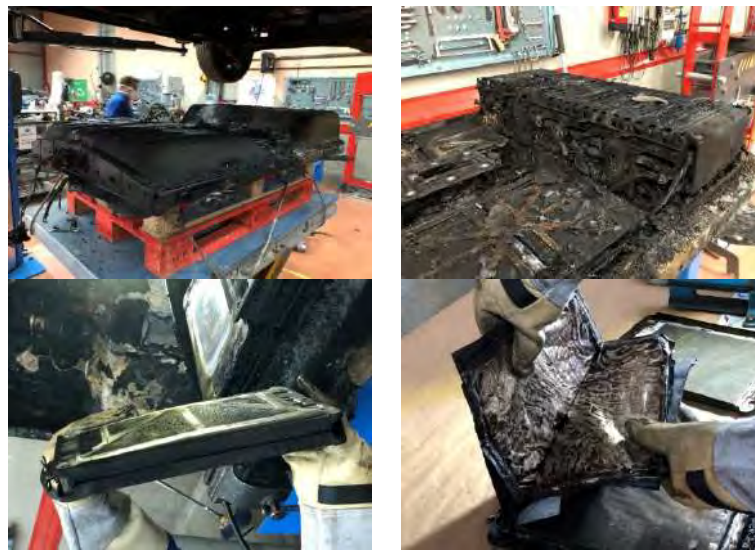
Figure 5. Pictures of the state of the battery pack, the module, and the lithium-ion cells inside the battery pack.

Once the test had been carried out and the necessary quarantine time had elapsed, the cells were dismantled (Figure 5) to see how they behaved and their condition according to the position they were in. The aim was to analyze how the enclosure was damaged according to the position of each cell within the enclosure. Moreover, deformation suffered by each of the cells was studied. Finally, the condition of these cells has been perfectly documented.

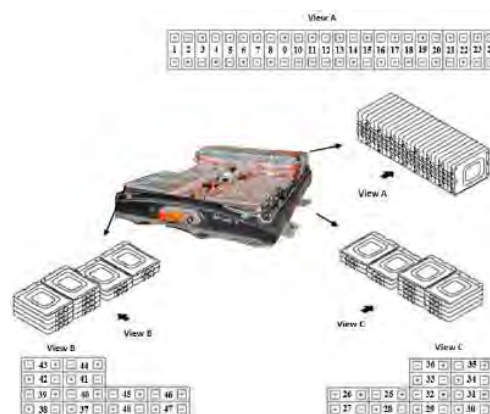
Figure 6. Exploded view and module identification of the traction battery of a first-generation Nissan Leaf.

In Figure 6 a number has been assigned to each of the battery modules in order to identify them.

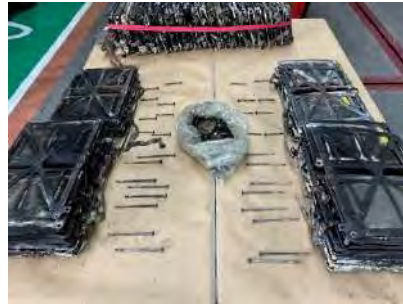
Figure 7. Burnt Nissan Leaf battery disassembled in the arrangement in which it is in the vehicle.

Figure 7 shows burnt Nissan Leaf battery disassembled in the arrangement in which it is in the vehicle.

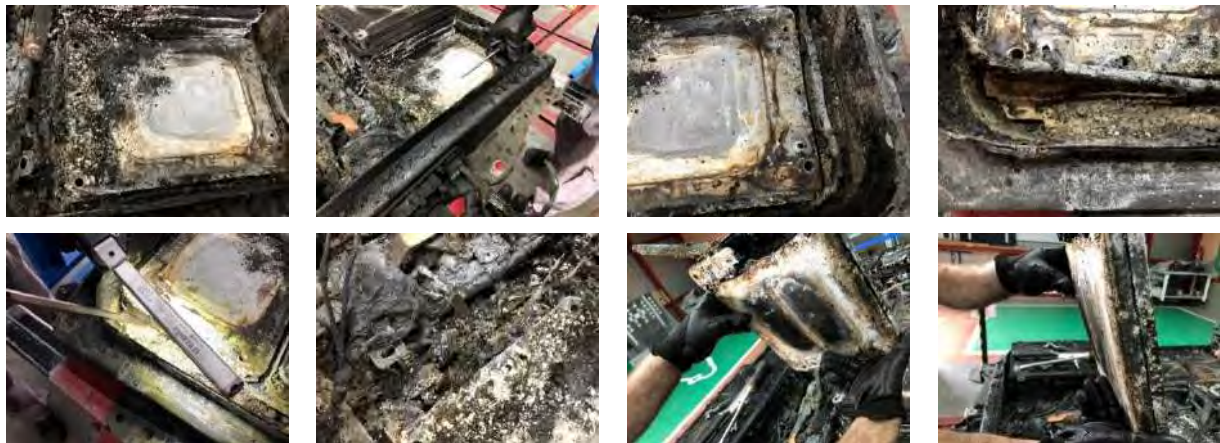
Figure 8. Images of the condition of module 30 (horizontal arrangement) of the battery pack of the burnt Nissan Leaf vehicle. This module has been identified as the most damaged among the modules in the horizontal arrangement.

Once the burnt battery of the Nissan Leaf had been disassembled, the most damaged modules were visually identified, being those modules that showed the greatest deformation and breakage, both vertically (module 11) and horizontally (module 30), and all modules were disassembled and visually analyzed.

The following pictures show the state of the most damaged modules, firstly, Figure 8 shows the state of the burnt Nissan Leaf vehicle battery module 30 and secondly, Figure 9 shows the state of the burnt Nissan Leaf vehicle battery module 11:

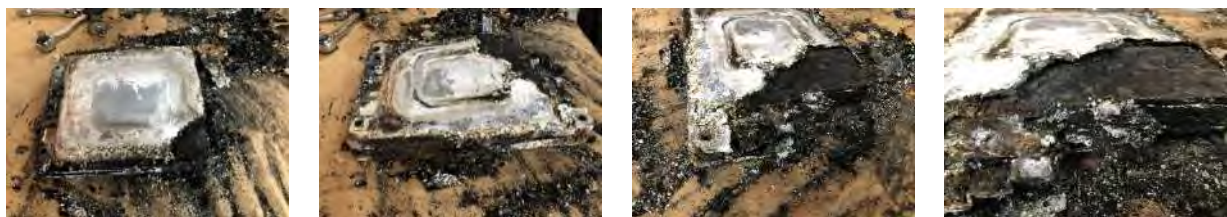
Figure 9. Images of the condition of module 11 (vertical arrangement) of the battery pack of the burnt Nissan Leaf vehicle. This module has been identified as the most damaged among the vertically arranged modules.

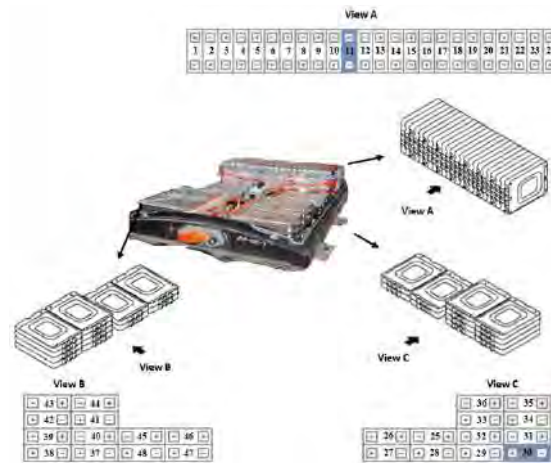
Figure 10. Exploded view of the first-generation Nissan Leaf battery, with identification of the most damaged modules, shaded in blue.

The following Figure 10 identifies the position of the most damaged modules in the battery pack analyzed:

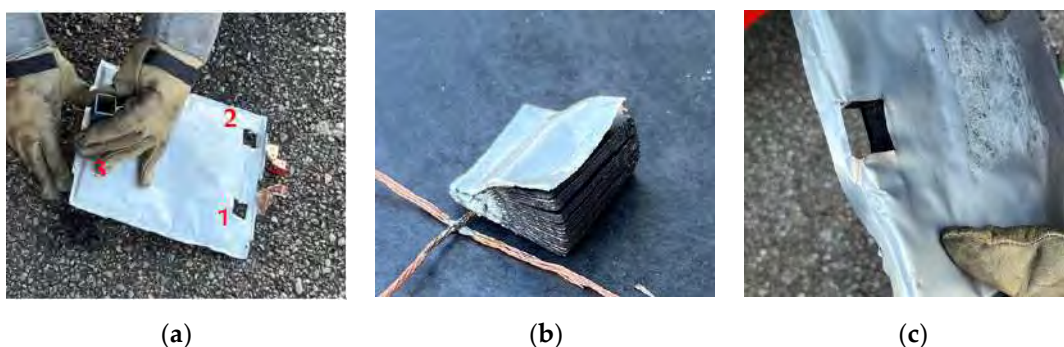
Figure 11. Sample and obtaining the sample for structural analysis. (a) Location of the points from where the samples have been obtained for the structural analysis of the stacked layers: 1. Anode tab (copper); 2. Cathode tab (aluminum); 3. (b) Sample generated in position 3. (c) Section of the pouch cell once the sample has been extracted.

For the structure analysis test, three transversal section samples were taken from a cell of module 11, three transversal section samples from a cell of module 30, and two transversal section samples from a new cell. For chemical composition and morphology analysis, one sample was taken from the cathode, one sample from the anode, and one sample from the separator for module 11, module 30, and the new cell, respectively. The samples for the tests were obtained at Centro Zaragoza facilities, and once the samples had been obtained, the tests were carried out at the Material Science Department of the University of Zaragoza. Sampling has been carried out considering the indications of a previous study [35]. Images from sample preparation to Sibe tested for the new cell are shown below.

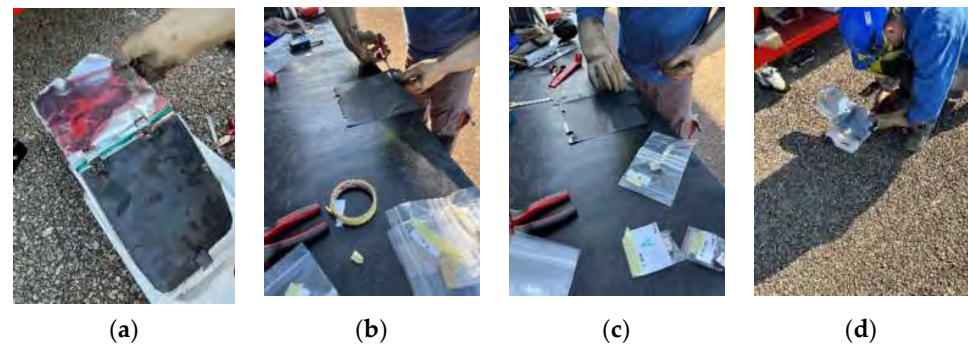
Figure 12. Obtaining the sample for surface analysis. (a) Image of the inside of a pouch cell from where the samples for surface analysis of the stacked layers (anode, cathode, and separator in the case of the intact cell) have been obtained. (b) Sample generated from the anode (copper tab). (c) Sample generated from the cathode (aluminum tab). (d) Sample generated from the separator.

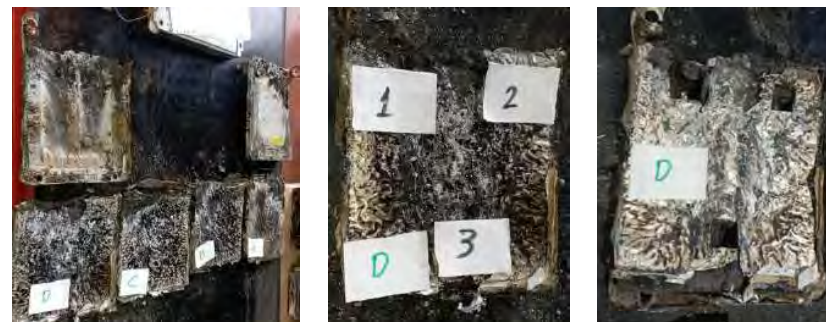
Figure 13. Obtaining samples from a module 30 calcined cell. The letters A–D identify the cell within the module and the numbers 1–3 indicate the position from which the sample has been taken.

Figure 13 below shows the position from which samples have been taken from a calcined cell of module 30:

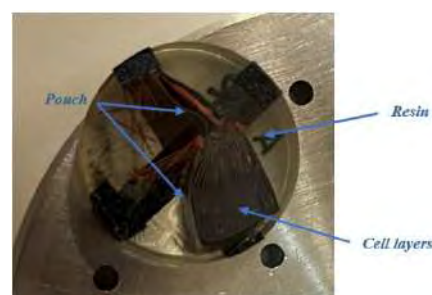
Figure 14. Layer structure of a resin-embedded and polished cell, used to identify cell parameters and cell structure.

After obtaining the samples, with a surface area of approximately $10 \text{ mm} \times 10 \text{ mm}$, from the electrode stack, the samples are embedded in resin to improve the preparation result and then polished so that the surface is scratch- and deformation-free, flat, and highly reflective. A prepared sample embedded in resin is shown below (Figure 14).

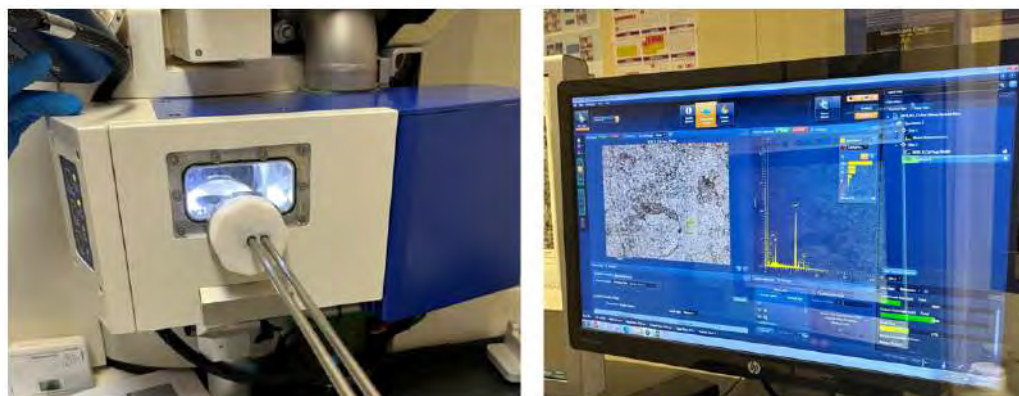
Figure 15. Views of the surface tests carried out.

The Figure 15 below shows two views of the surface tests carried out.

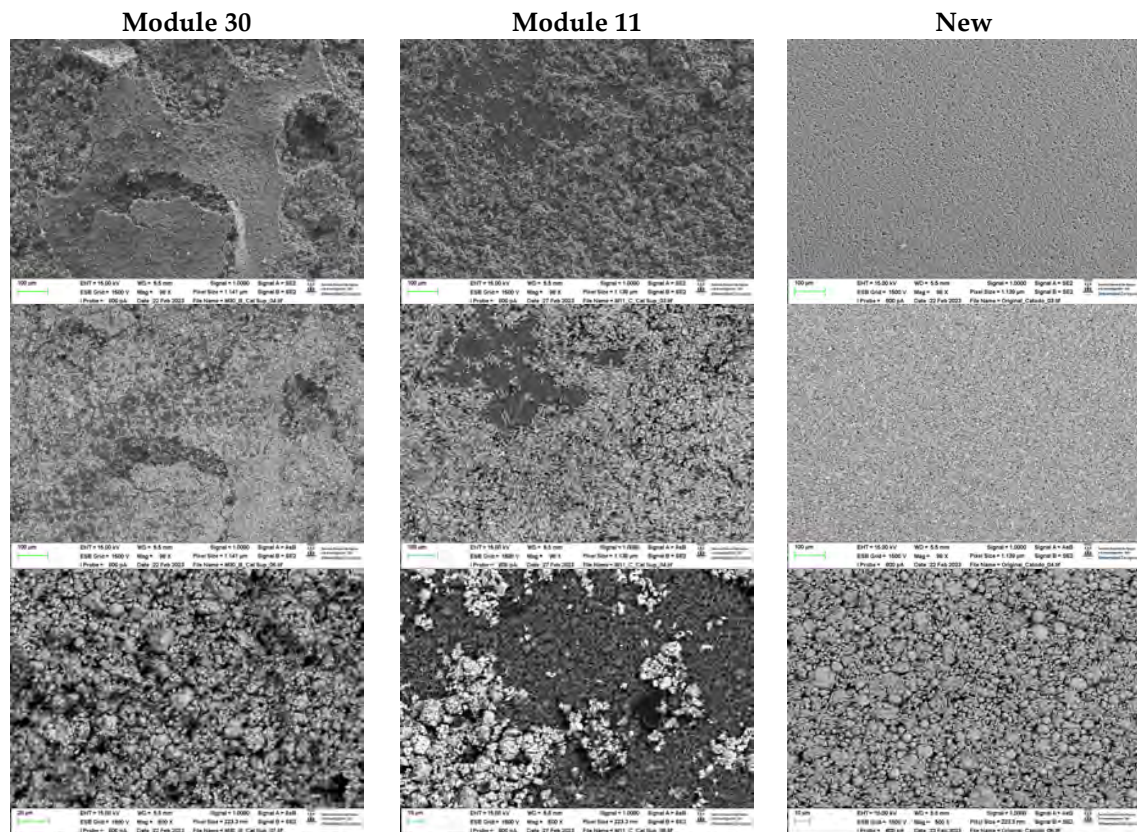
Figure 16. Comparison of images obtained with the FESEM of different areas of the upper cathode of module 30, module 11, and the new cell.

The following images (Figure 16) compare different pictures obtained with FESEM of the upper cathode of module 30, module 11, and the new cell.

With respect to the cathode electrodes in the figure above, the cathode of an original cell has been compared with two cathodes (one upper and one lower) of module 30 and module 11 of the battery of the burning Nissan Leaf after experiencing the thermal runaway. It should be remarked that rather than a single particle size, most materials, especially the active materials used in battery electrodes, contain a variety of particle sizes.

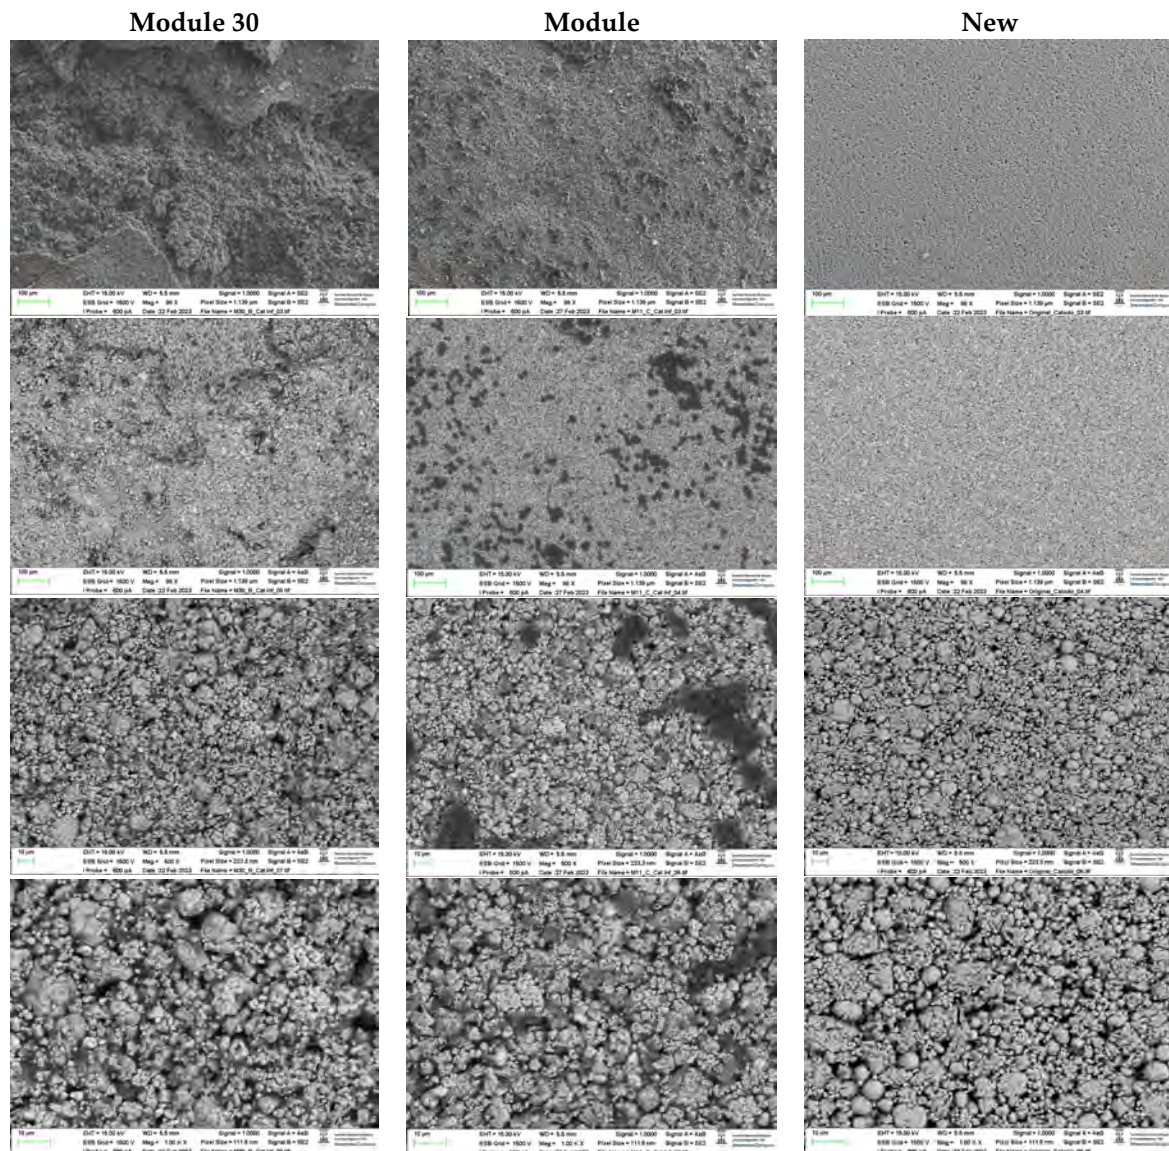
Figure 17. Comparison of images obtained with the FESEM of different areas of the lower cathode of module 30, module 11, and the new cell.

It is noted in Figure 17 that after experiencing the thermal runaway phenomenon, the cathode surface is covered with off-white floccules. The distribution of these floccules on the surface of the cathode electrodes is not uniform, being more concentrated in one area and more dispersed in another area.

The temperature of decomposition of a PE-PP-based polymer is more than 300 °C. Therefore, it is appropriate to cover the surfaces of the cathode electrodes with unevenly distributed separator particles.

It should be noted that the burned modules being analyzed had a 68% SoC (State of Charge). As the SoC increases, the number of flocs increases greatly, and darker-colored and spherical flocs appear, indicating that having an elevated SoC during TR, the reaction temperature inside the cell is higher, and the agglomeration and decomposition reactions of the separators are more intense [36].

It is observed that in the case of module 11, there are more dark-colored flocs than in the case of module 30, and there are more in the upper cathode than in the lower cathode. Therefore, it is concluded that module 11, in a vertical arrangement, experiences a higher

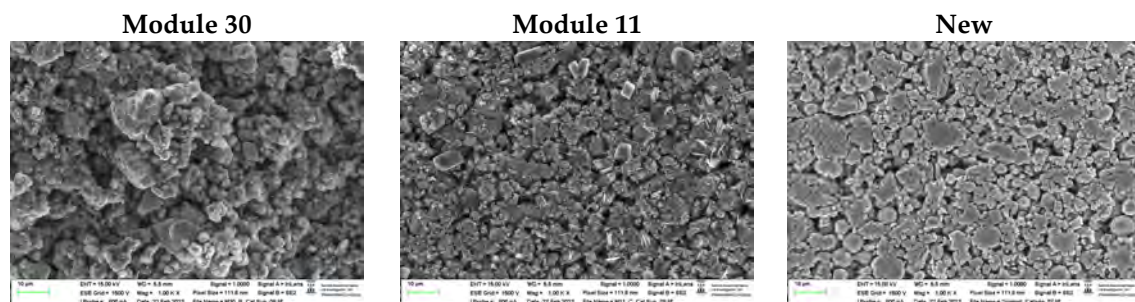
Figure 18. Morphological analysis of the transformation of the upper cathode of Module 30 and Module 11 after the thermal runaway compared with the initial cathode structure of a new cell.

temperature in the TR at the same SoC as module 30, which is in a horizontal arrangement. If the structural transformation (morphology analysis with InLens) of the cathode materials after the TR is analyzed (Figures 18 and 19), it is observed that in the case of modules 30 and 11 with a SoC of 68% after the TR, the layered structure of the material was destroyed, the resulting particles dispersed out of the original layered structure and subsequent adhesion occurred. The cathode (positive electrode) material reacted at high temperatures and decomposed. On the other hand, carbon particles from the anode (negative electrode) were doped into the cathode (positive electrode) through the damaged diaphragm.

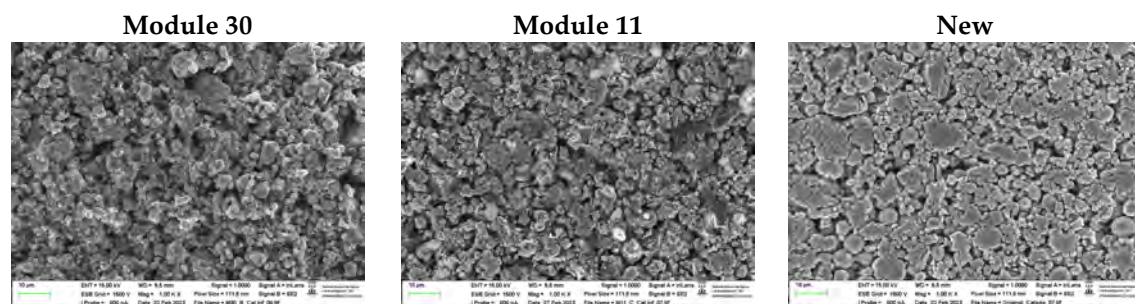
Figure 19. Morphological analysis of the transformation of the lower cathode of Module 30 and Module 11 after the thermal runaway compared with the initial cathode structure of a new cell.

It is observed that in the case of the lower cathode of module 30 (horizontal arrangement), the particles are smaller compared to the upper cathode of module 30; this may be due to the higher temperature as it is more exposed.

In the case of module 11 (vertical arrangement), there is no difference between the particle size of the upper cathode and the lower cathode. Hereafter, the chemical composition analysis of the upper cathode of module 30 and module 11 will be presented in comparison to the composition of the original cathode. The cathode showed a granular surface structure, as can be seen in the following image (Figure 20). The largest particles were about 6 μm in size. The following chemical elements were identified by EDXS: nickel (Ni), manganese (Mn), cobalt (Co), oxygen (O), and carbon (C). This led to the conclusion that this compound has the chemistry of a LiNiMnCoO_2 (NMC) cathode. Two different types of compounds were observed on the cathode surface, marked in Figure 21 by two red boxes. The results of a detailed analysis of the formed compounds show that the compound marked with “1” had the NMC chemistry mentioned above, while the second compound was determined to be a manganese oxide compound (LMO), some fluorine was also observed that may be from the electrolyte (LiPF_6) when in contact with the cathode and anode. Considering these issues, cathode layer chemistry could be concluded as a mixture of NMC and LMO.

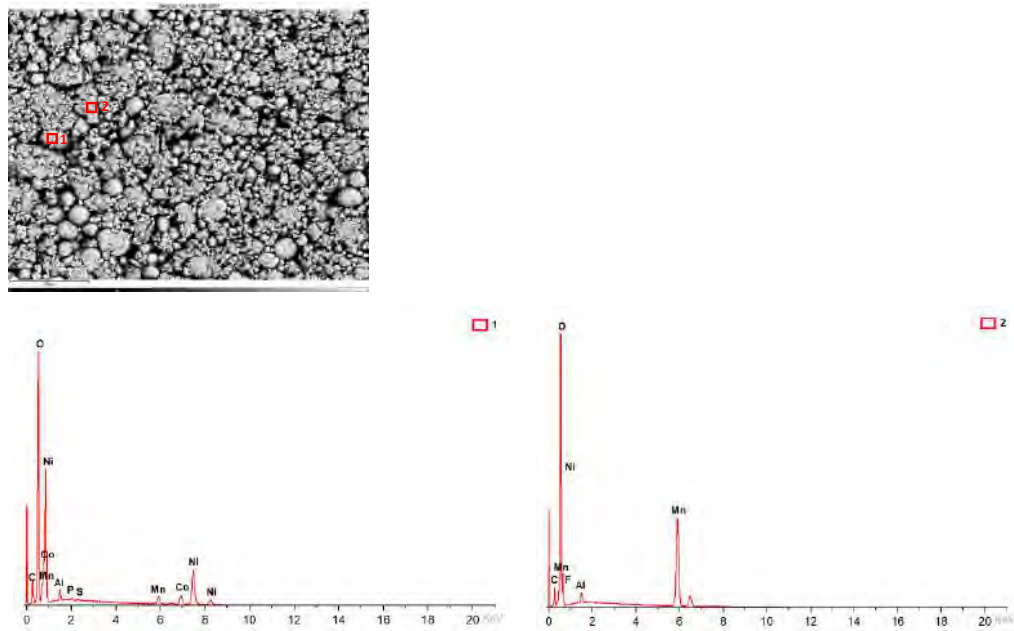
Figure 20. Chemical composition of the original cathode.

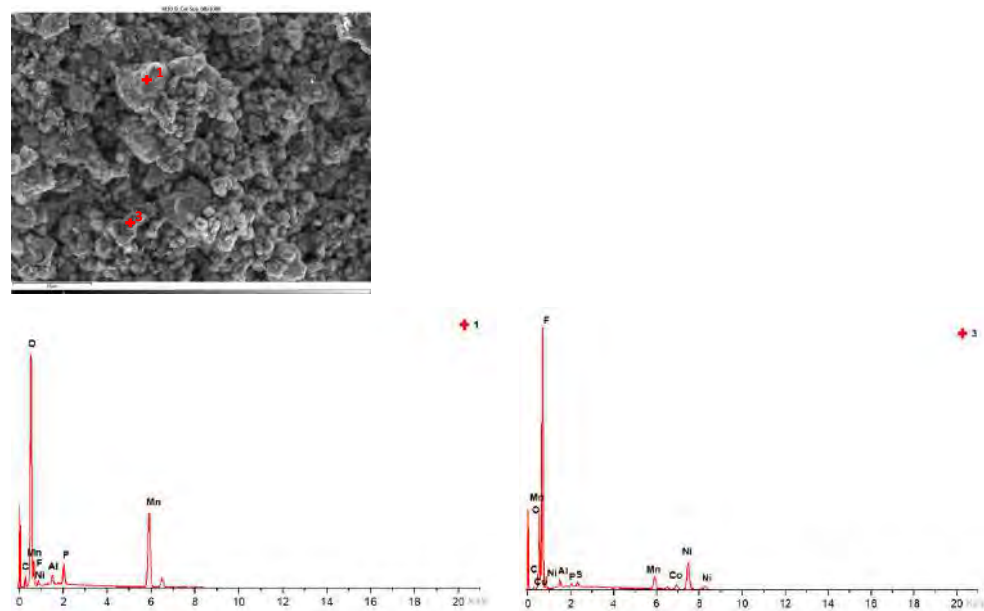
Figure 21. Chemical composition of the upper cathode of module 30.

Next, the chemical composition of the upper cathode of the ignited module 30 is analyzed. The upper cathode of module 30 no longer shows a defined granular surface, as in the case of the original cathode; the structure was broken. The largest particles are about 5 µm in size. The following chemical elements were identified by EDXS: nickel (Ni), manganese (Mn), cobalt (Co), oxygen (O), fluorine (F), phosphorus (P), carbon (C), and aluminum (Al). Two different compound types were observed on the cathode surface of module 30, marked in Figure 21 by two red crosses. The results obtained from an exhaustive analysis of the formed compounds show that the compound marked with “1” had the chemistry of a compound with manganese and oxygen and some fluorine and phosphorus, while in the rectangular-shaped compound “3” fluorine and nickel were observed. This last compound is due to the reactions that have taken place in the TR, and that is why there are leftovers of the electrolyte.

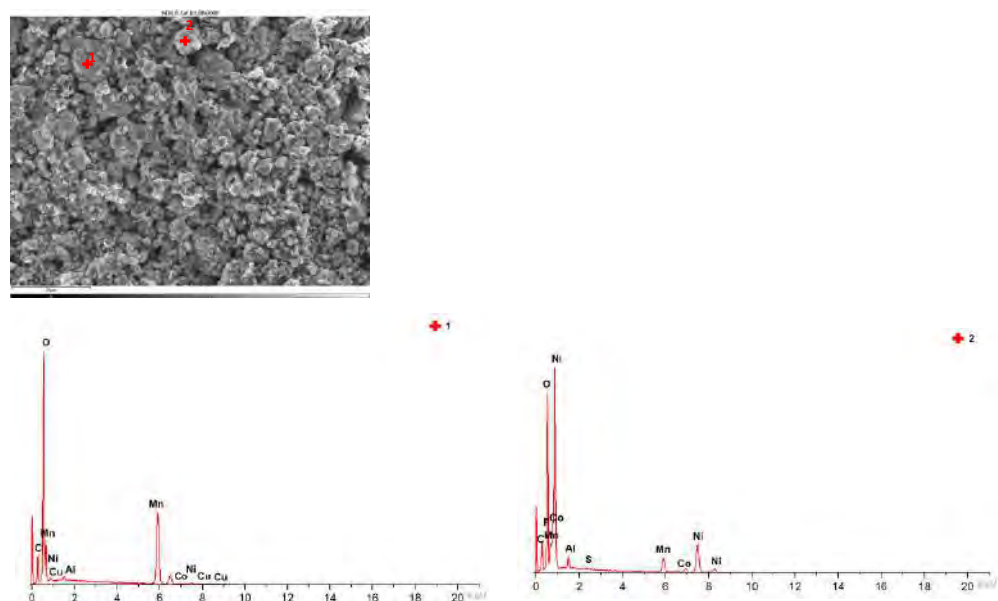
Figure 22. Chemical composition of the lower cathode of module 30.

Next, the chemical composition of the lower cathode of the ignited module 30 is analyzed. The lower cathode of module 30 also does not show a defined granular surface, as in the case of the original cathode; the structure was broken. The larger particles are about 4 μm in size, so the particles are smaller than in the case of the upper cathode of the same module, probably because they have been exposed to higher temperature values. Two different compound types were observed on the surface of the lower cathode of module 30, marked in Figure 22 with two red crosses. A detailed analysis of the compounds obtained shows that the compound marked with “1” had the chemistry of a compound with oxygen and manganese, while it was determined that the second structure was also the chemistry of a nickel and oxygen compound; some manganese, fluorine, cobalt, and aluminum were also observed.

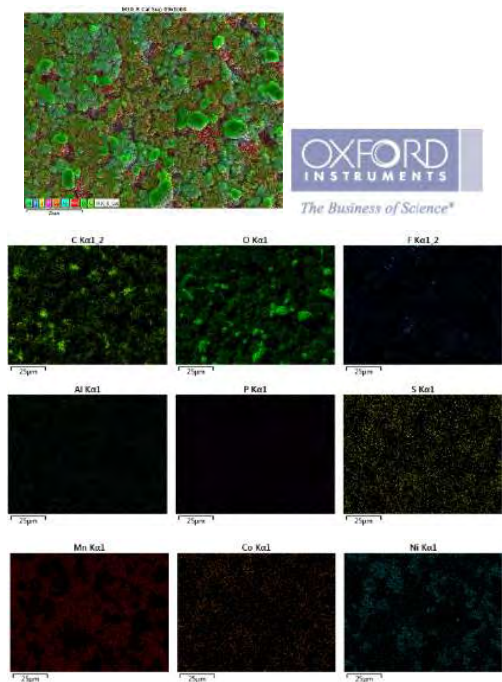
Figure 23. Distribution of elements in each area of the upper cathode of module 30.

The distribution of elements in each area of the upper cathode of module 30 is also mapped. This information is also collected with the EDS detector and then processed with the AZtec software (Figure 23).

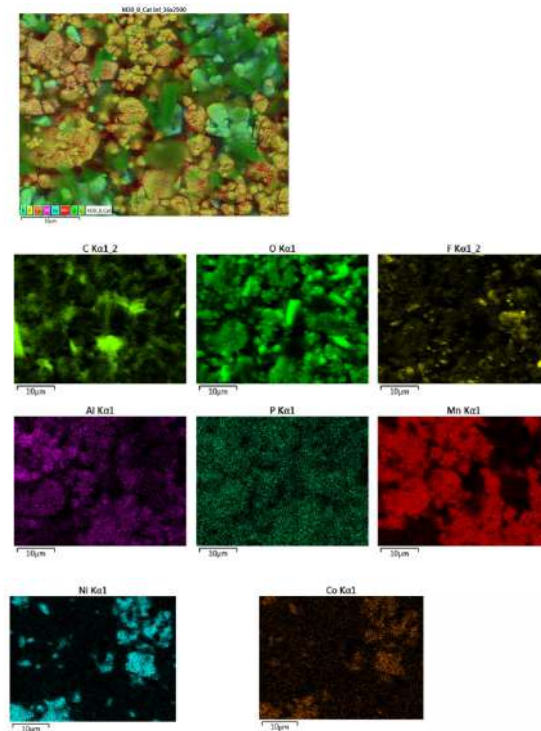
Figure 24. Distribution of elements in each area of the lower cathode of module 30.

Below (Figure 24) is a map of the distribution of elements in each area of the lower cathode of module 30.

In the lower cathode, there is a higher amount of fluorine, aluminum, manganese, phosphorus, nickel, and cobalt than in the upper cathode. The following figure shows the chemical composition of the upper cathode of modulo 11. The upper cathode of module 11 also does not show a defined granular surface, as in the case of the original cathode; the structure was broken. The larger particles are about 5 µm in size, so the particles are smaller than in the case of the original cathode. Three different types of structures are observed on the surface of the upper cathode of modulo 11, marked in Figure 25 with three red squares.

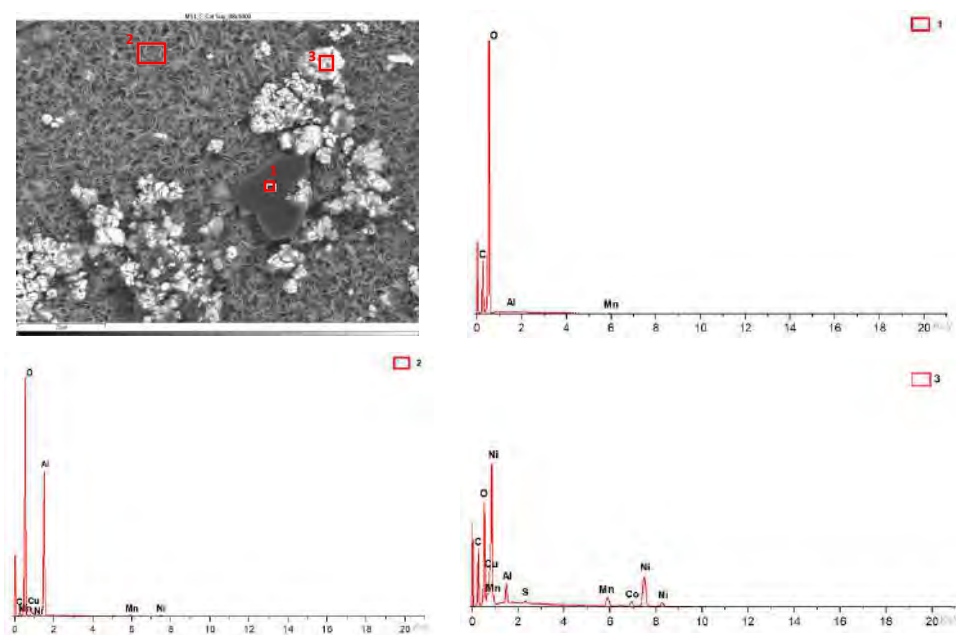
Figure 25. Chemical composition of the upper cathode of module 11.

A thorough analysis of the chemicals that were created reveals that the compound marked with “1” had the chemistry of a carbon and oxygen compound, while the second structure was determined to be an aluminum and oxygen compound, formed from the fusion of the cathode aluminum collector, and the third structure was a chemical compound containing nickel, carbon, oxygen, cobalt, manganese, and aluminum. They are all elements that are products of the cathode and collector coating. Regarding module 11, a higher amount of aluminum is observed; this may be since, in this case, the aluminum collector has been more damaged than in the case of module 30.

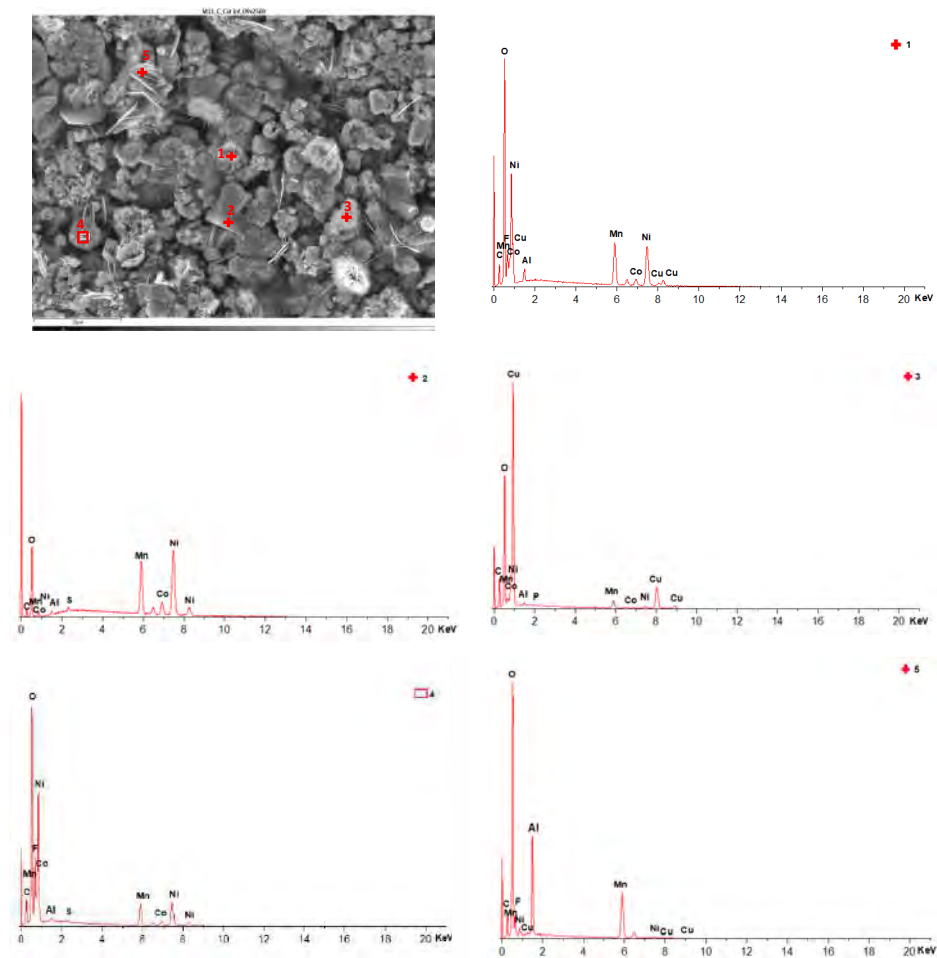
Figure 26. Chemical composition of the lower cathode of module 11.

The following Figure 26, shows the chemical composition of the lower cathode of module 11. The lower cathode of module 11 also does not show a defined granular surface, as in the case of the original cathode; the structure was broken. Five different types of compounds are observed on the surface of the lower cathode of module 11, shown in Figure 26. A detailed analysis of the compounds formed reveals that the compound marked with “1” had peaks of nickel, manganese, oxygen, copper, carbon, cobalt, and fluorine, so it presents all the elements of the cathode coating; there is also copper that can come from the anode collector. The second structure was a compound of nickel, manganese, cobalt, oxygen, and carbon, and the third structure was a compound of copper and oxygen, probably because the anode collector had melted. If compound 4 is analyzed, it is a nickel, oxygen, manganese, and fluoride-containing chemical compound. And finally, compound 5 is a manganese and oxygen compound formed from the active material of the cathode, and there is also aluminum coming from the aluminum collector of the cathode. In this area, an aluminum peak appears; this is the result of a thermal failure that leaves the aluminum current collector exposed.

During the EDXS measurement, different areas were focused on, and the corresponding peaks are shown in Figure 26. Details of the five spectra of the component values measured in atomic and weight % are listed in Table 8.

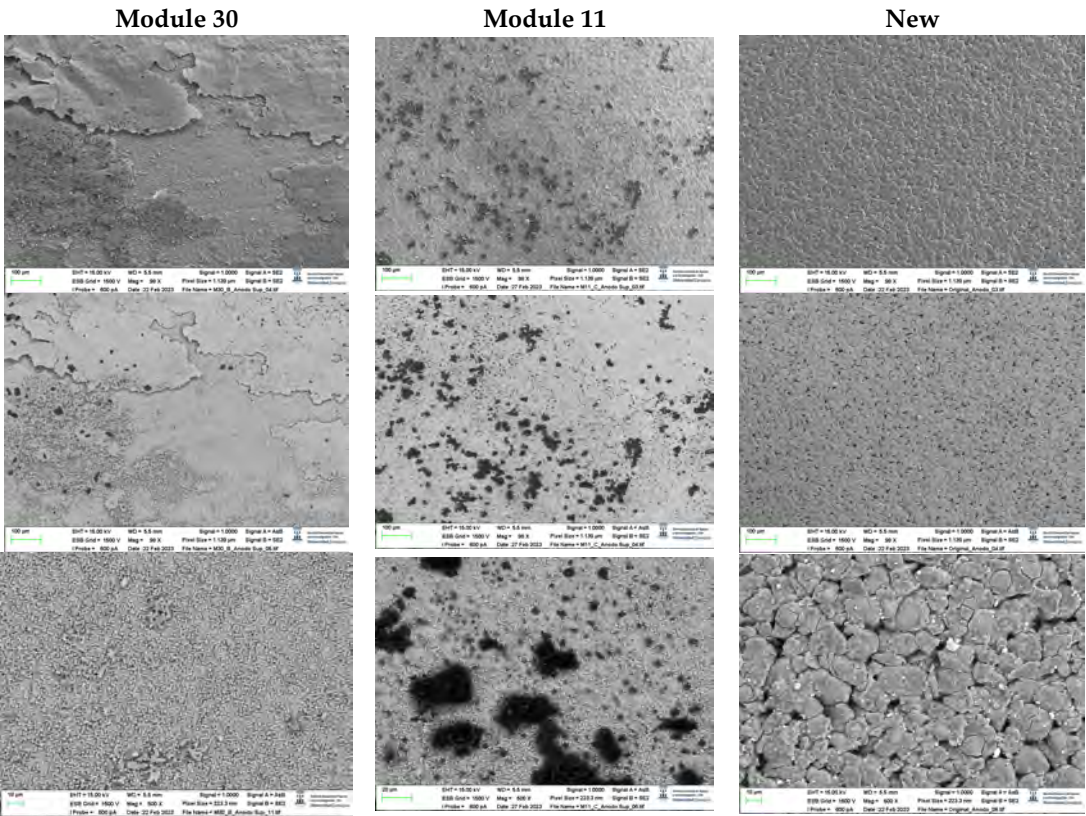
Figure 27. Comparison of images obtained with the FESEM of different areas of the upper anode of module 30, module 11, and the new cell.

The following images (Figure 27) compare different images obtained with FESEM of the upper anode of module 30, module 11, and the new cell. And in Figure 28, different images obtained with FESEM of the lower anode of module 30, module 11, and the new cell are compared.

With respect to the anode electrodes in the previous figure, as it has been done with the cathode electrodes, the anode of an original cell with two anodes (one upper and one lower) was compared with module 30 and module 11 of the battery of the burning Nissan Leaf, i.e., after experiencing the thermal runaway. It is observed that after experiencing the thermal runaway, spherical particles exist on the graphite anode surface. These spherical surfaces are covered with smaller stereoscopic particles, as can be seen in Figures 28 and 29.

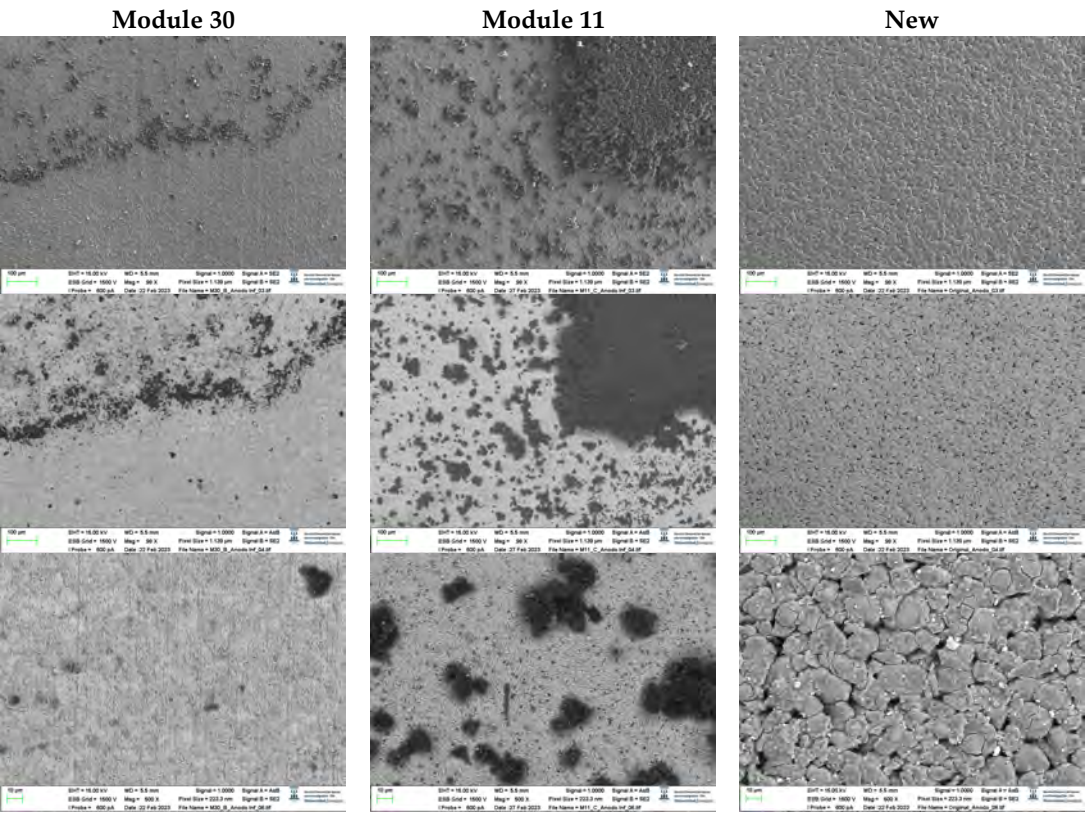
Figure 28. Comparison of images obtained with the FESEM of different areas of the lower node of module 30, module 11, and the new cell.

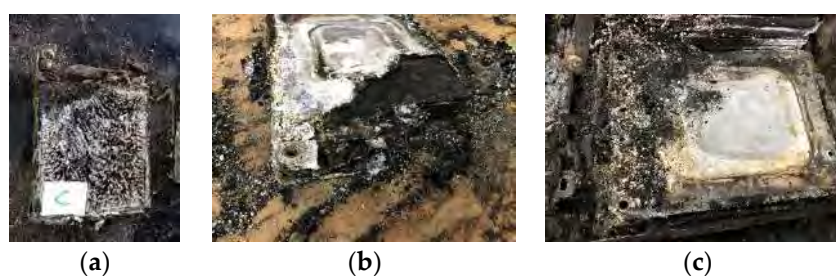
Figure 29. (a) Cell c of module 30; (b) Module 11 set on fire; (c) Module 30 burned down.

It is observed that there are many impurities, not regular in shape, on the surface of the electrode. Sometimes it is rectangular, and sometimes it is spherical. The surface distribution is chaotic, as can be seen in Figure 29b,c. Because the temperature at which TR is reached in NMC pouch cells is high, the aluminum current collector of the cathode is oxidized and bonded to the anode. Therefore, it is normal to identify debris in the image observed with the SEM. Studies [30] indicate that this debris can be fragments of cathode materials, separator and cathode ash, products of exothermic reactions, as well as graphite flaking. In some areas, a dense and brittle layer has been found on the surface of the electrode. In other areas, flake graphite particles were found under this layer. Thus, it follows that this layer was an oxidized aluminum current collector. Unlike in the cathode, the pores of the anode have been clogged by materials from TR reactions. In some areas, a dense, brittle layer covering the surface of the electrode is also observed. In other areas, flake graphite particles were observed under this layer. Therefore, the authors contemplated that this layer was an oxidized Al current collector. Judging by the structure of the base layer, it was the layer of active material on the anode. Unlike the active material coating of the cathode of new cells, the pores of the electrode that suffered thermal runaway had been completely clogged by the products of the thermal runaway reactions. The active material of the cathode had completely ceased to function. If the structural transformation (morphology analysis with InLens) of the anode materials after the TR is analyzed (Figures 30 and 31), it is observed that in the case of modules 30 and 11 with a SoC at 68% after the TR, the layered structure of the material was destroyed, the particles dispersed outside the original layered structure and adhesion occurred. The cathode (positive electrode) material reacted at high temperatures and decomposed. On the other hand, carbon particles from the anode (negative electrode) went into the positive electrode (cathode) structure through the damaged diaphragm.

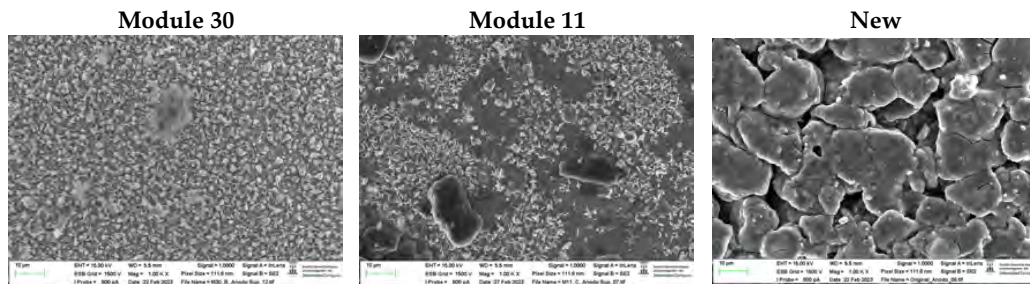
Figure 30. Morphological analysis of the transformation of the upper anode of module 30 and module 11 after the thermal runaway compared with the initial anode structure of a new cell.

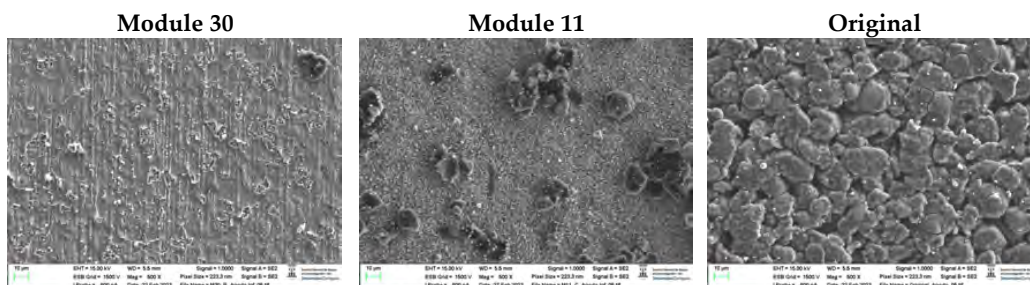
Figure 31. Morphological analysis of the transformation of the lower anode of module 30 and module 11 after the thermal runaway compared with the initial anode structure of a new cell.

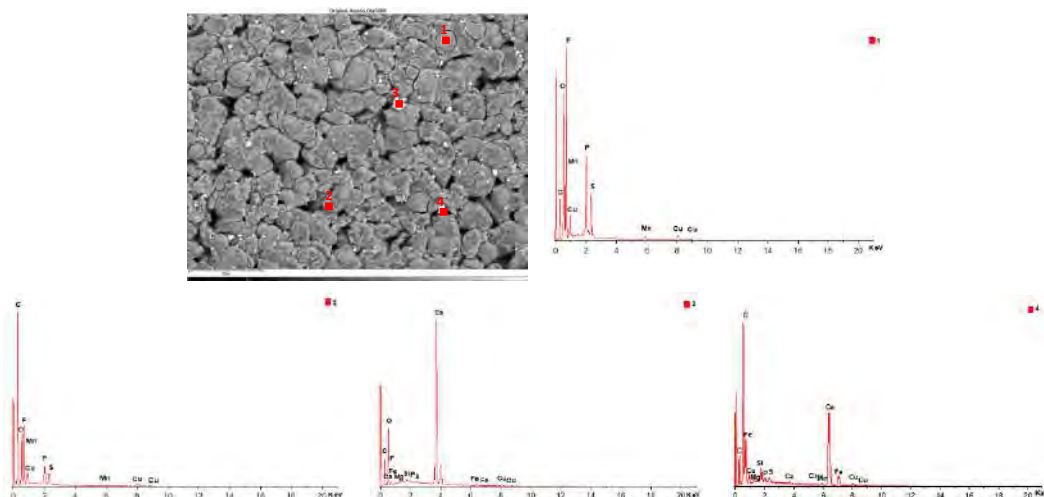
Figure 32. Chemical composition of the new cell anode.

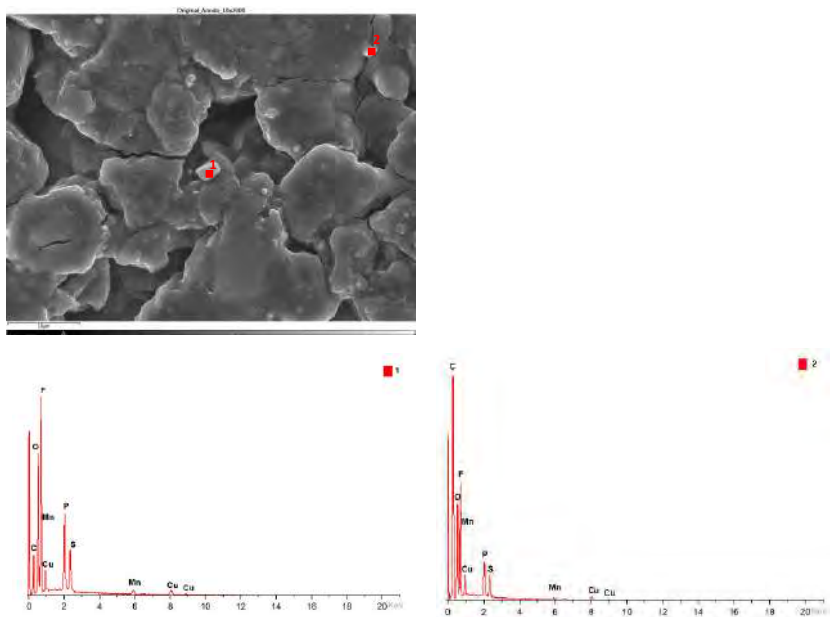
Figure 33. Chemical composition of the new cell anode 2.

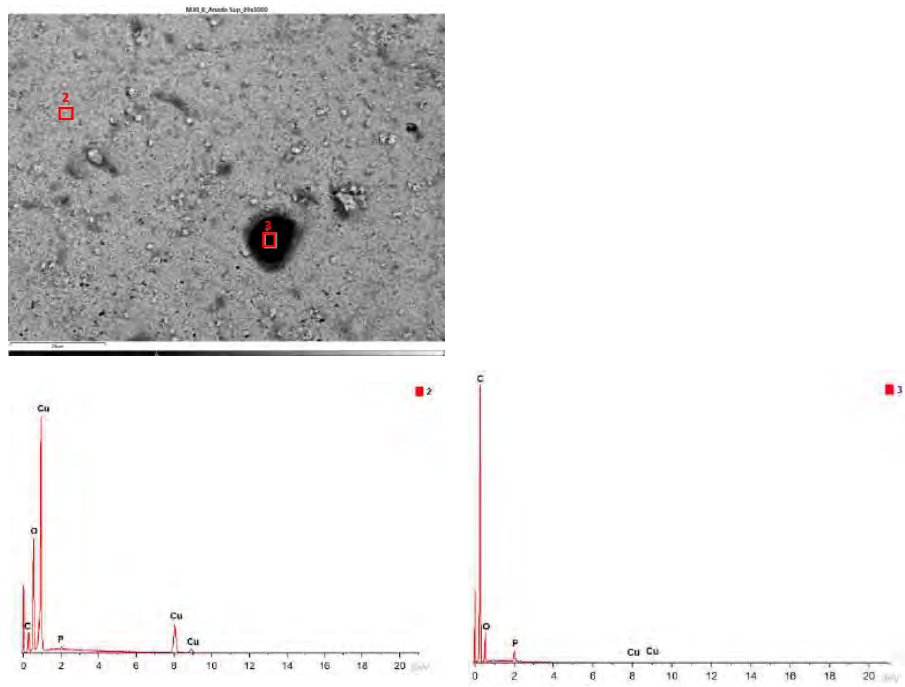
Figure 34. Chemical composition of the upper anode of module 30.

Afterward, the chemical composition of the upper anode of the ignited module 30 is analyzed. The upper anode of module 30 also does not show a defined granular surface, as in the case of the original anode; the structure was broken. Two different types of compounds were observed on the surface of the upper anode of module 30, shown in Figure 34. A detailed analysis of the compounds formed shows that the compound marked with “2” had the chemical of a copper and oxygen compound, which may be due to the anode collector having melted due to the elevated temperatures; moreover, while zone 3 was a carbon and oxygen compound, it may be due to the coating of the graphite anode.

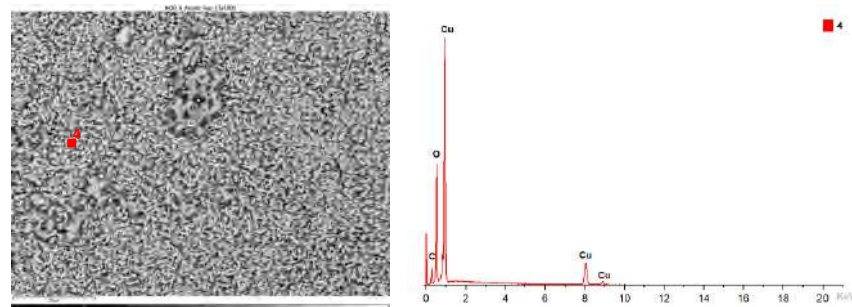
Figure 35. Chemical composition of the upper anode of module 30, second area analyzed.

In Figure 35 below, the chemical composition in another area of the upper anode of the ignited module 30 is analyzed. A single type of compound was observed on the surface of the upper anode of module 30. This compound features copper, carbon, and oxygen.

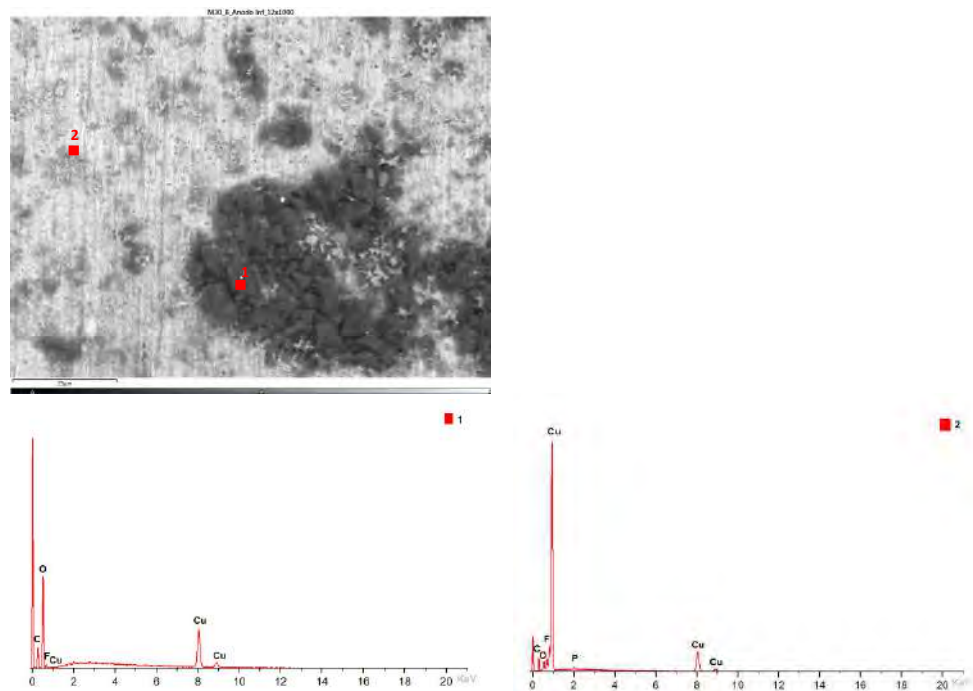
Figure 37. Chemical composition of the lower anode of module 30.

Next, the chemical composition of the lower anode of the ignited module 30 is analyzed. The lower anode of module 30 also does not show a defined granular surface, as in the case of the original anode; the structure was broken. Two different types of compounds were observed on the surface of the lower anode of module 30, shown in Figure 37. A detailed analysis of the compounds formed shows that the compound marked with “1” had the chemistry of a Carbon and oxygen compound, which may be due to the anode coating, and the second structure features copper, carbon, and oxygen.
