Article

Influence of the Arrangement of the Cells/Modules of a Traction Battery on the Spread of Fire in Case of Thermal Runaway

Citation: Olona, A.; Castejón, L. Influence of the Arrangement of the Cells/Modules of a Traction Battery on the Spread of Fire in Case of Thermal Runaway. *Batteries* **2024**, *10*, 55. <https://doi.org/10.3390/batteries10020055>

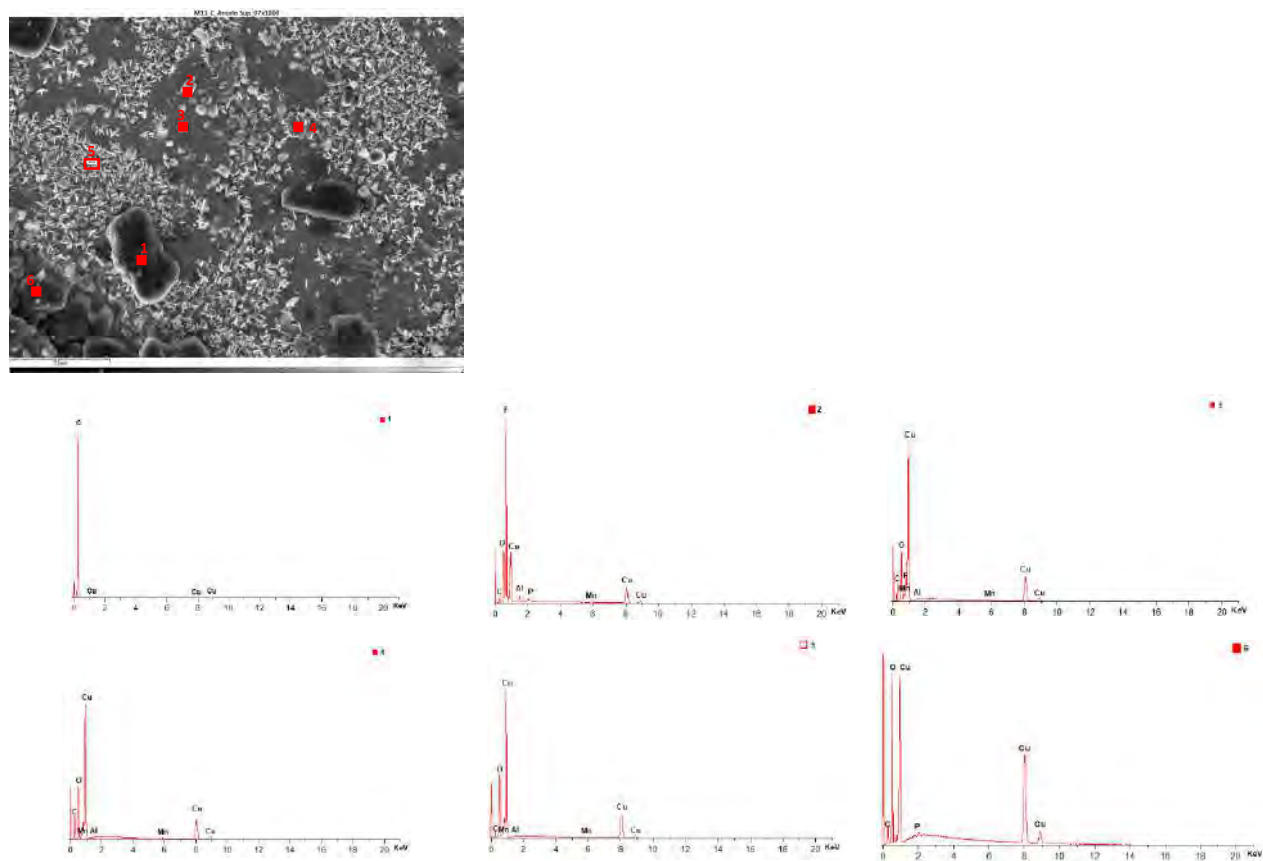
Figure 38. Chemical composition of the upper anode of module 11.

Figure 38 below shows the chemical composition in another area of the upper anode of the ignited module 11. Six different types of compounds were observed on the surface of the upper anode of module 11. The compound marked with “1” is carbon, coming from the graphite of the anode coating; the compound marked with “2” is a compound of fluorine, copper, and oxygen; fluorine comes from the electrolyte; and the rest of the compounds have copper, carbon, and oxygen.

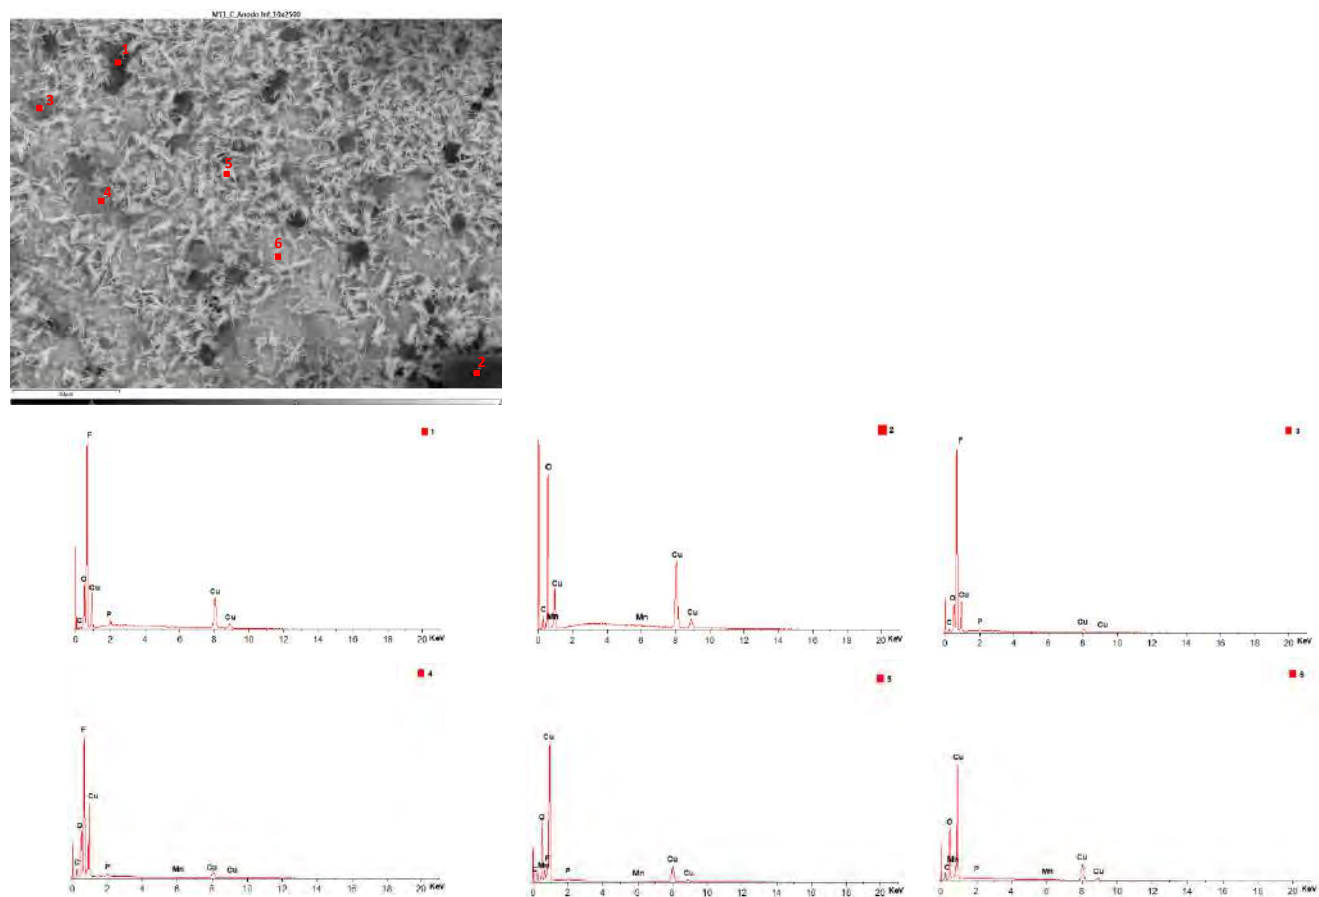
Figure 39. Chemical composition of the lower anode of module 11.

And finally, in the following Figure 39, the chemical composition in another area of the lower anode of the burning module 11 is analyzed. Six different types of compounds were observed on the surface of the lower anode of module 11. The first structure was a compound of fluorine, copper, and oxygen; in compound 2, copper and oxygen were identified; compound 3 is like the first, which is a compound of fluorine, copper and

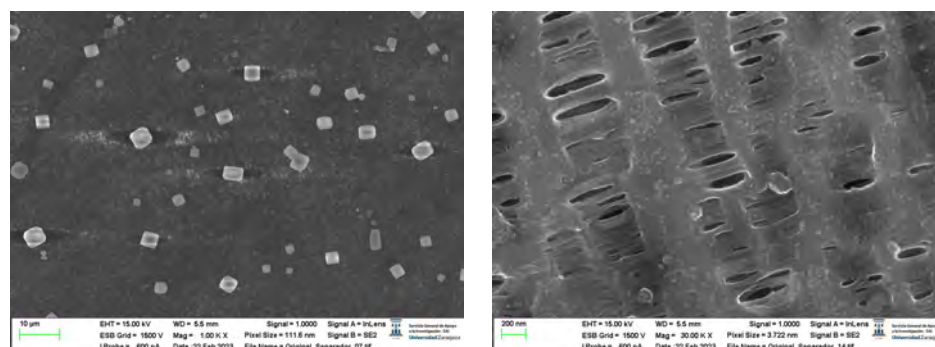
Figure 40. Morphological analysis of the separator. The first image has been obtained with a magnification of 1.00 K X, and the second image with a magnification of 30.00 K X.

A morphological analysis of the separator of the new cell is then performed since the separator cannot be recovered in the burned modules because it has melted in the thermal runaway reaction. The surface structure of the separator was investigated to determine the thickness of the separator fibers and the size of the pores, as well as to determine whether an alumina layer had been deposited on the separator membrane, as described above. Figure 40 shows the results of the SEM image. The structure of the fibers of the polypropylene membrane (C_3H_6)_n is shown on the right. The separator fibers were aligned perpendicular to the cell tabs.

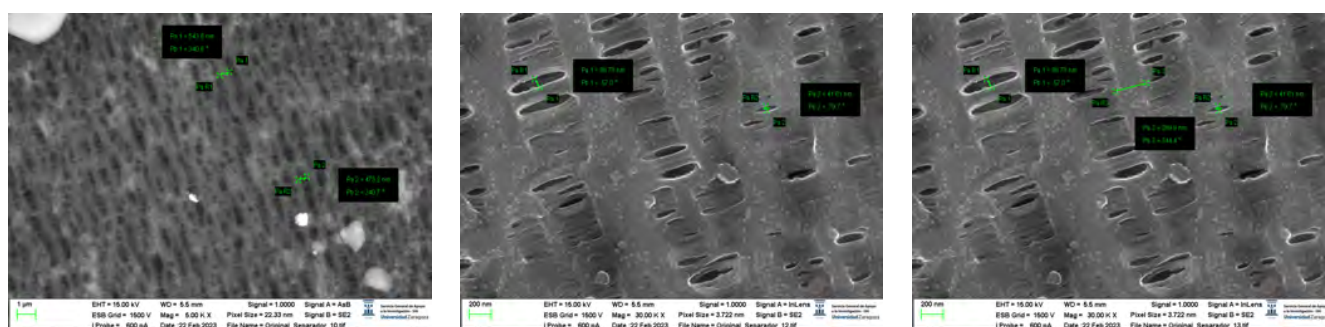
Figure 41. Morphological analysis of the separator. Measurement.

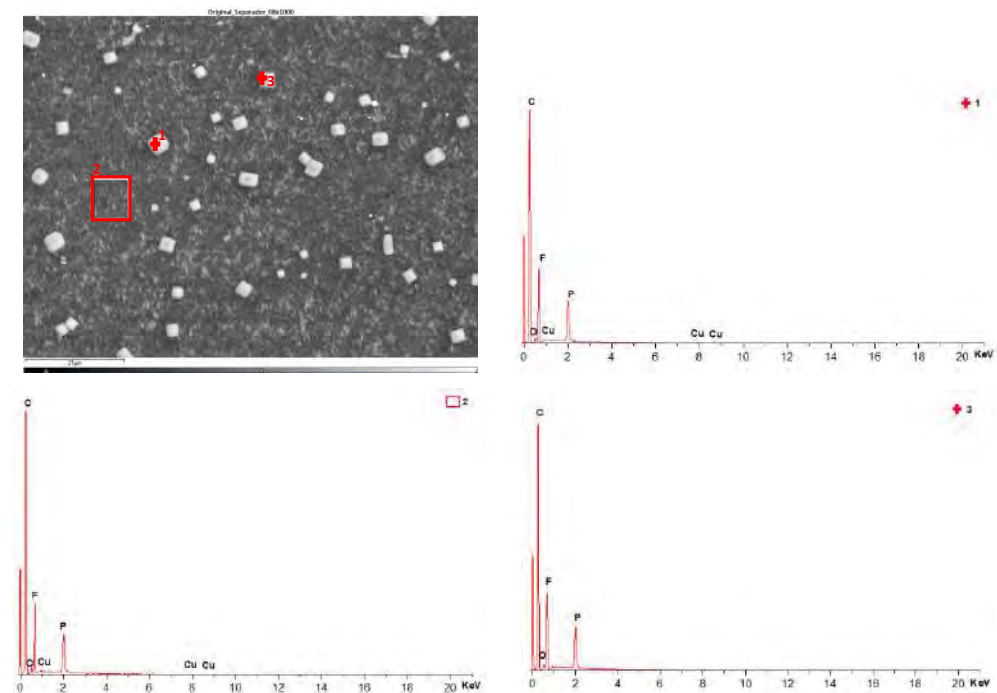
Figure 42. Chemical composition of the separator.

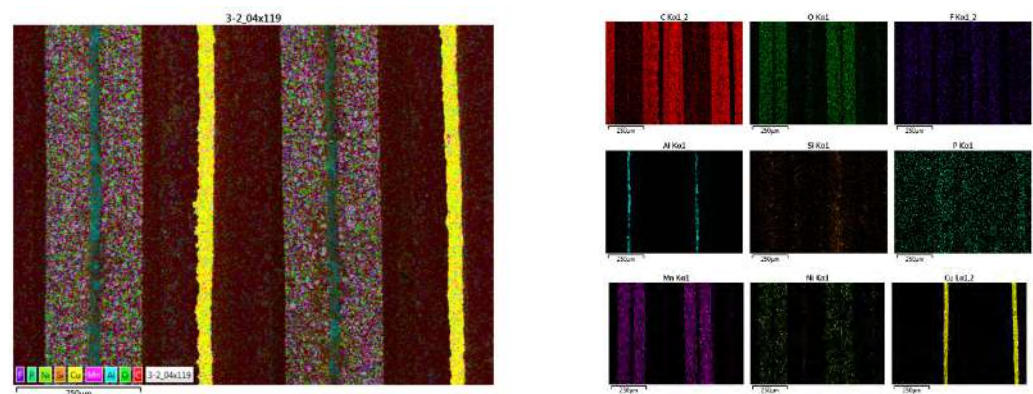
Figure 44. Distribution of the elements of a new pouch cell in zone 3 (central area on the opposite side to the one where the battery tabs of the cell are located).

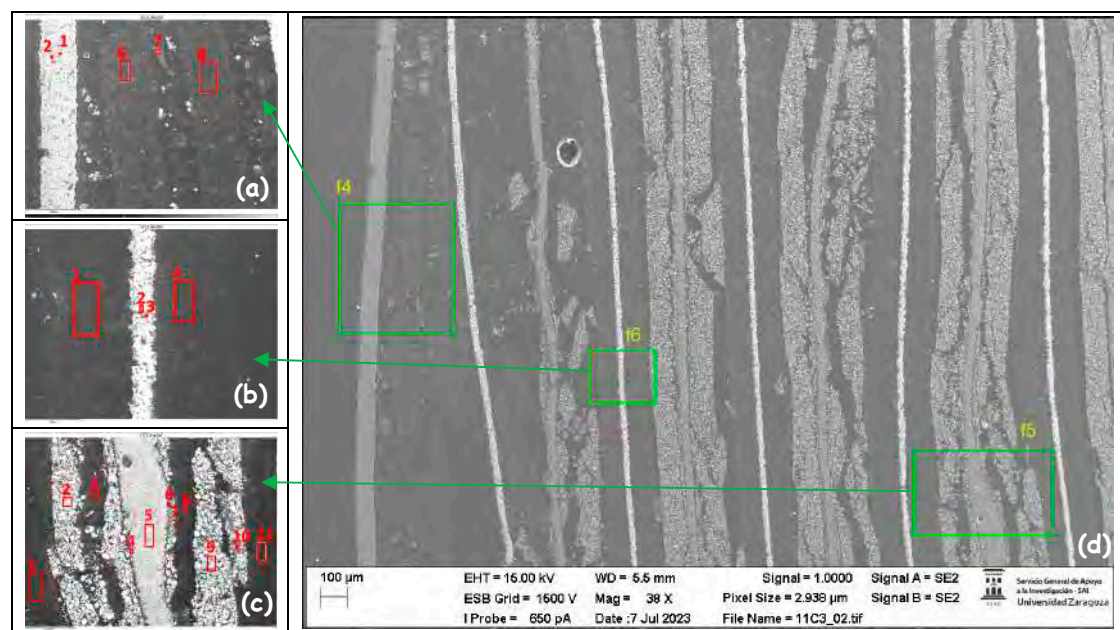
Figure 46. Chemical composition of each of the layers of the pouch cell of module 11 in zone 3 (central zone on the opposite side to that of the battery tabs of the cell Figure 12a).

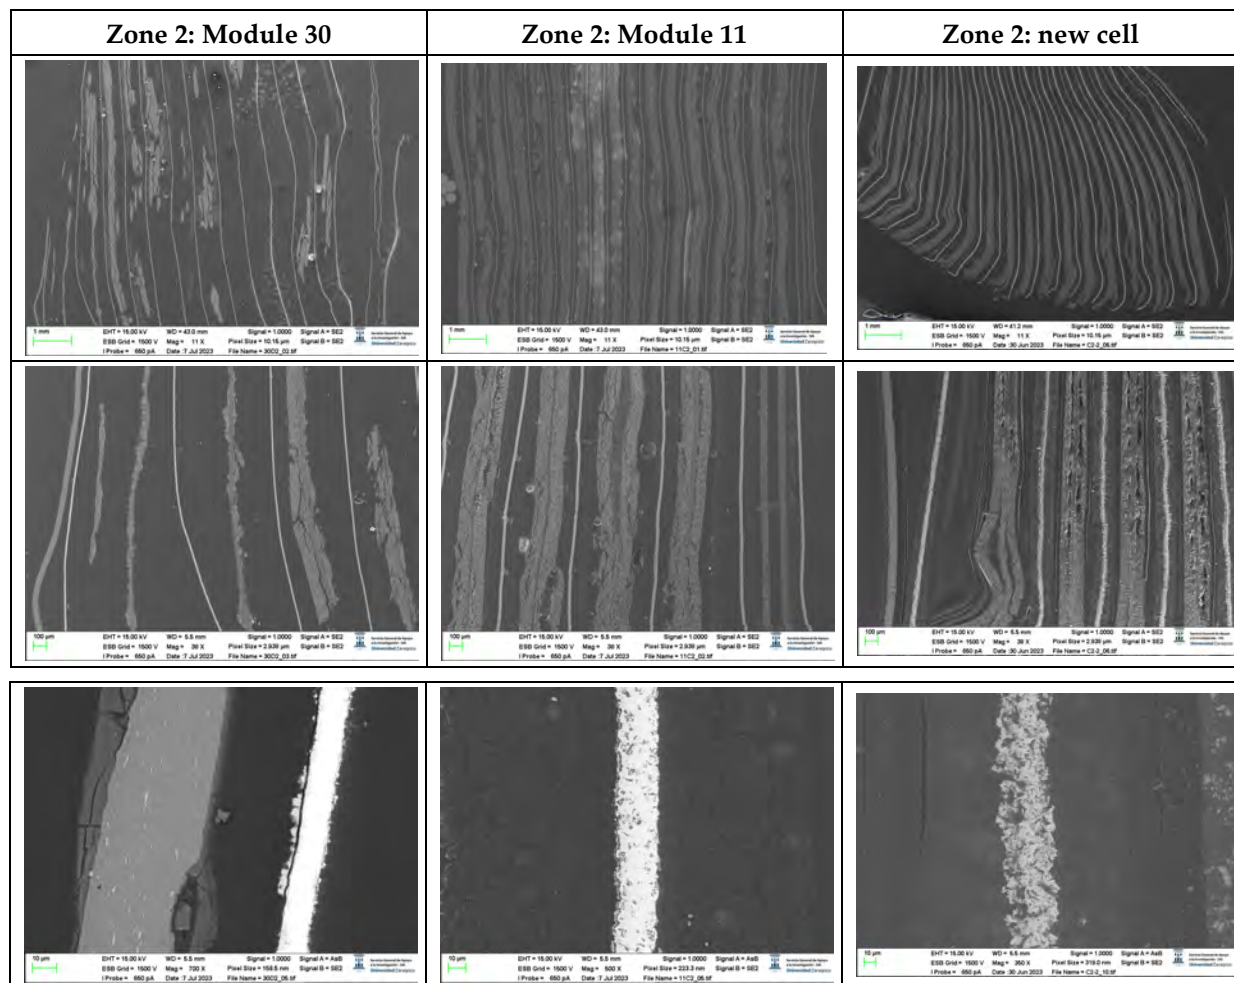
Figure 51. Images of the pouch cell section in zone two (cathode zone) of the cell.
