# Analysis of the Temperature Reached by the Traction Battery of an Electric Vehicle during the Drying Phase in the Paint Booth

Analysis of the Temperature Reached by the Traction Battery of an Electric Vehicle during the Drying Phase in the Paint Booth. *Energies* **2024**, *17*, 3437.

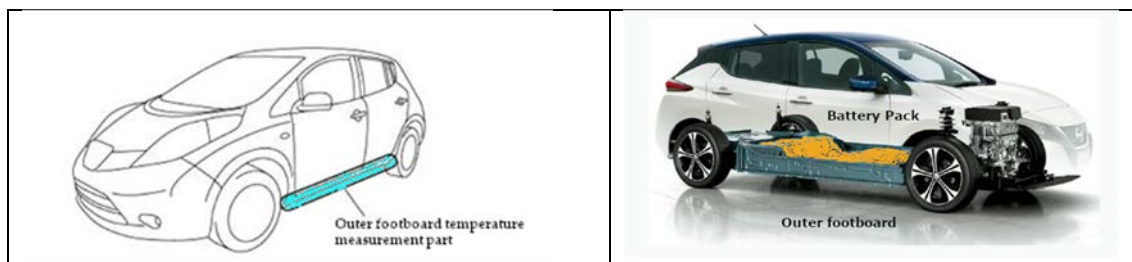
**Figure 1.** Location of the footboard [13]. Picture showing the position of the high-voltage battery and the position of the footboard [14].

If the temperature of the outer footboard exceeds 60 °C, remove the lithium-ion battery beforehand and then bring the vehicle into the paint booth. Figure 1 below shows the location of the footboard in the Nissan Leaf.

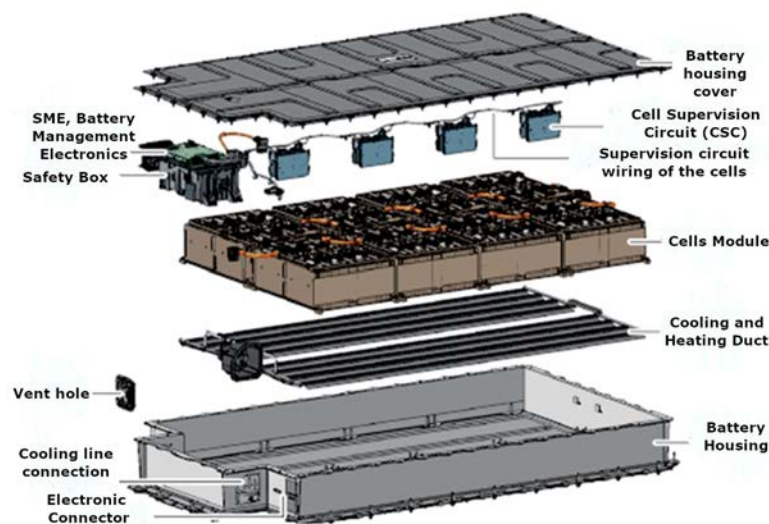
**Figure 2.** Different parts of the high-voltage battery unit of the BMW i3 vehicle used in the tests. Source: BMW manuals.

The different parts of the traction battery of the tested vehicle are shown in Figure 2.

The battery management electronics (SME), which can be seen in Figure 2, continuously monitor the condition of the battery cells and the parameters required for safe battery operation. The SME control unit performs the following functions.

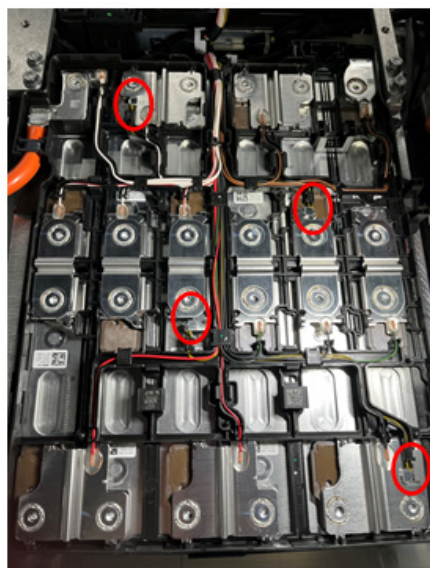
**Figure 3.** Image of a module from the traction battery of the BMW i3 vehicle used in the testing of the paint booth and location of the temperature sensors.

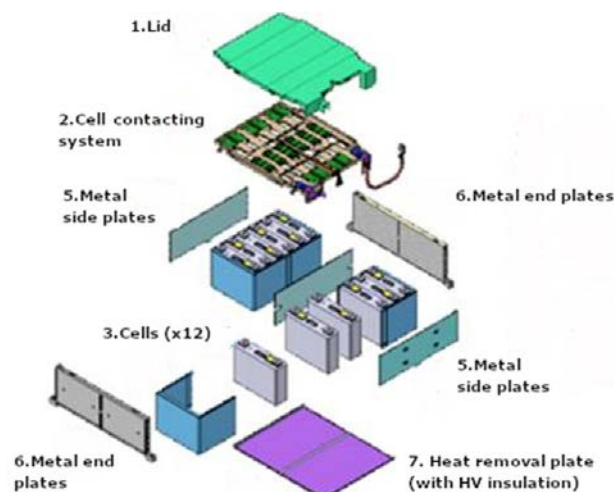
**Figure 4.** Components and module layout of the energy storage system of the BMW i3 vehicle [26].

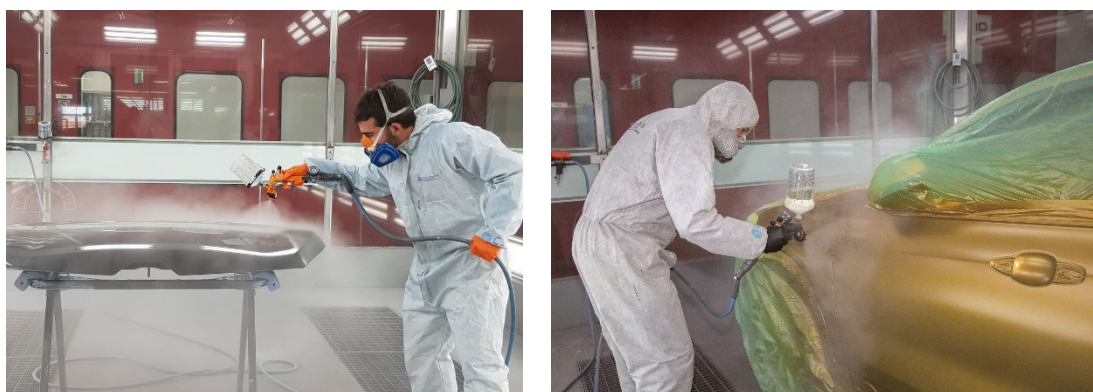
**Figure 5.** Different painting works in the paint booth of CENTRO ZARAGOZA.

The paint booth (Figures 5 and 6) used in the tests is supplied by SAICO, model KL/78, and is equipped with a TRONIC control panel. The AZ-20 burner employed is a diesel burner, with a minimum power of 128 kW and a maximum power of 249 kW (equivalent to 112,000 and 214,000 Kcal, respectively). It consumes fuel nominally at a rate of from 6.9 to 15 kg/h. To initiate the drying phase in the paint booth, the temperature controller is adjusted to the desired temperature, typically set at 60 °C for vehicle repair applications. The heating timer for the drying phase is then adjusted by turning it clockwise until the indicator aligns with the set drying time. For instance, if the drying time is 30 min, the timer should be set to 40 min because the temperature (T) does not instantly reach the set value.

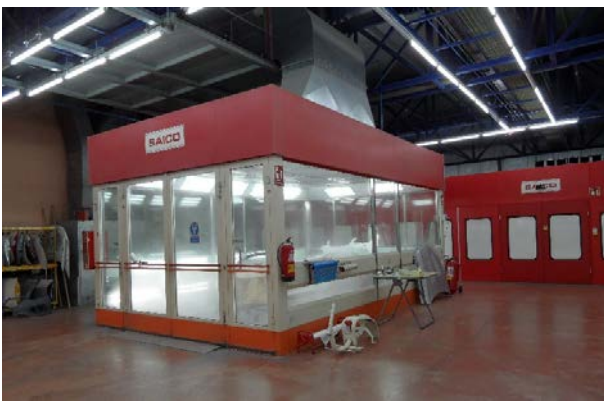
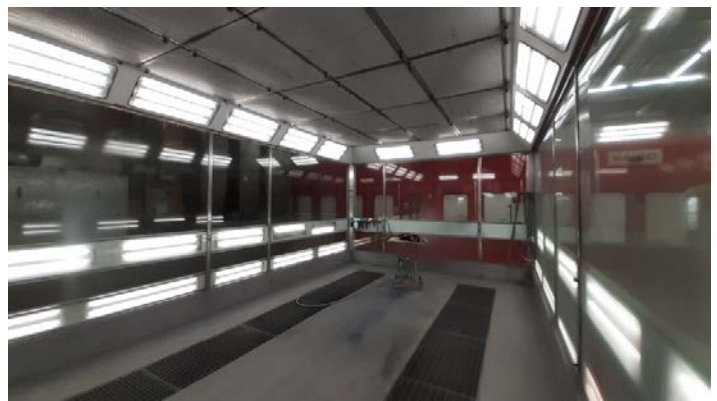
**Figure 6.** Image of the exterior (left) and interior (right) of the CENTRO ZARAGOZA paint booth used during the tests.

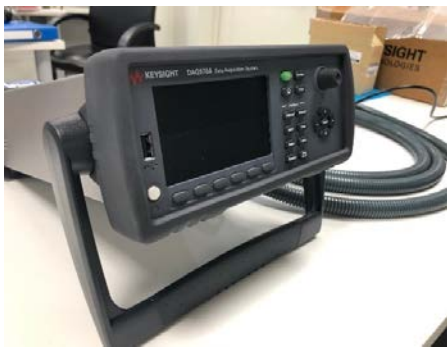
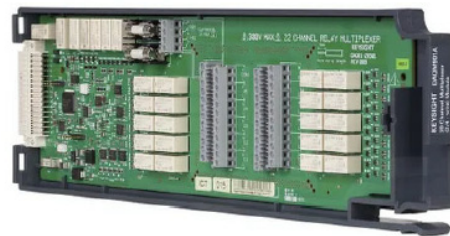
**Figure 7.** Image of the Keysight 970A Datalogger and 20-channel acquisition module.

- Keysight 970A Datalogger (see Figure 7) measures, records, and stores data, together with a 20-channel acquisition module. This data logger can also read/store electrical variables by changing the type of recording module.
- Includes visualization and recording software: BenchVue. 2020 Update 2.0.
- Panel for 12 T-type mini-thermocouples.

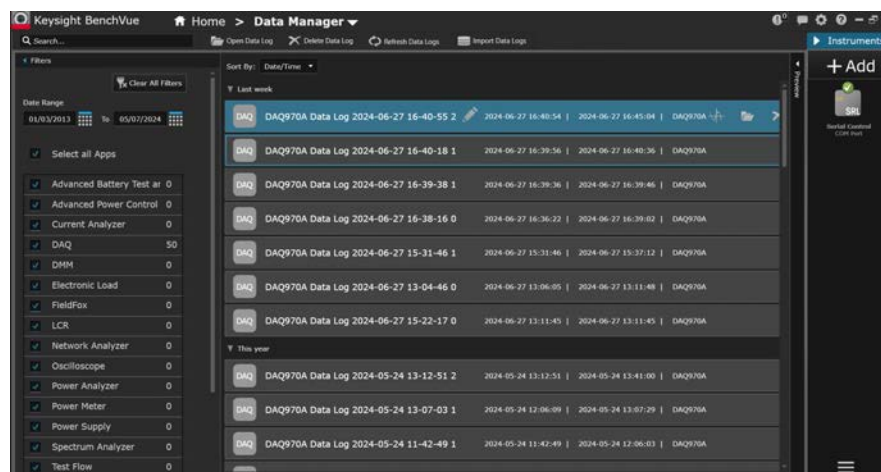
**Figure 8.** Screenshot of the BenchVue viewing and recording software.

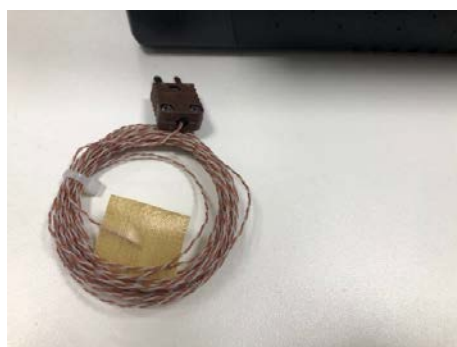
**Figure 9.** Image of the T-type thermocouple with a 4-m cable for connection to the thermocouple panel.

T-type thermocouples are placed on the surface to be measured, have a 4-m cable (see Figure 9), and are then placed in the thermocouple connection panel, which has a 4-m cable to the datalogger, allowing the data extraction equipment to be located outside the cabin during the tests.

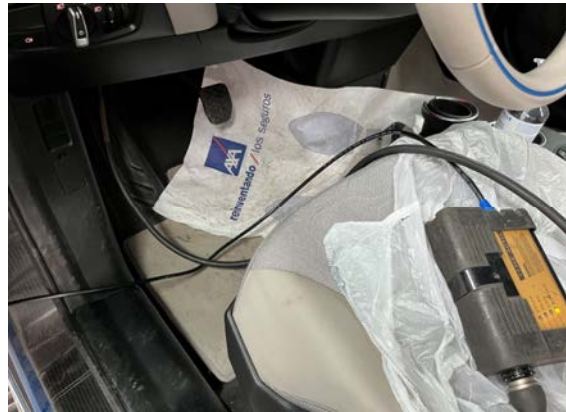
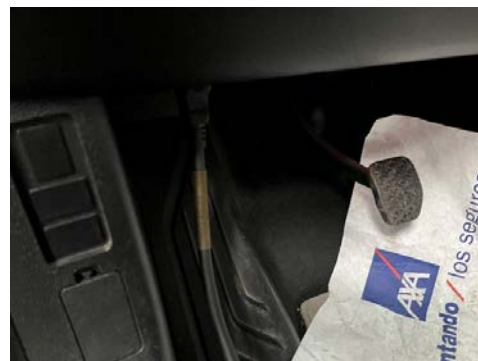
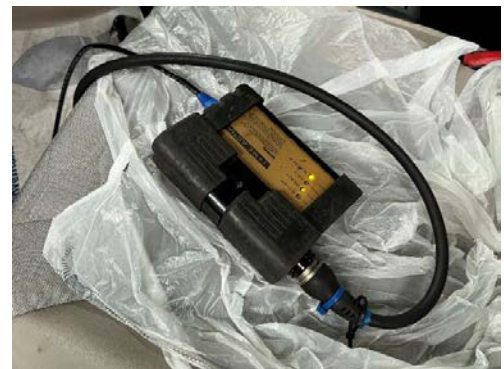
**Figure 11.** Image of the connection of the BMW diagnostic equipment to the OBD of the BMW i3 vehicle.

The data are obtained by connecting the BMW diagnostic machine to the OBD of the BMW i3 vehicle (see Figure 11). The software used is BMW ISTA (Integrated Service Technical Application) 4.39.20. ISTA consists of several components designed to communicate with each other via LAN, WLAN, and Internet. The entire system provides up-to-date information and diagnostic data from BMW headquarters. It is an important diagnostic tool, offering various options for vehicle identification, searching for very specific information and guided troubleshooting.

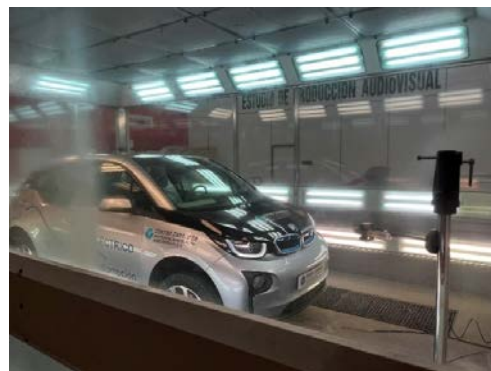
**Figure 12.** Image of the BMW i3 vehicle inside the paint booth, ready for the temperature measurement test.

The following Figure 12 shows two images of the BMW i3 inside the paint booth:

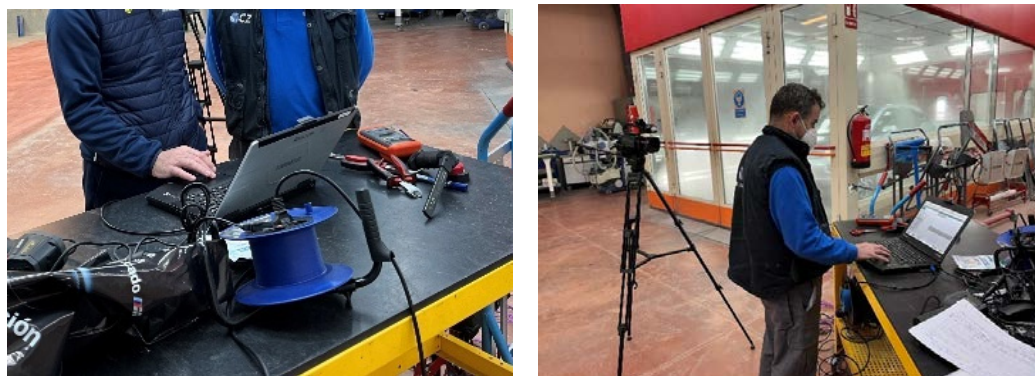
**Figure 13.** Images during the tests with the BMW diagnostic equipment.

The test is carried out with the BMW i3 vehicle connected, as the ignition of the vehicle must be switched on for the diagnostic machine to connect. The machine is connected to the OBD II (On Board Diagnostics) connector.

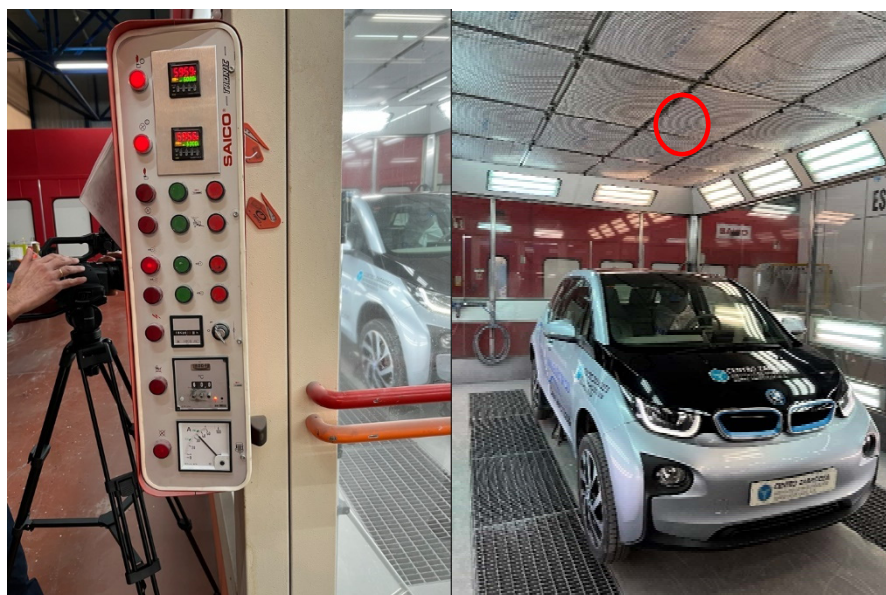
**Figure 14.** Image of the paint booth control panel, showing the temperature and the programmed time (left). Image of the location of the probe that controls the temperature inside the booth (right).

The paint booth controls the temperature by means of a probe located in the central part of the roof, as shown in the picture (Figure 14). On the other hand, the temperature inside the cabin and the humidity are measured with an EL-USB-2-LCD temperature meter (Figure 15), which is programmed to measure every minute. It is placed inside the cabin with support to measure the evolution of the temperature and humidity, as well as the dew point (Dew Point °C), over time.

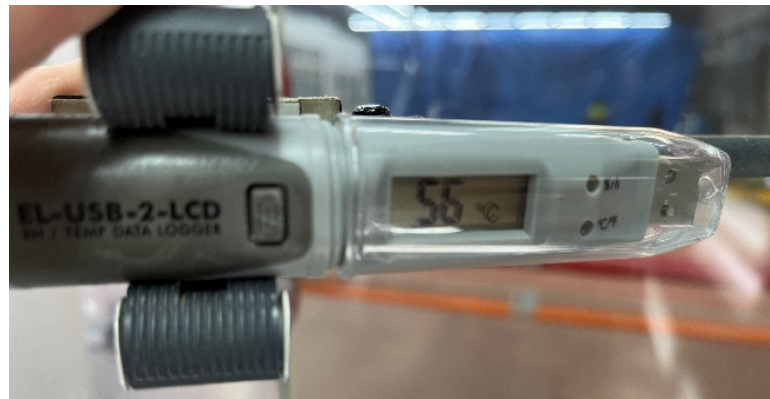
**Figure 15.** Image of the EL-USB-2-LCD meter used to measure the temperature and humidity inside the spray booth during the tests.

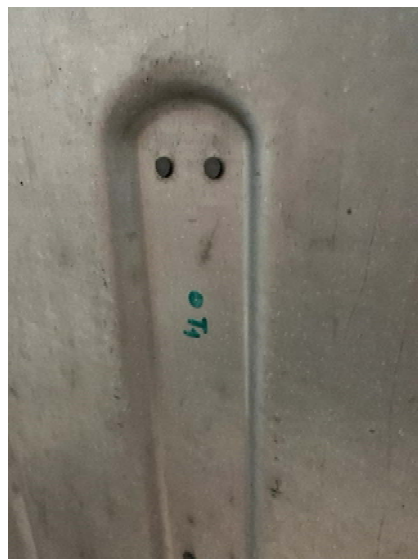
**T<sub>1</sub>** measured at the lower rear of the vehicle.

**Figure 17.** Images of the measurement points on the underside of the vehicle (under the high-voltage battery).

The four points to be measured using the HTI 03 THERMAL IMAGER thermographic camera (120 × 90) are shown below (see Figure 17).

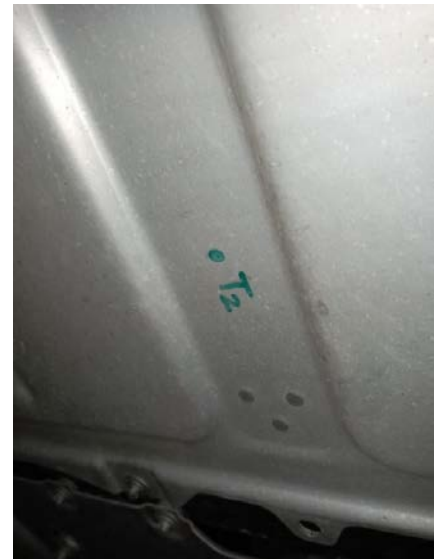
**T<sub>2</sub>** measured at lower front of the vehicle.

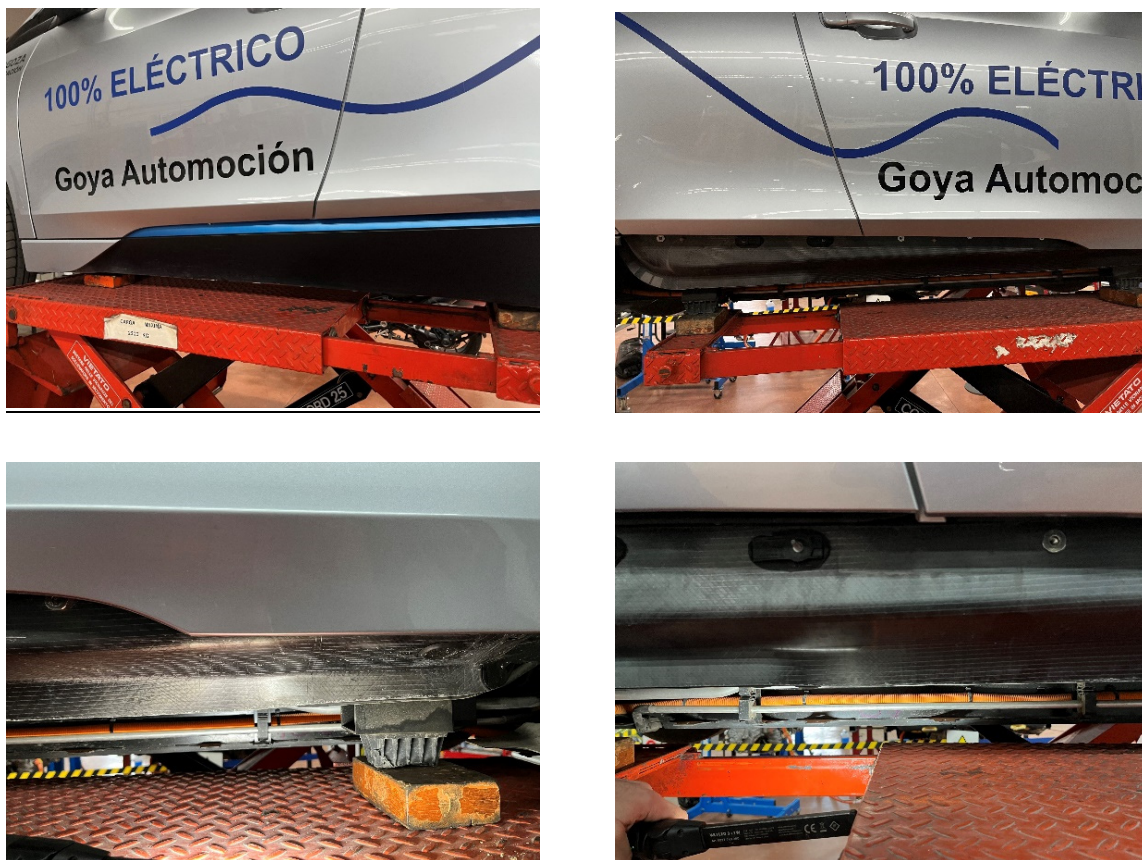
T3 right-hand front side (depending on the direction of travel of the vehicle)

T4 right-hand side rear area (depending on the direction of travel of the vehicle)

**Figure 18.** Images of the measuring point in the footboard area.

To measure the temperature in the footboard area, the outer plastic must first be removed (see Figure 18).

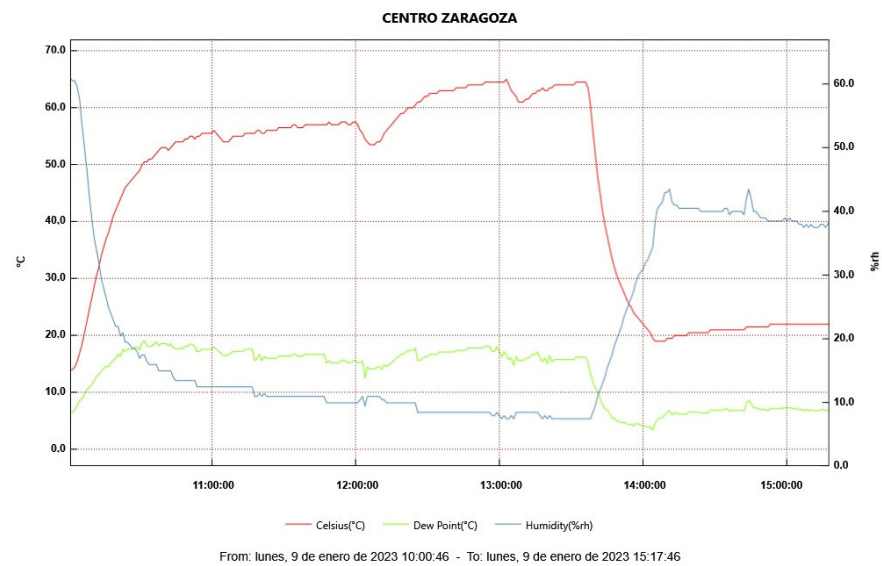
Figure 22. Graph displaying the temperature (red line) and humidity (blue line) recorded by the EL-USB-2-LCD meter inside the cabin during the test conducted with the battery at 50% SoC.

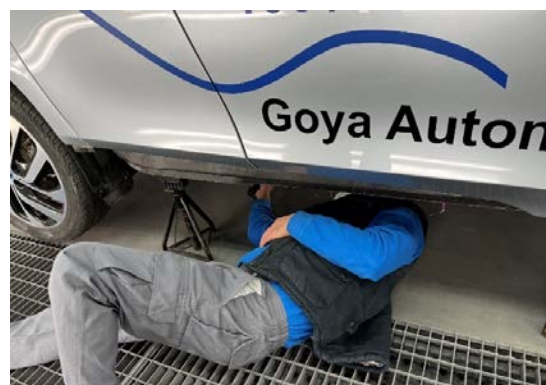
Figure 23. Image of the temperature measurement on the underside of the BMW i3 vehicle using the thermal imaging camera.

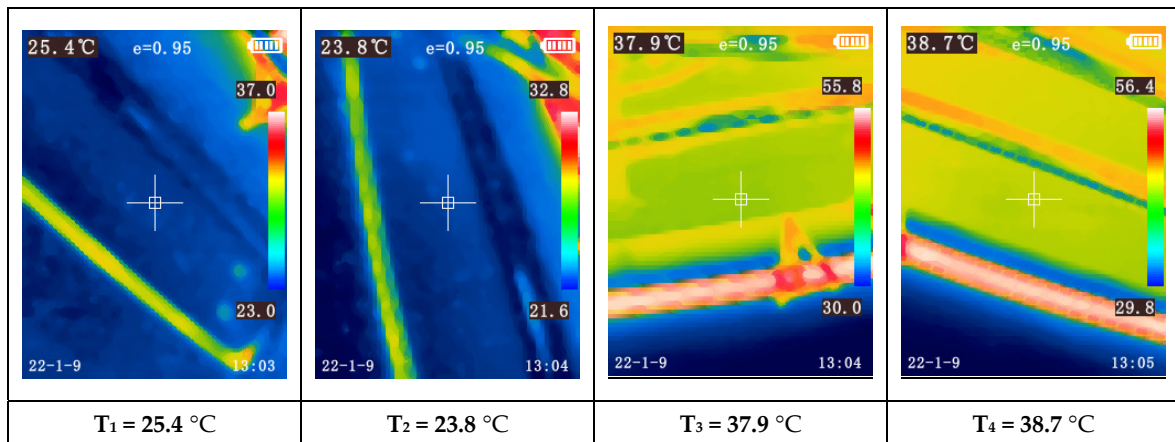
**Figure 25.** Images captured with the thermal imaging camera at the four defined measurement points, at the end of Test 2, as specified in Table 2.

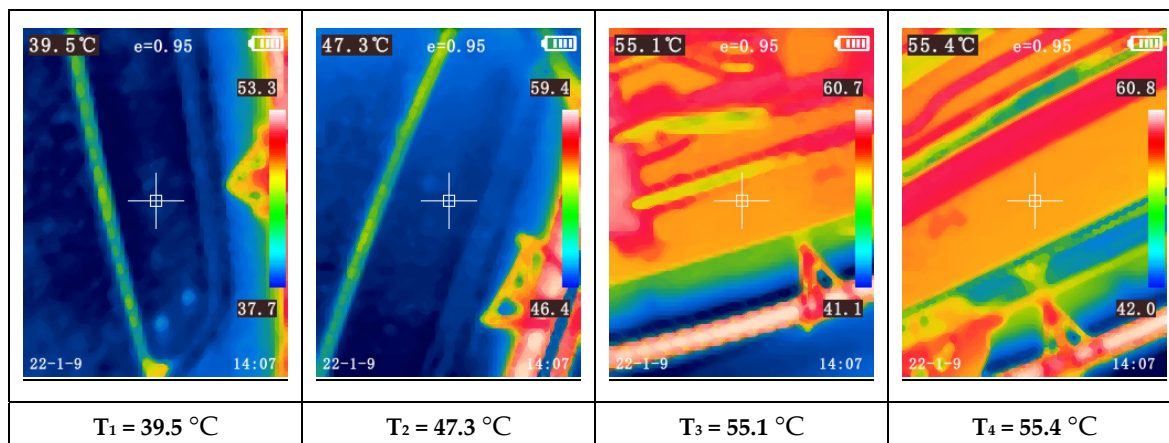
**Figure 26.** Images captured with the thermal imaging camera at the four defined measurement points, at the end of Test 3, as specified in Table 2.

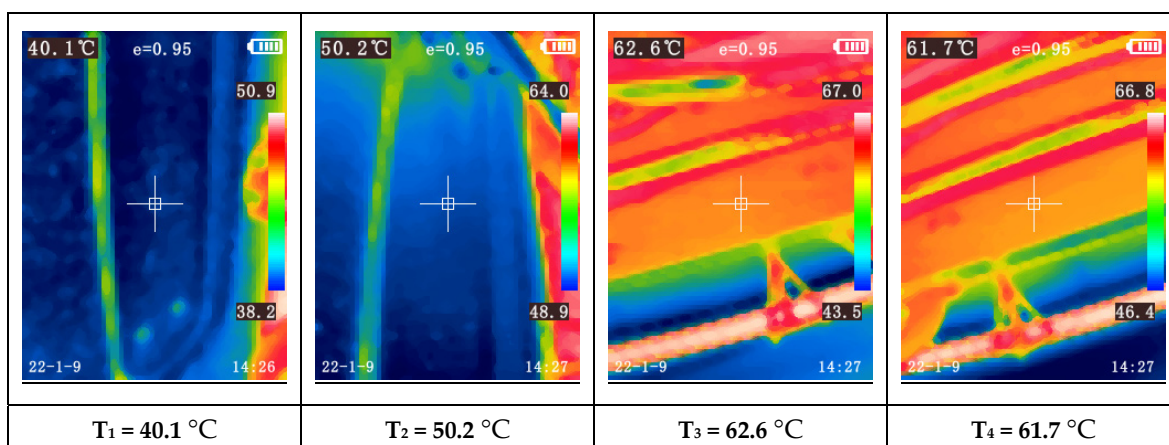
**Figure 27.** Images captured with the thermal imaging camera at the four defined measurement points, at the end of Test 4, as specified in Table 2.

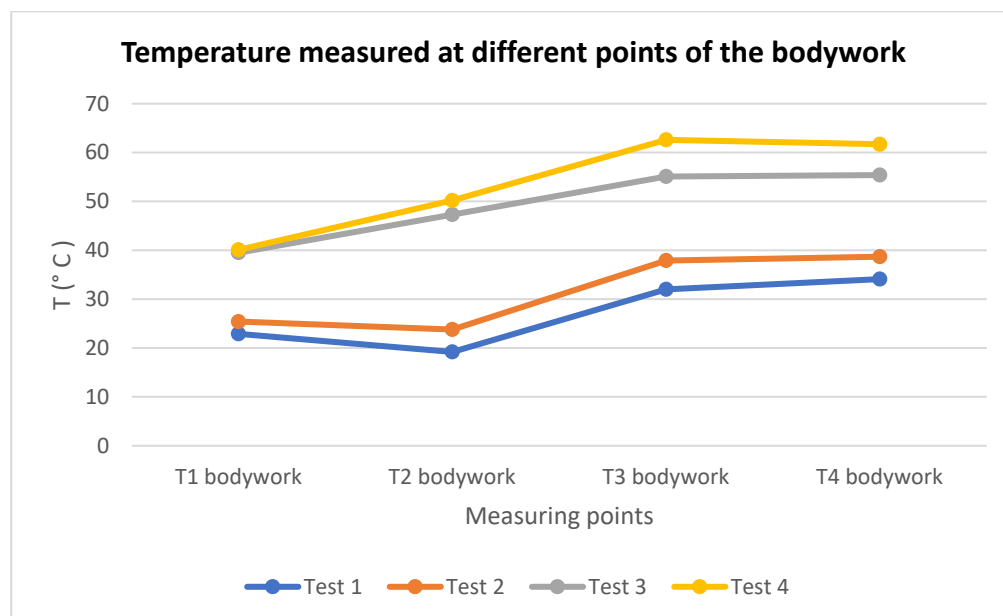
**Figure 28.** Graph of the temperature measured at different points of the bodywork with a thermographic camera in the four tests carried out with the battery at 50% SoC.

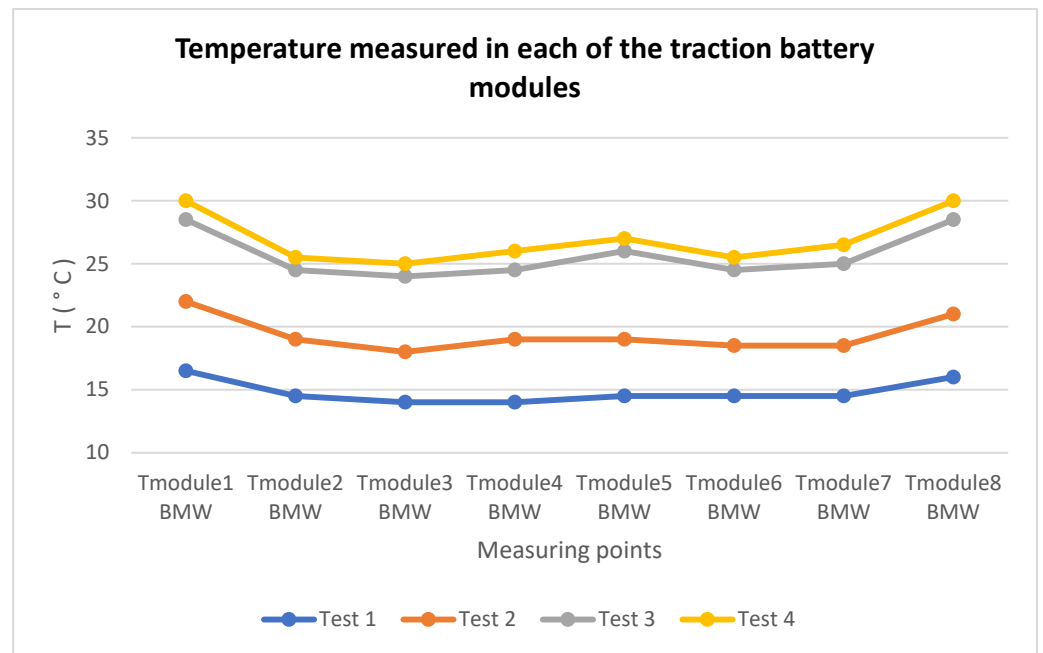
**Figure 29.** Temperature graph of each of the traction battery modules obtained with the BMW diagnostic equipment in the four tests carried out with the battery at 50% SoC.

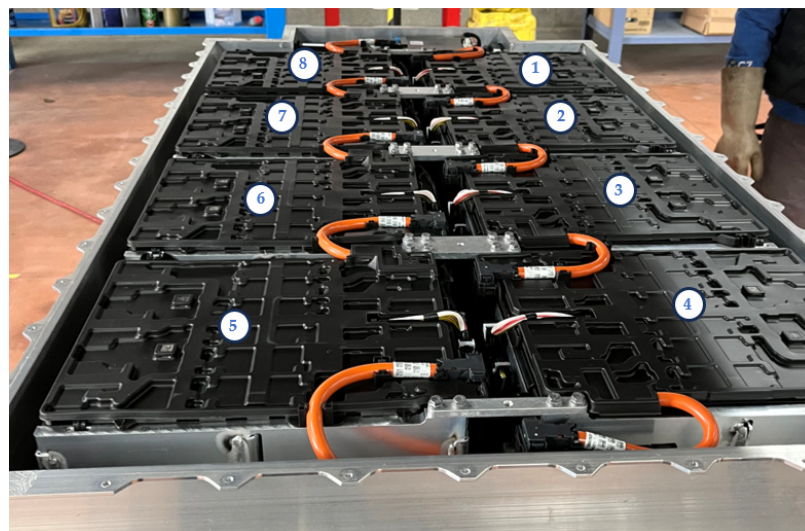
**Figure 30.** Identification of the position of the modules in the battery pack. Source: BMW i01 manual.

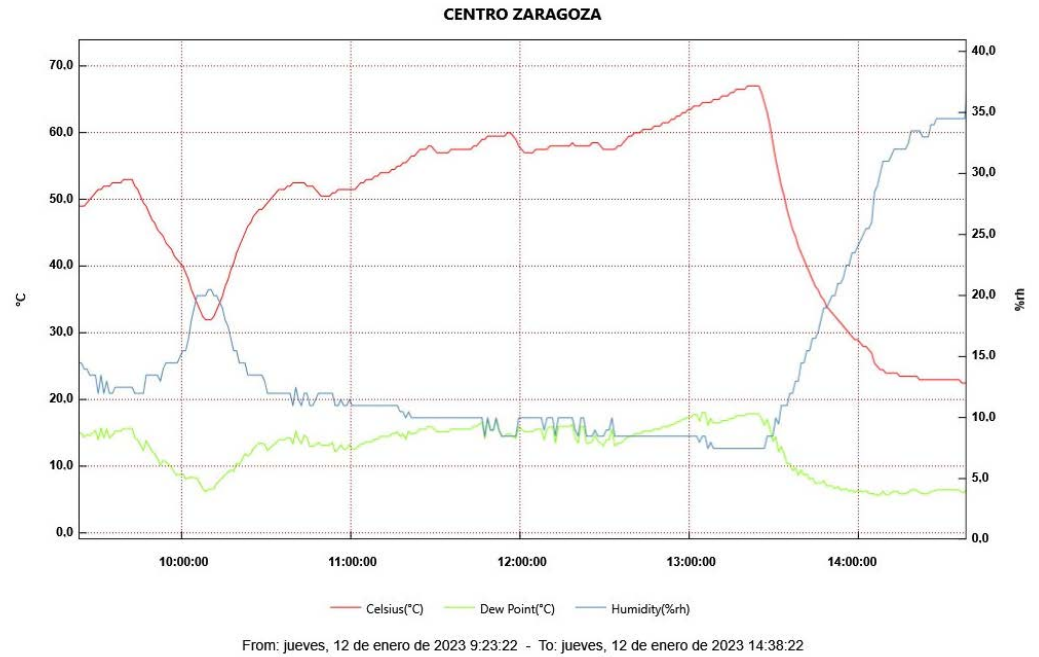
**Figure 32.** Graph showing the temperature (red) and humidity (blue) recorded by the EL-USB-2-LCD meter inside the cabin during the test carried out with the battery at 100% SoC.

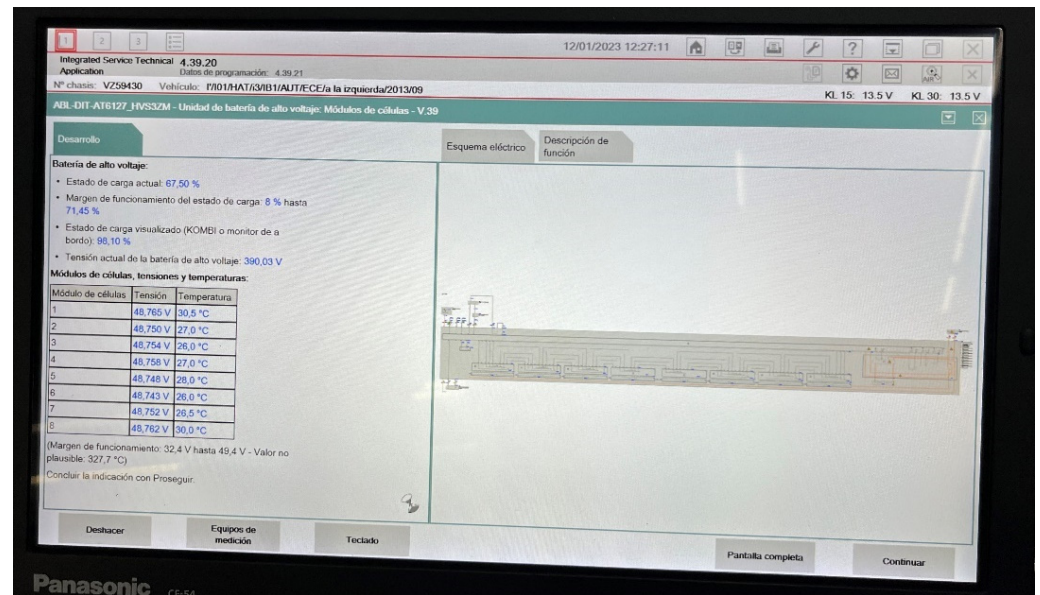
**Figure 34.** Image showing the temperature and voltage of each of the modules of the voltage battery tested, when the cabin temperature is 58.5 °C.

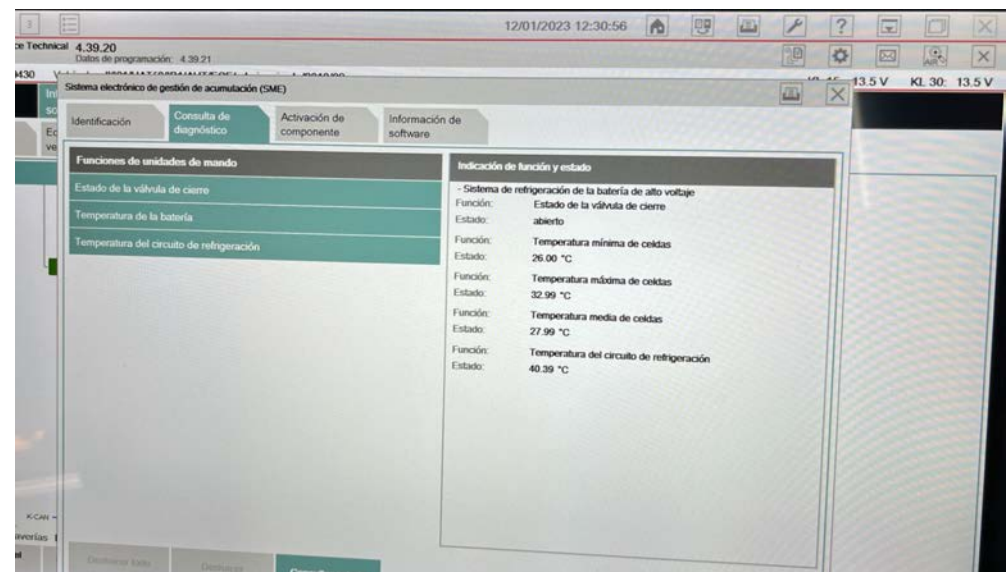
**Figure 35.** Image showing that the shut-off valve of the cooling system is open.

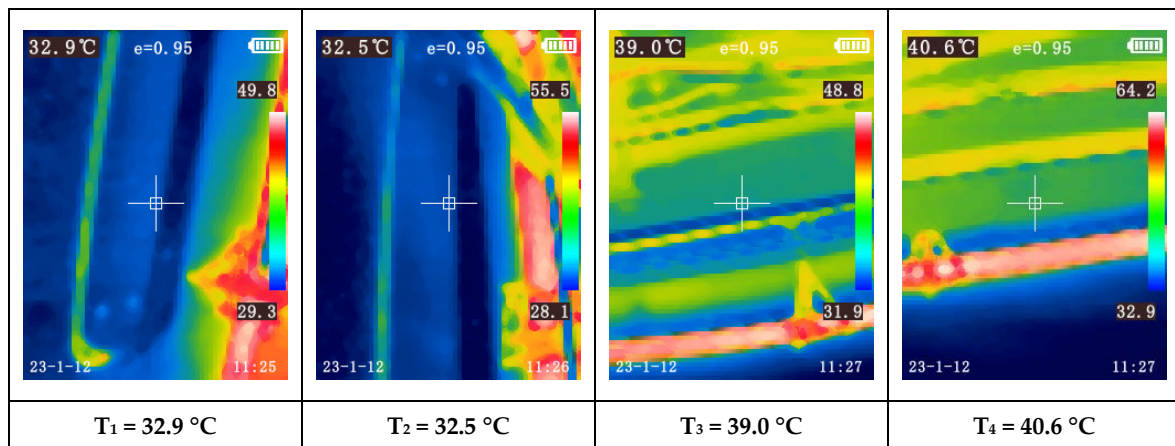
Figure 39. Images captured with the thermal imaging camera at the four defined measurement points at the end of Test 1, as specified in Table 5.

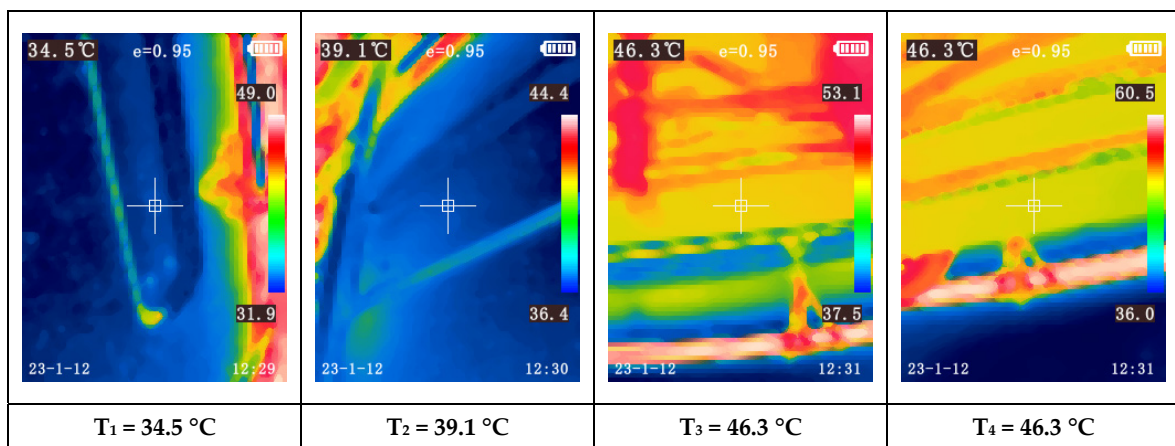
Figure 40. Images captured with the thermal imaging camera at the four defined measurement points at the end of Test 2, as specified in Table 5.

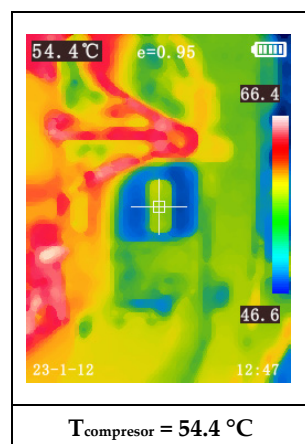
Figure 41. Image captured with the thermal imaging camera on the compressor to check its operation in Test 2.

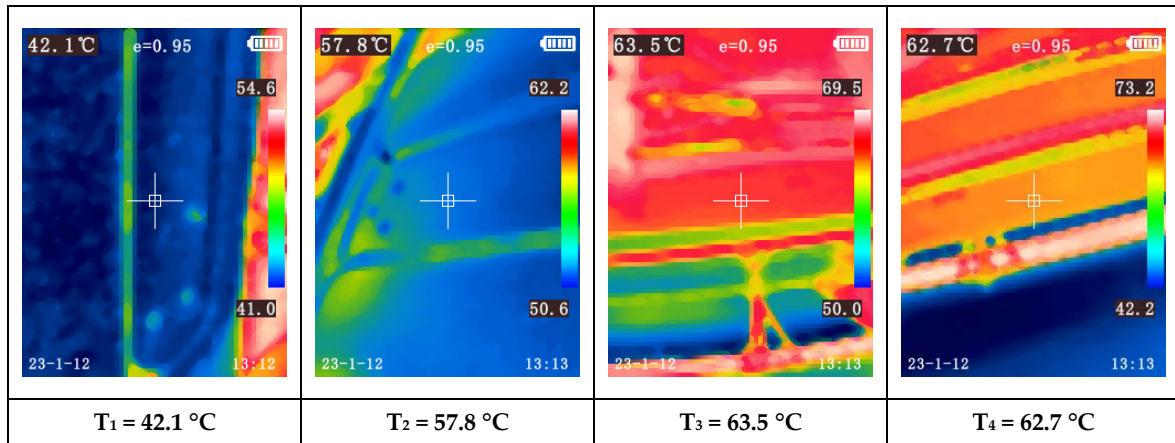
**Figure 42.** Images captured with the thermal imaging camera at the four defined measurement points at the end of Test 3, as specified in Table 5.

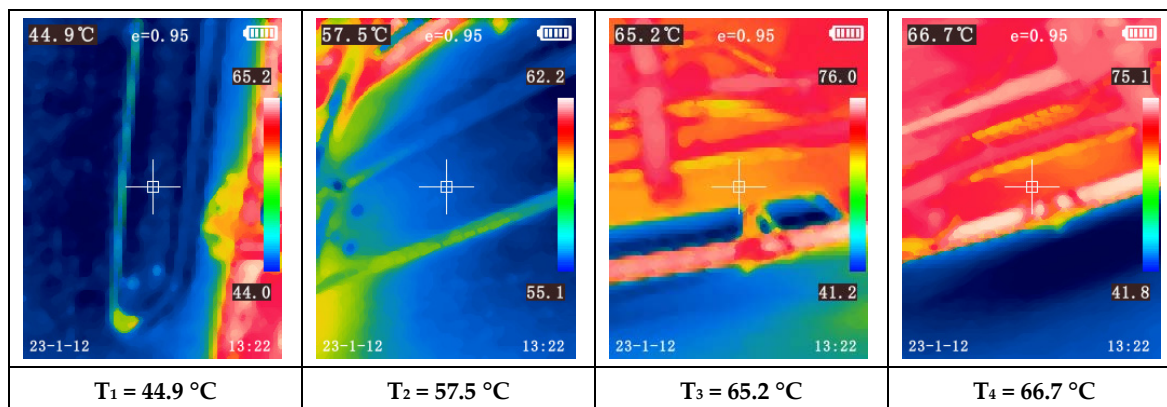
**Figure 44.** Images captured with the thermal imaging camera at the four defined measurement points at the end of Test 4, as specified in Table 5.

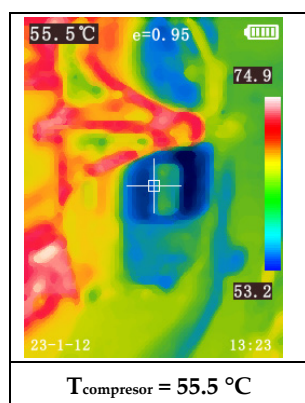
**Figure 45.** Image captured with the thermal imaging camera on the compressor to check its operation in Test 4.

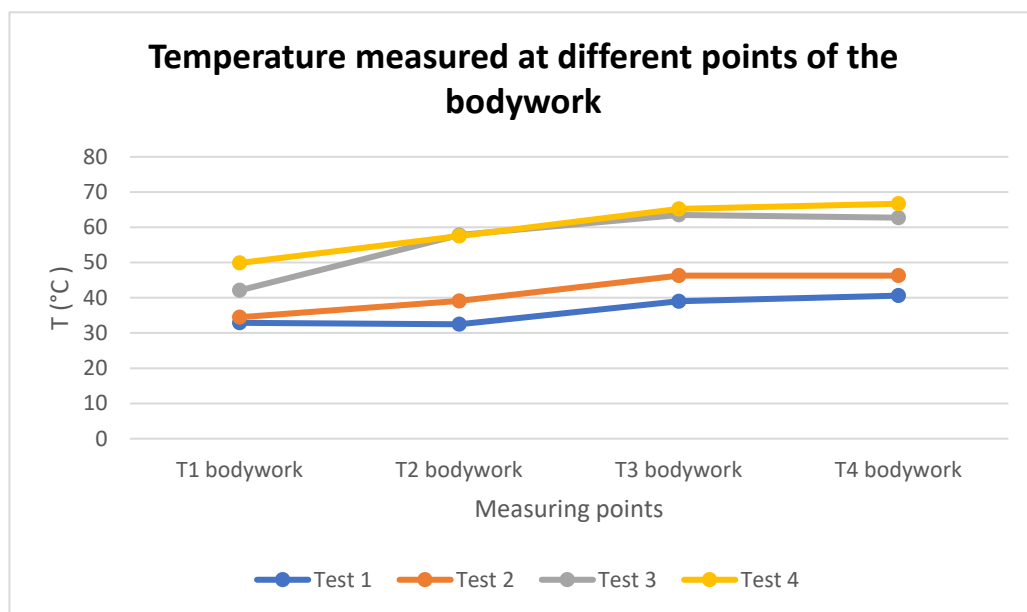
**Figure 46.** Graph of the temperature measured at different points of the bodywork with a thermal imaging camera in the four tests conducted with the battery at 100% SoC.

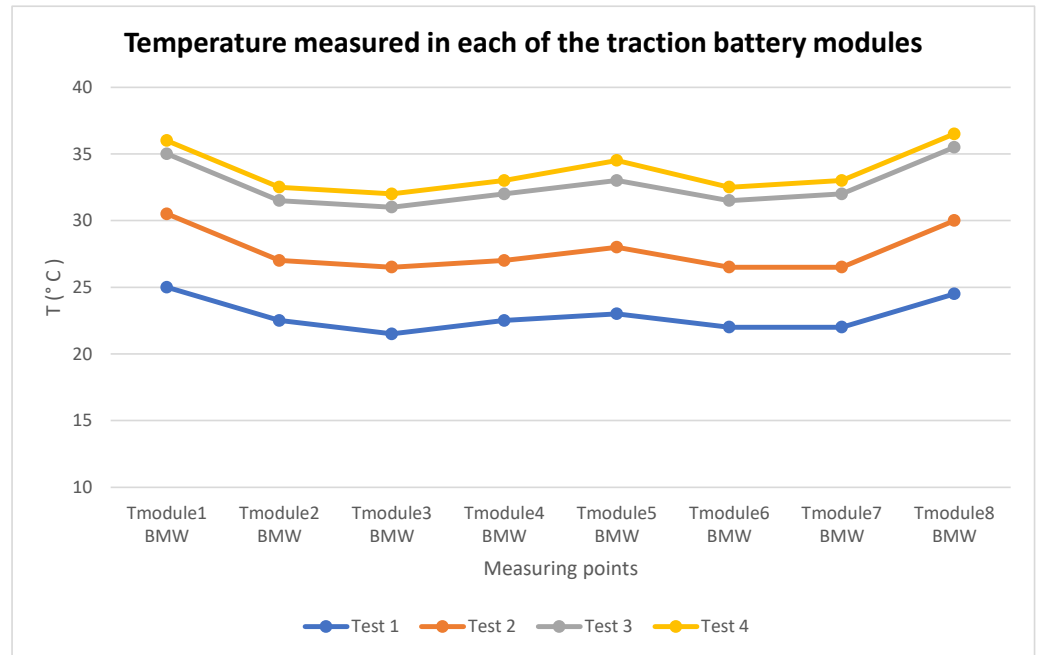
**Figure 47.** Temperature graph of each of the traction battery modules obtained with the BMW diagnostic equipment in the four tests conducted with the battery at 100% SoC.

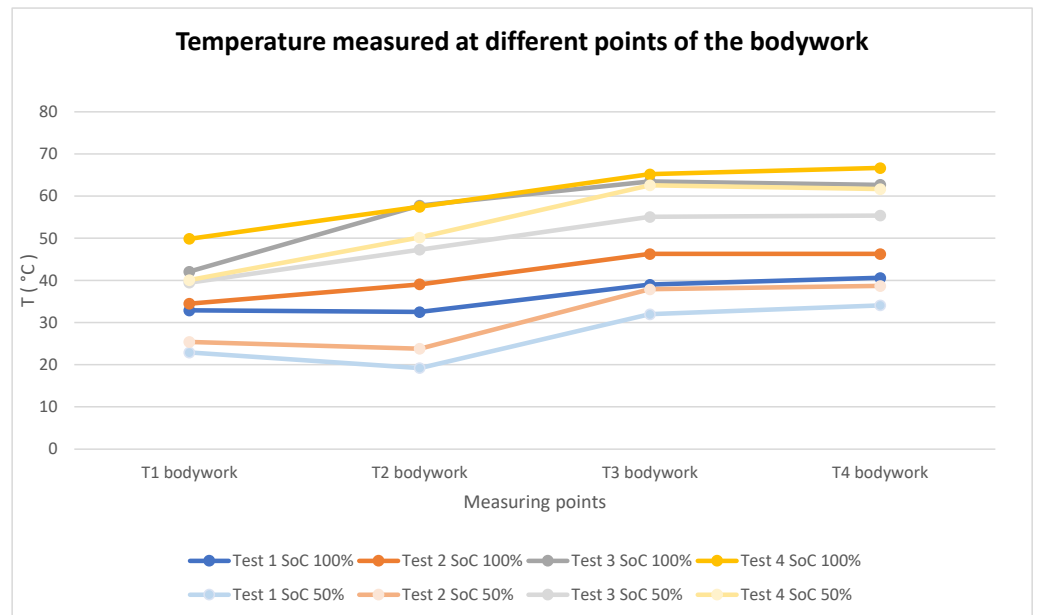
**Figure 48.** Graph of the temperature measured at different points of the bodywork with a thermal imaging camera in the four tests conducted for different battery SoCs analysed.

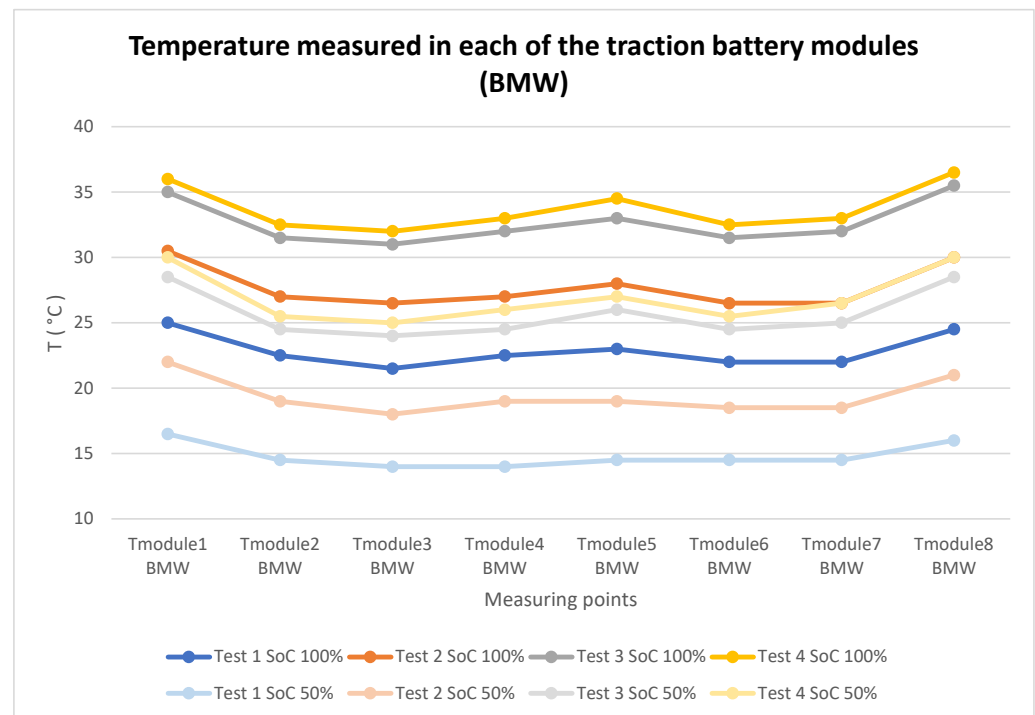
**Figure 49.** Temperature graph of each of the traction battery modules obtained with the BMW diagnostic equipment in the four tests conducted for different battery SoCs analysed.

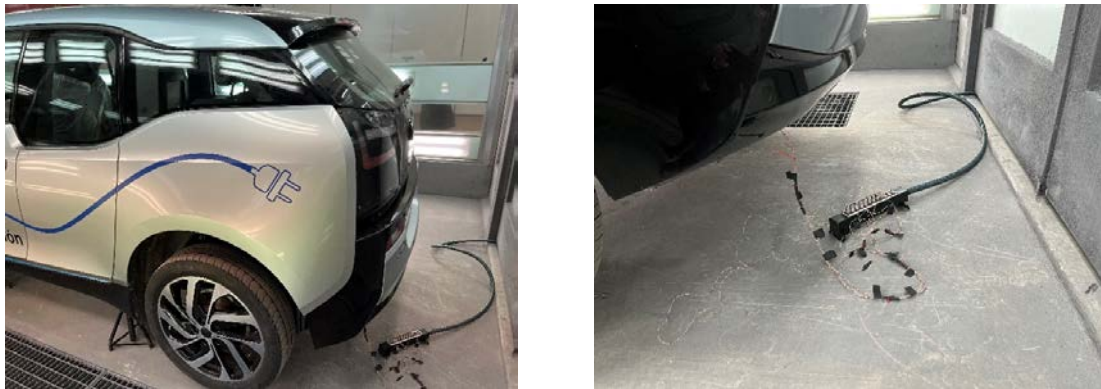
**Figure 50.** Image of the BMW i3 being tested inside the paint booth with the thermocouple connection panel (left). Detail of the panel showing the cables from the 8 thermocouples placed in each of the battery modules and the thermocouple positioned in the compressor (right).

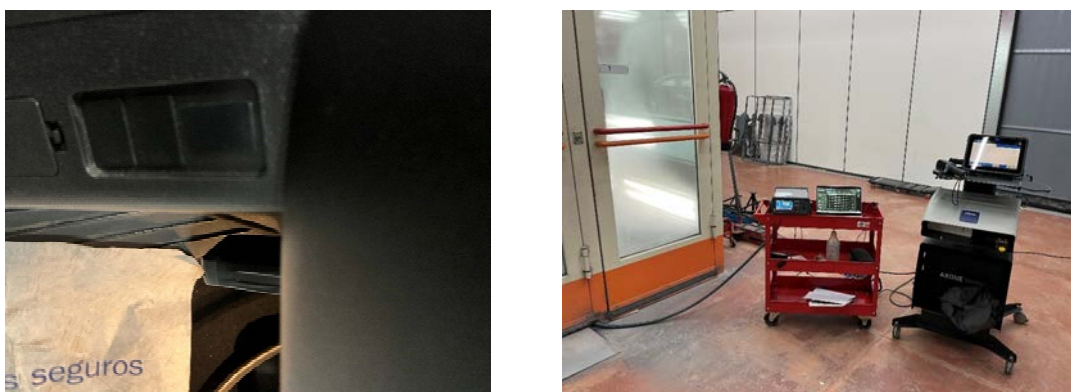
**Figure 51.** Image showing the connection of the TEXA diagnostic equipment to the OBD II port of the BMW I3 vehicle (left) and another image displaying the temperature measurement equipment alongside the TEXA equipment (right).

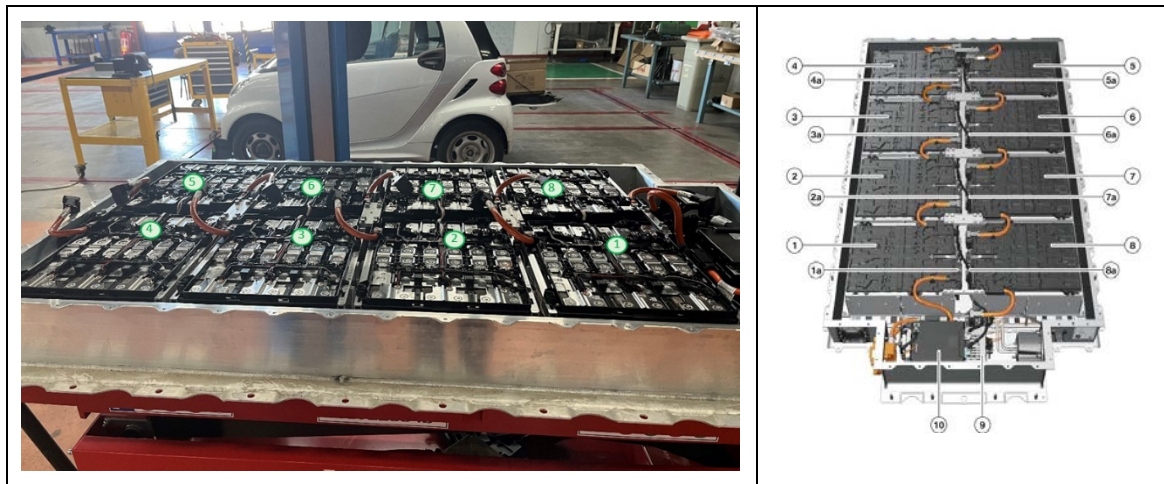
**Figure 54.** Image showing the numbering assigned to each of the traction battery modules of the BMW i3 vehicle (left), taking into account the numbering provided by the manufacturer (right).

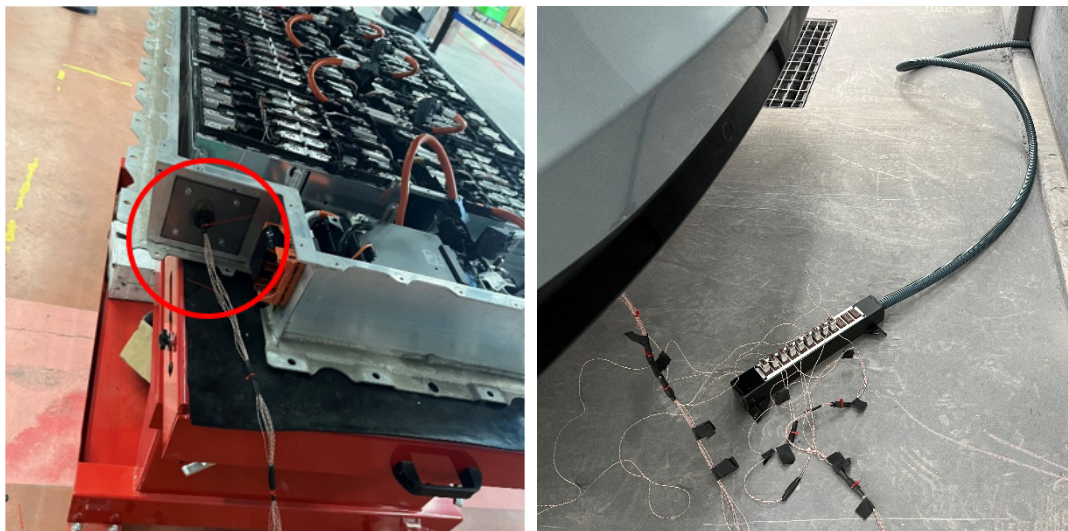
**Figure 55.** Image showing the hole (relief valve) through which the wiring of the thermocouples is passed out, which will later be connected to a connection panel (left). Image of the connection panel where the thermocouple cables are connected to display the temperature in the measured area using the datalogger (right).

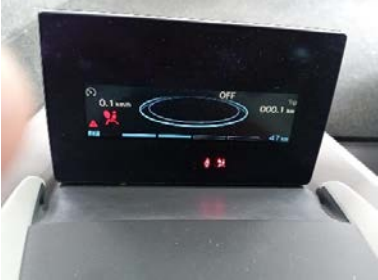
<p>1. Disconnection of the high voltage. Wait and check that the screen shows that the high voltage system is disconnected.</p>	<p>2. The high-voltage battery is placed in the lift table to be able to assemble it in the vehicle (front view).</p>

<p>3. The high-voltage battery is placed on the lift table so that it can be mounted on the vehicle (rear view).</p>	<p>4. The high-voltage battery is lifted on the lift table so that it can be mounted on the vehicle (rear view), the thermocouple cables can be seen.</p>

**Figure 56.** Assembly procedure of the high-voltage battery of the BMW i3 vehicle to be tested, after placing the thermocouples on the modules where their temperature will be measured during the tests.

The following images (Figure 56) show the battery being reassembled after placing the thermocouples on each of the battery modules.

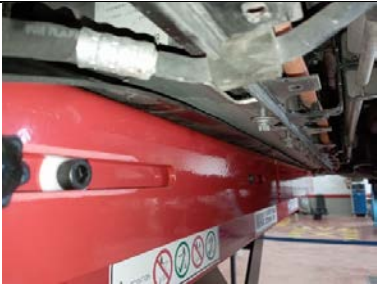
<p>5. Detail of the position of the thermocouple cables after the high-voltage battery has been fitted to the vehicle.</p>	<p>6. The battery must then be secured by tightening the corresponding screws.</p>

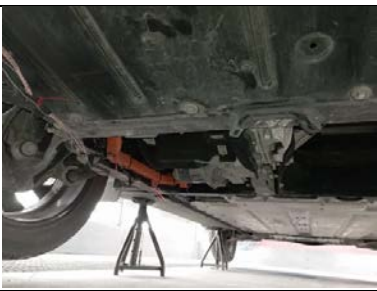
<p>7. Detail of the position of the insulated thermocouple on the compressor housing.</p>	<p>8. Detail of the underside of the vehicle after the high-voltage battery has been fitted.</p>
