# Analysis of the Temperature Reached by the Traction Battery of an Electric Vehicle during the Drying Phase in the Paint Booth

Analysis of the Temperature Reached by the Traction Battery of an Electric Vehicle during the Drying Phase in the Paint Booth. *Energies* **2024**, *17*, 3437.

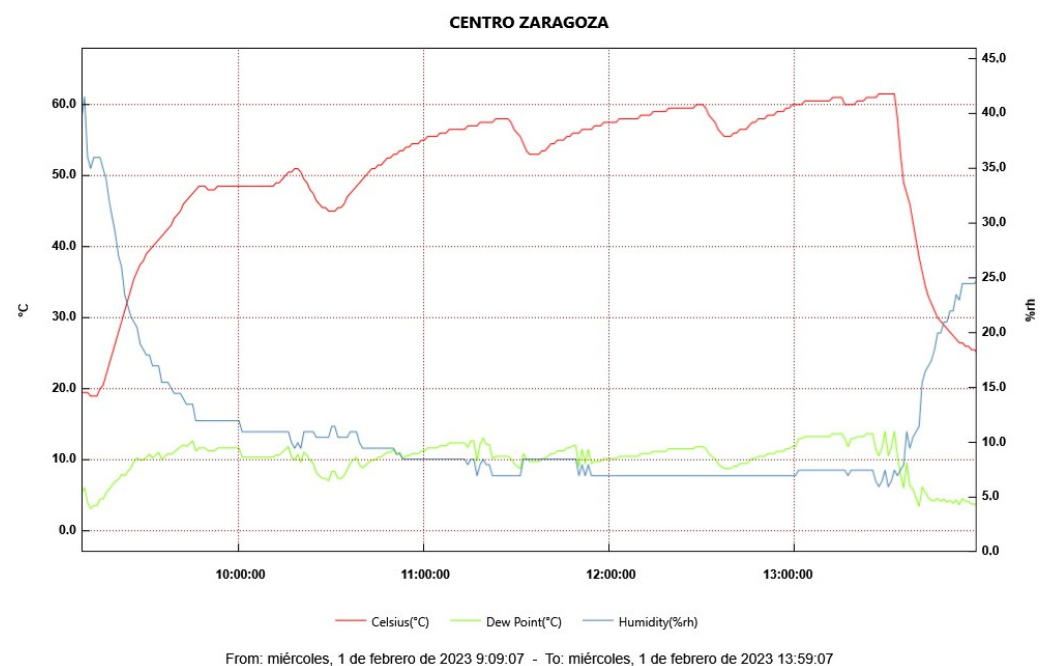
**Figure 57.** Graph illustrating the temperature (red line) and humidity (blue line) recorded by the EL-USB-2-LCD meter inside the paint booth during the test conducted with the battery at 50% SoC (TEXA diagnostic equipment + thermocouples).

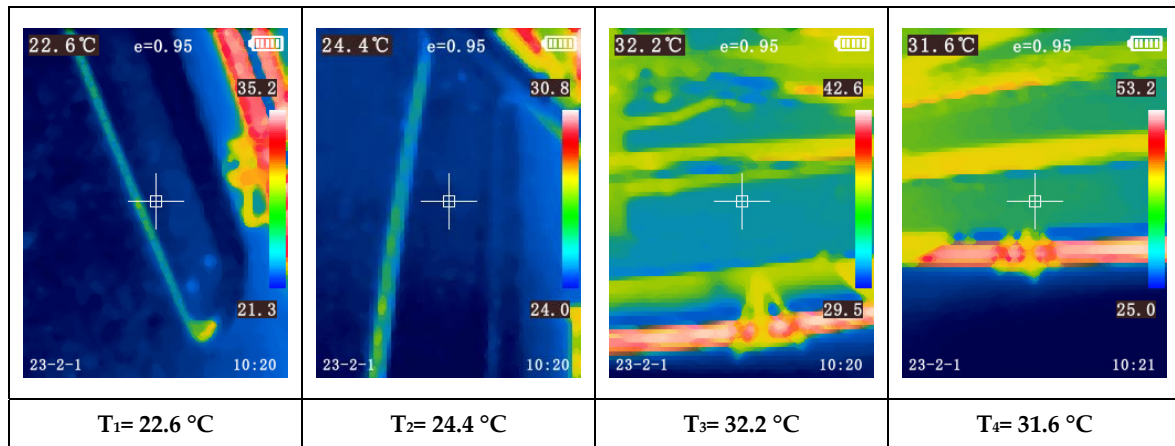
**Figure 58.** Thermal images captured at the end of Test 1, as outlined in Table 8, using a thermal imaging camera.

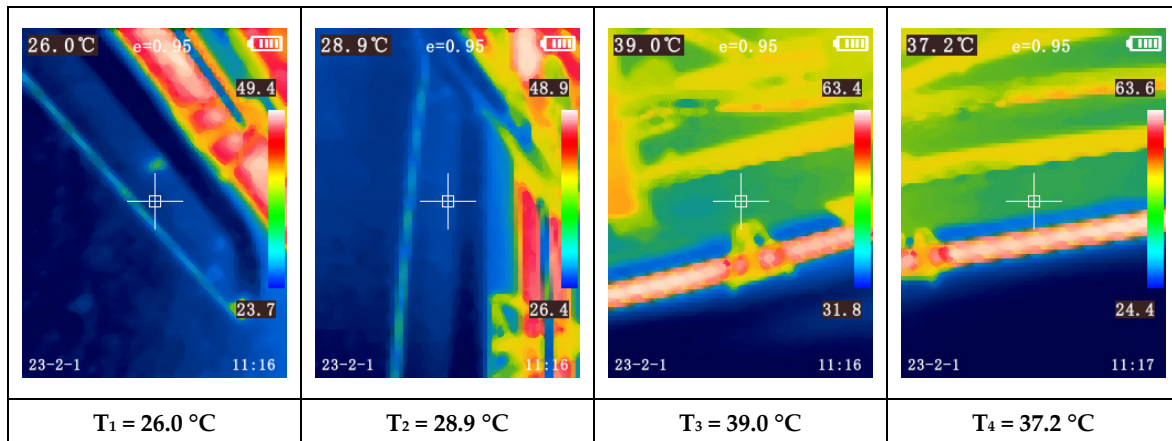
**Figure 60.** Images captured with the thermal imaging camera at the four defined measurement points, at the conclusion of Test 2, as specified in Table 8.

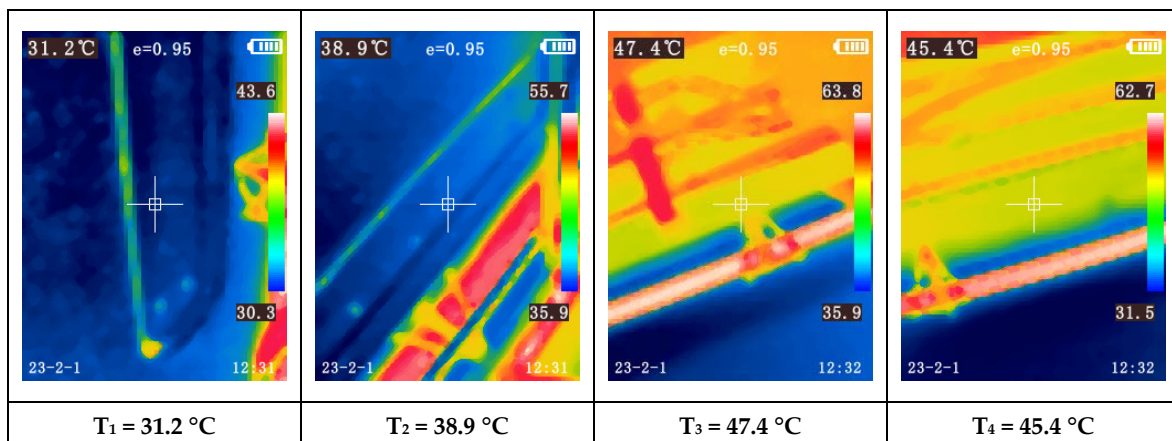
**Figure 62.** Images captured with the thermal imaging camera at the four designated measurement points, at the conclusion of Test 3, as specified in Table 8.

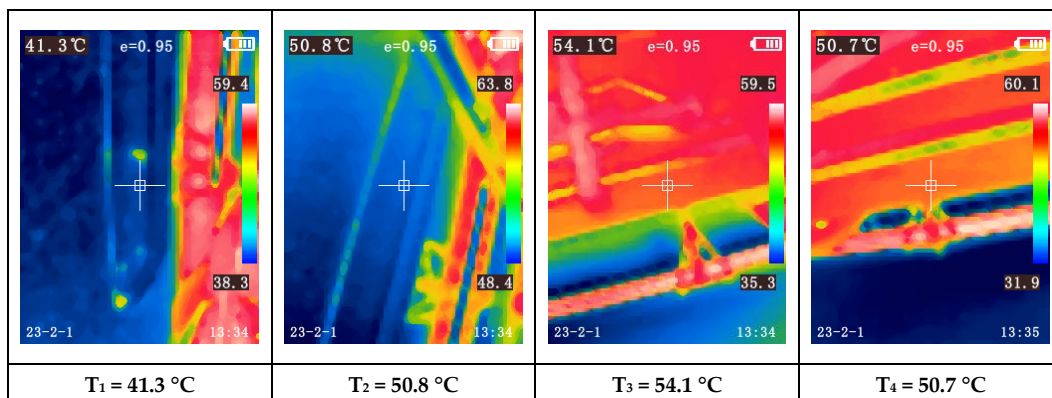
**Figure 64.** Images captured with the thermal imaging camera at the four designated measurement points, at the end of Test 4, as specified in Table 8.

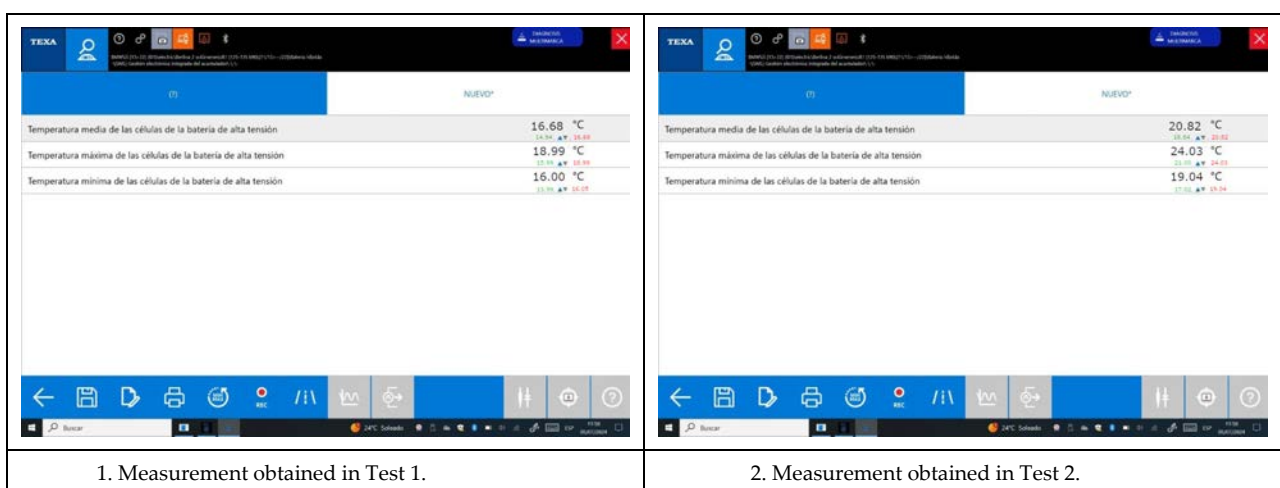
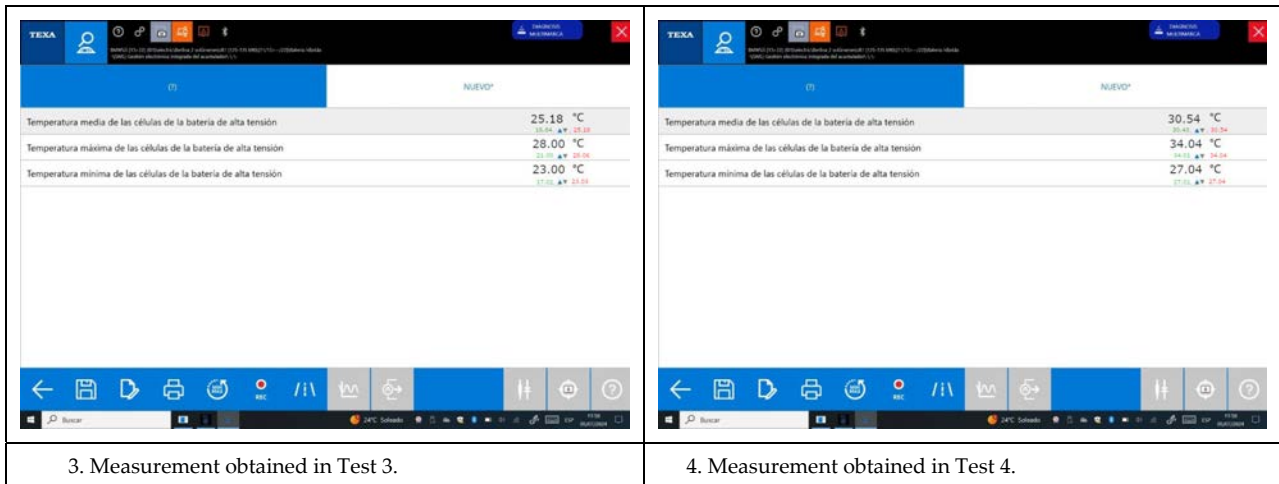
Figure 66. Temperature measurements obtained using the TEXA diagnostic equipment for the various tests conducted.

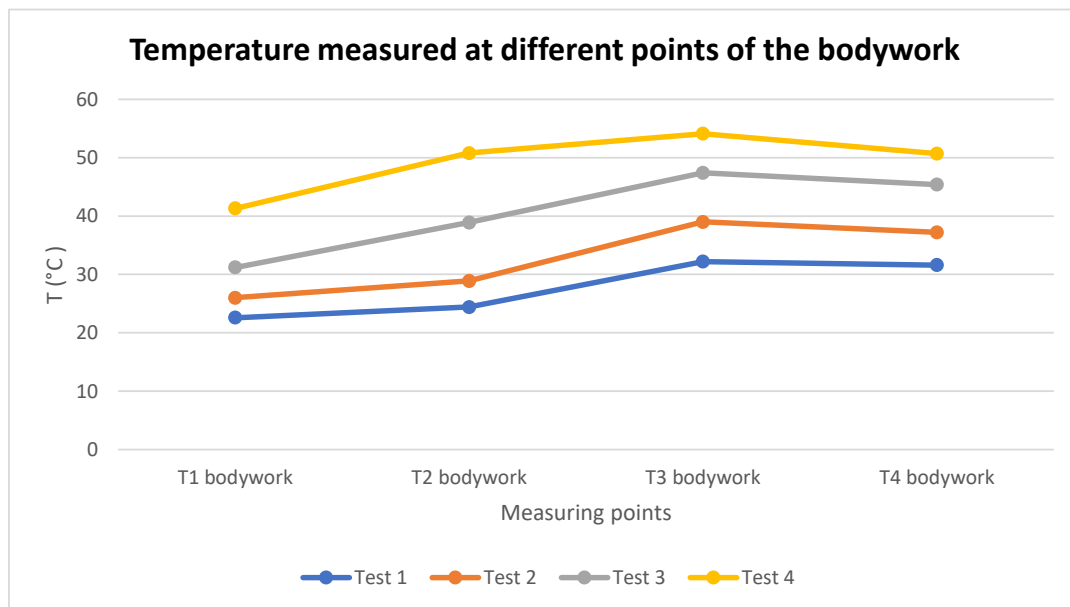
Figure 67. Graph showing the temperature measured at various points of the bodywork using a thermal imaging camera during the four tests conducted with the battery at 50% SoC.

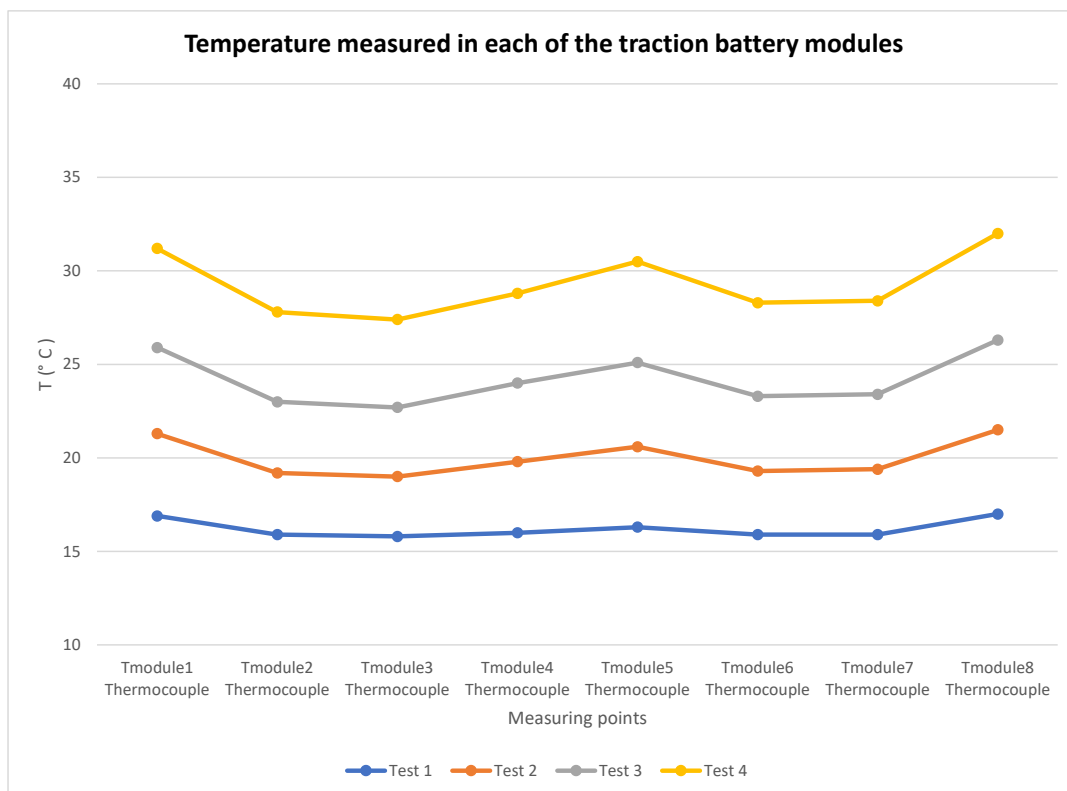
**Figure 68.** Graph showing the temperature in each of the traction battery modules obtained with temperature-measuring equipment (thermocouples) during the four tests conducted with the battery at 50% SoC.

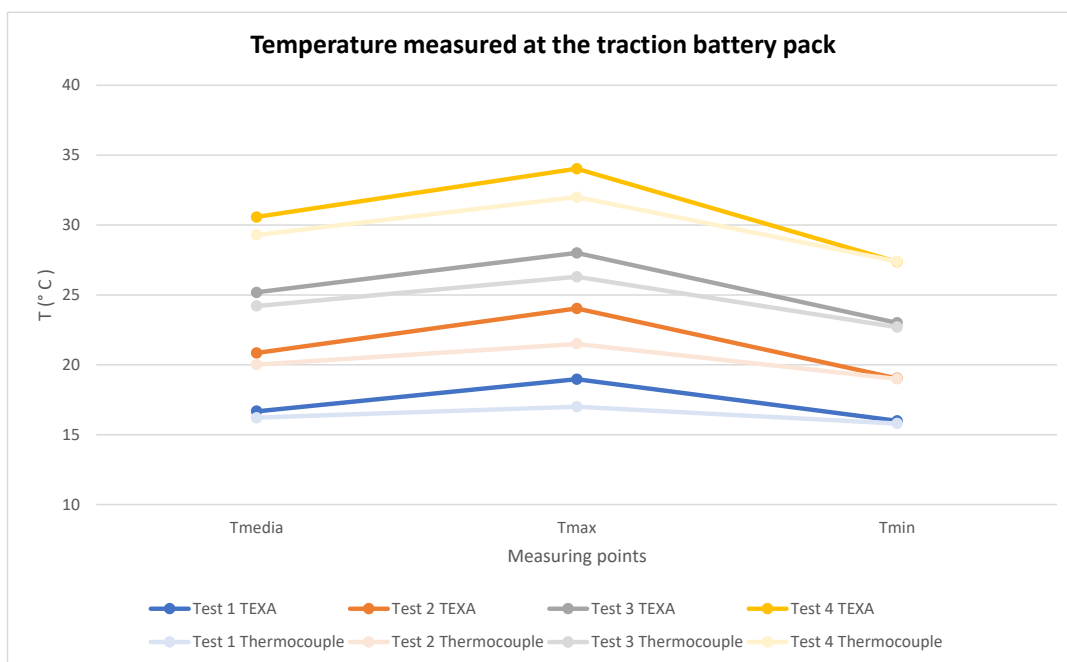
**Figure 69.** Graph depicting temperatures measured in the battery pack using TEXA diagnostic equipment and the average values from thermocouples in the modules.

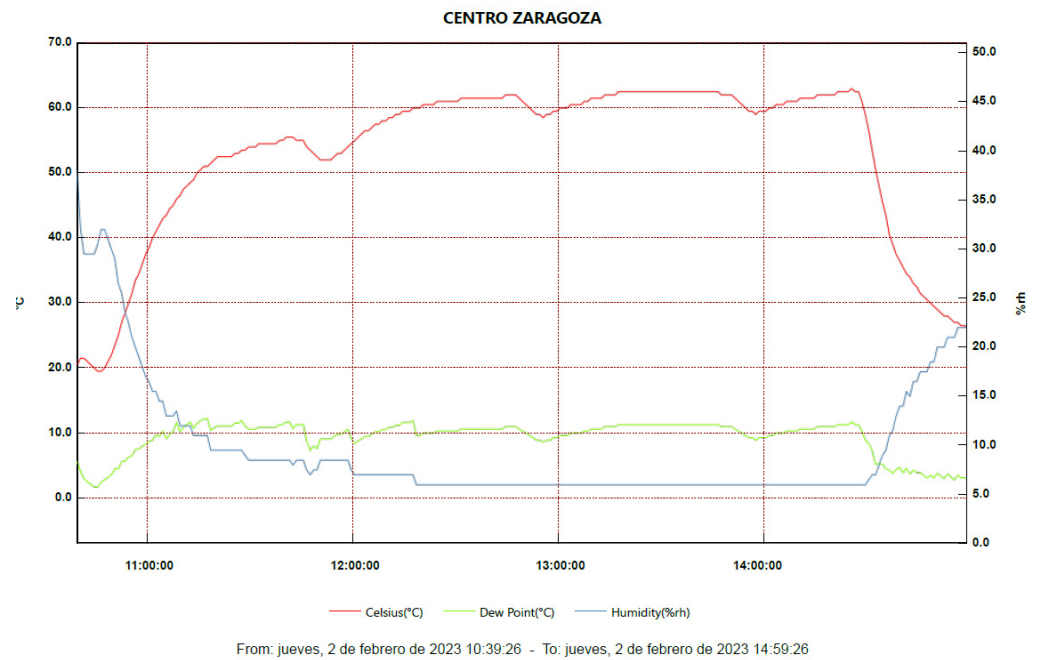
**Figure 70.** Graph showing the temperature (red line) and humidity (blue line) recorded by the EL-USB-2-LCD meter inside the paint booth during the test conducted with the battery at 100% SoC (TEXA diagnostic equipment + thermocouples).

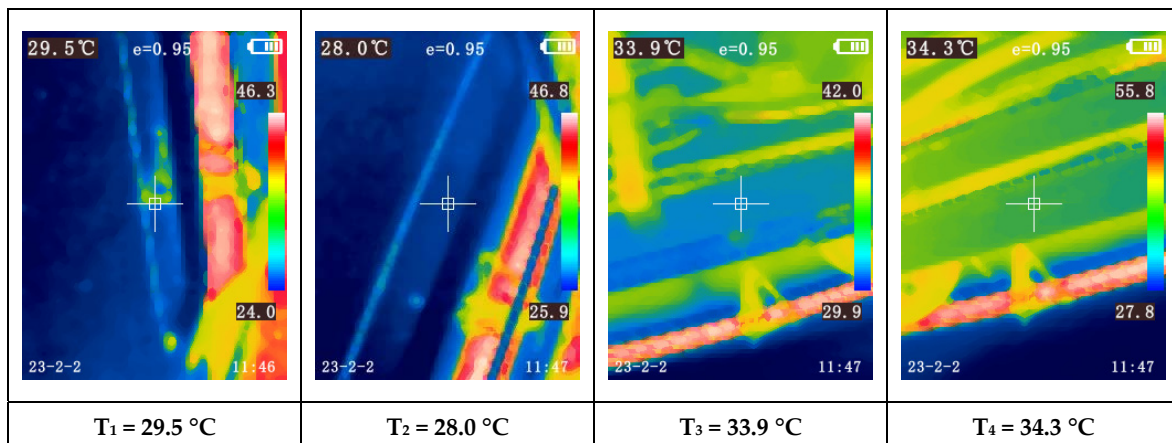
**Figure 71.** Images captured with the thermal imaging camera at the four designated measurement points, at the conclusion of Test 1, as specified in Table 13.

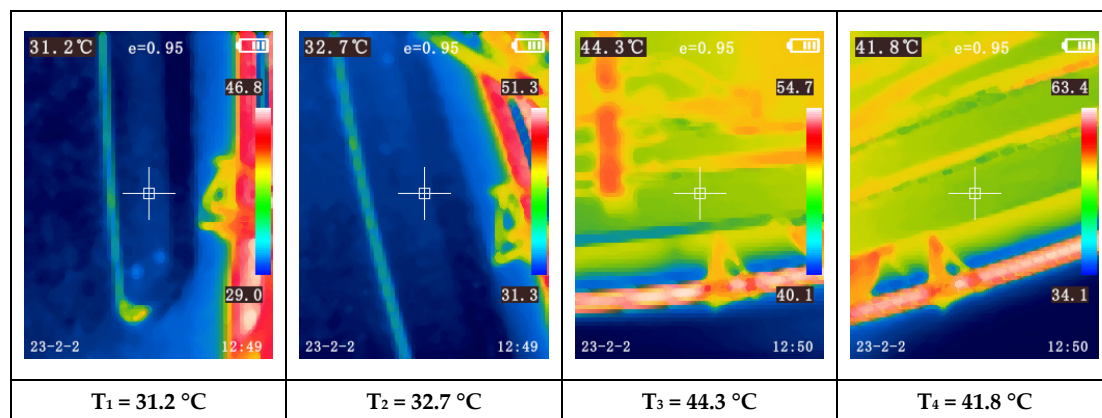
Figure 73. Images captured with the thermal imaging camera at the four specified measurement points, at the conclusion of Test 2, as outlined in Table 13.

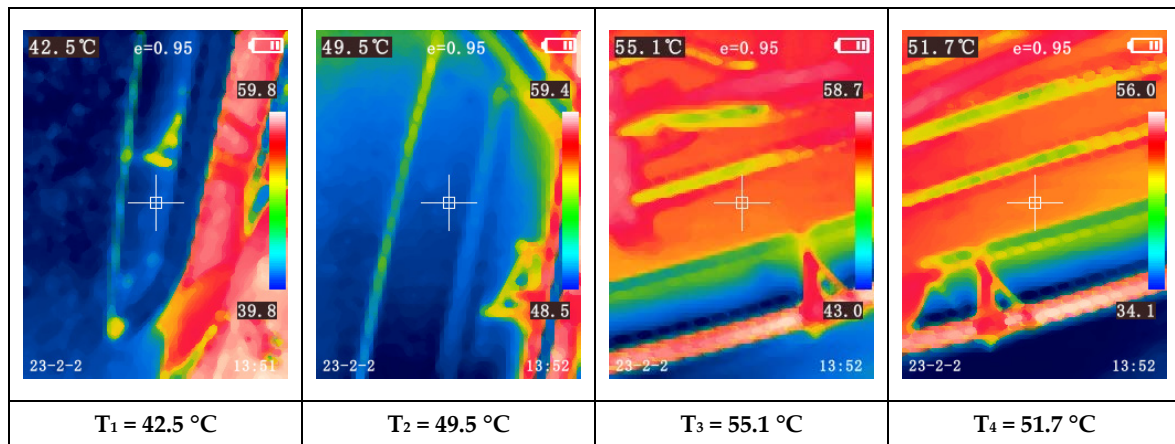
**Figure 75.** Images captured with the thermal imaging camera at the four defined measurement points, at the conclusion of Test 3, as outlined in Table 13.

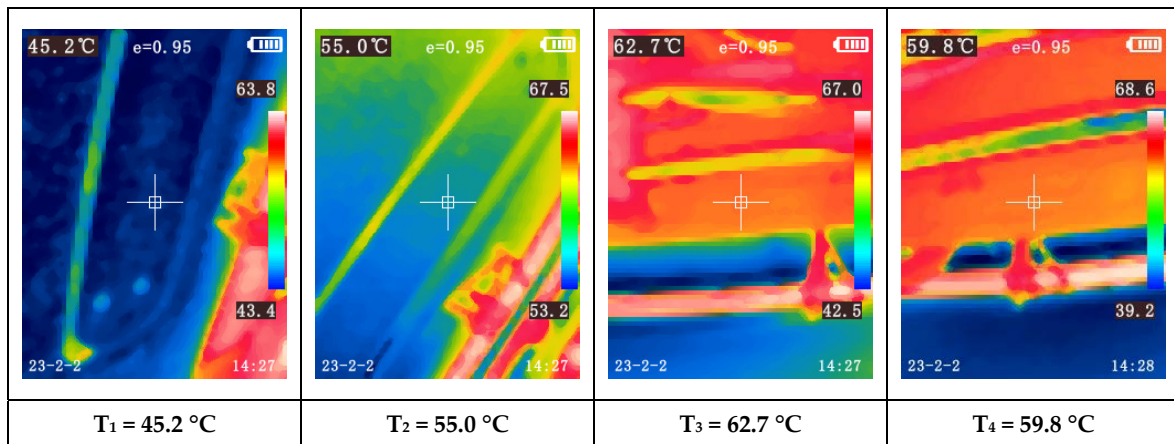
**Figure 77.** Images captured with the thermal imaging camera at the four specified measurement points, at the conclusion of Test 4, as outlined in Table 13.

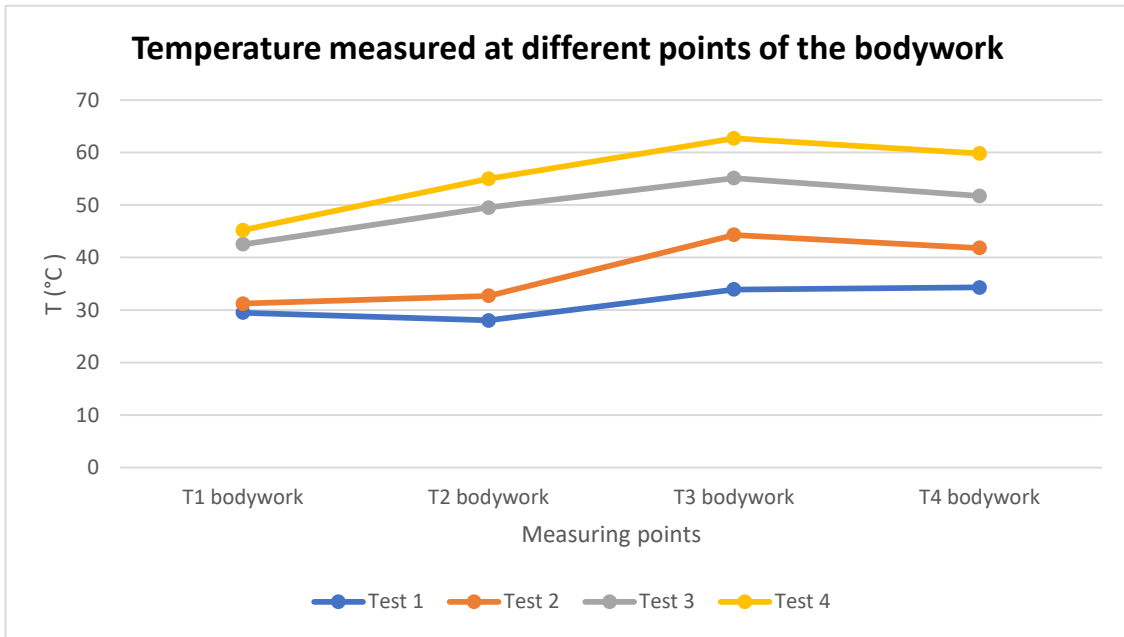
**Figure 80.** Graph of the temperature measured at different points of the bodywork with a thermal imaging camera in the four tests carried out with the battery at 100% SoC.

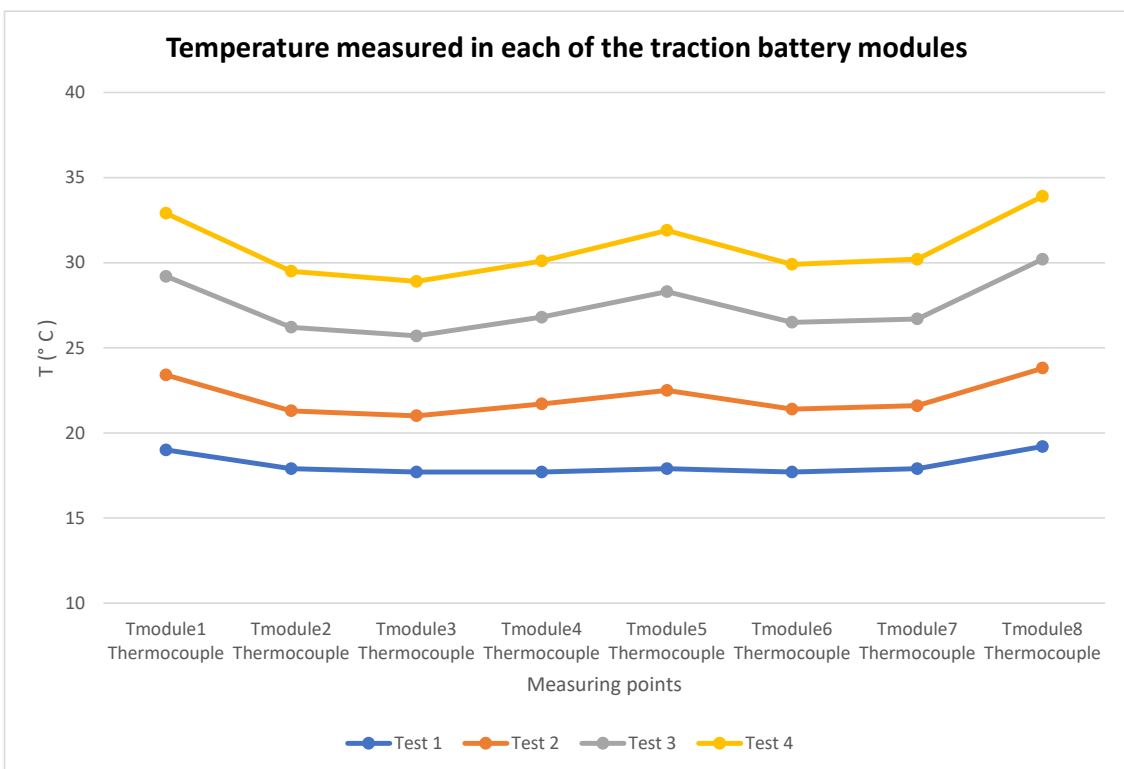
**Figure 81.** Graph of the temperature in each of the modules of the traction battery obtained with temperature-measuring equipment (thermocouples) in the four tests conducted with the battery at 100% SoC.

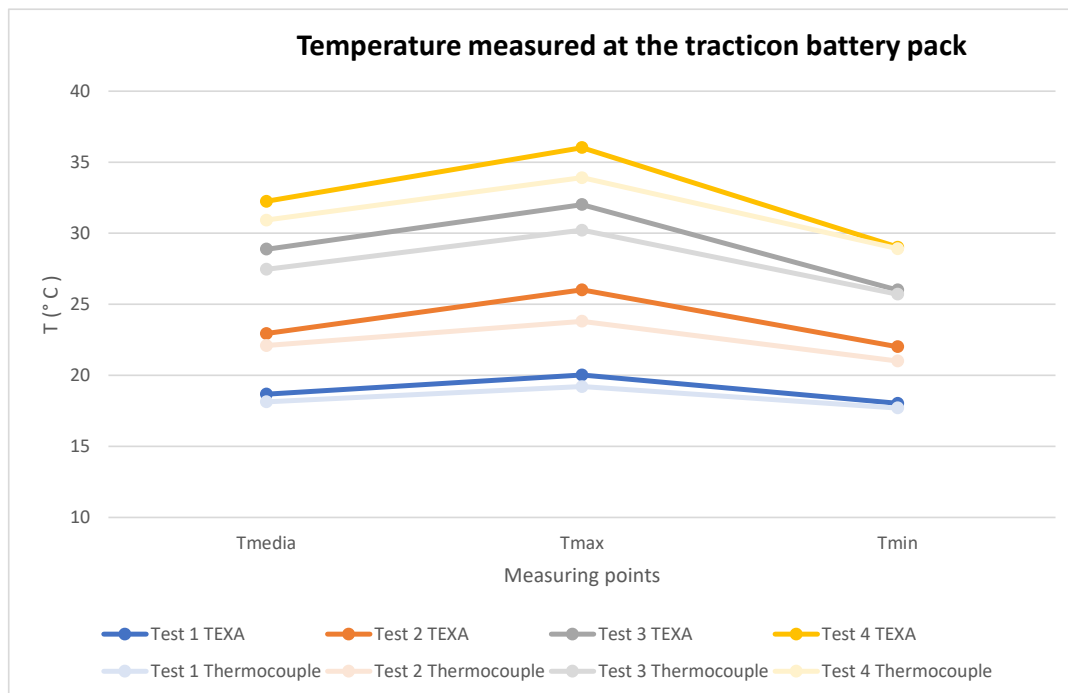
**Figure 82.** Graph of the temperature measured in the battery pack with the TEXA diagnostic equipment and from the average values in the modules with the thermocouples.

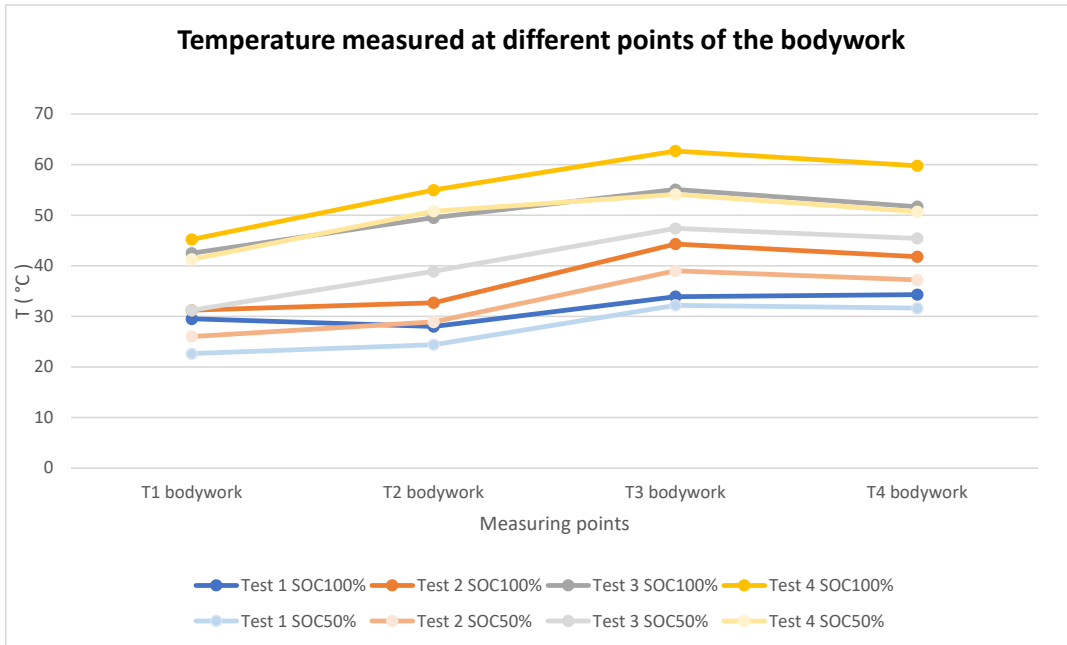
**Figure 83.** Graph of the temperature measured at different points of the bodywork with a thermal imaging camera in the four tests conducted for the different battery SoCs analysed.

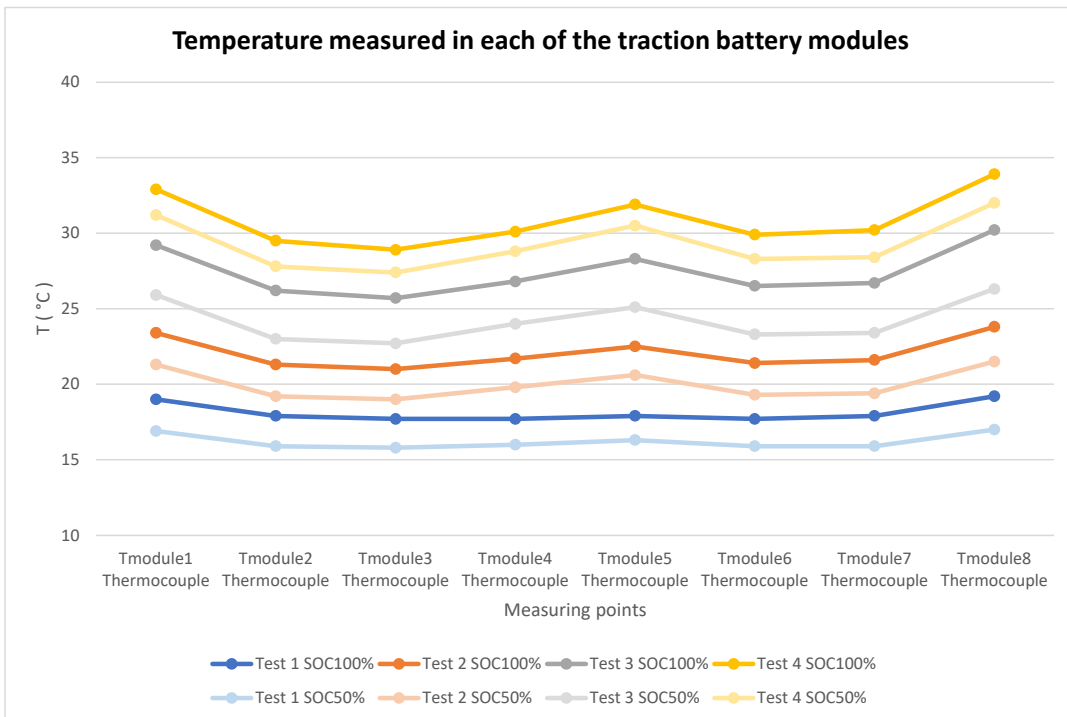
**Figure 84.** Graph of the temperature in each of the traction battery modules obtained with the thermocouple temperature measurement equipment, in the four tests conducted for the different battery SoCs analysed.

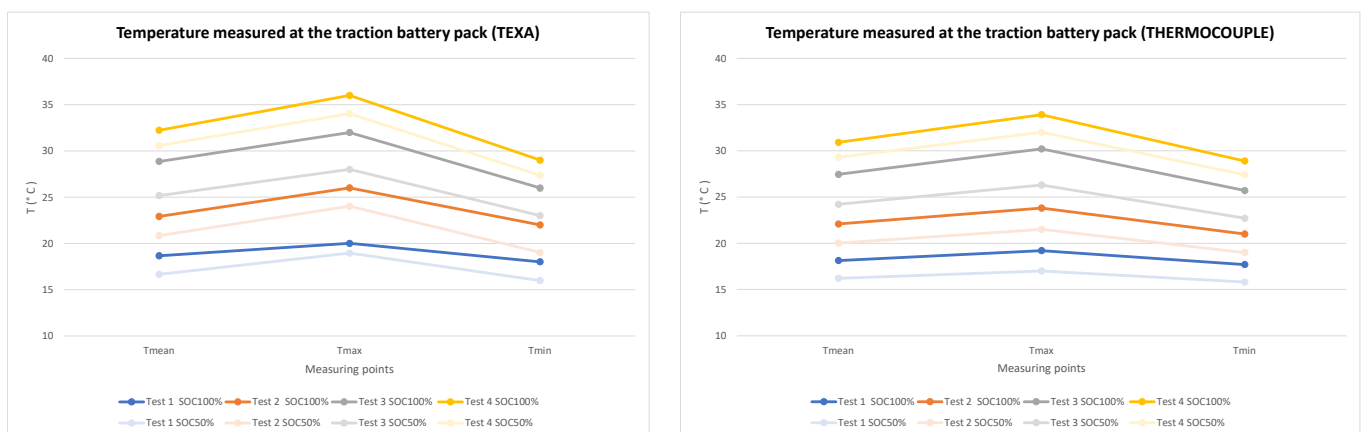
**Figure 85.** Graph of the temperature measured in the battery pack with the TEXA diagnostic equipment (left), and graph of the temperature measured in the battery pack with the temperature measurements taken in each module with the placement of thermocouples (right).

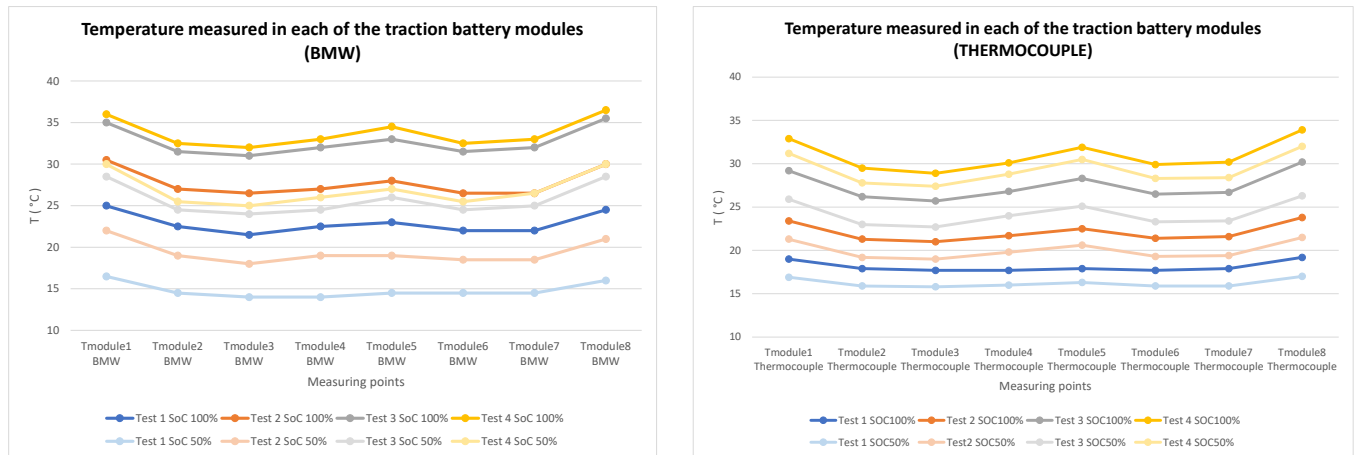
**Figure 86.** Graph of the temperature measured in each of the modules with the BMW diagnostic equipment (**left**) and graph of the temperature measured in each of the modules with the temperature measurement equipment using thermocouples (**right**).
