Article

Influence of the Layout of Cells in a Traction Battery on the Evolution of a Fire in the Event of a Failure

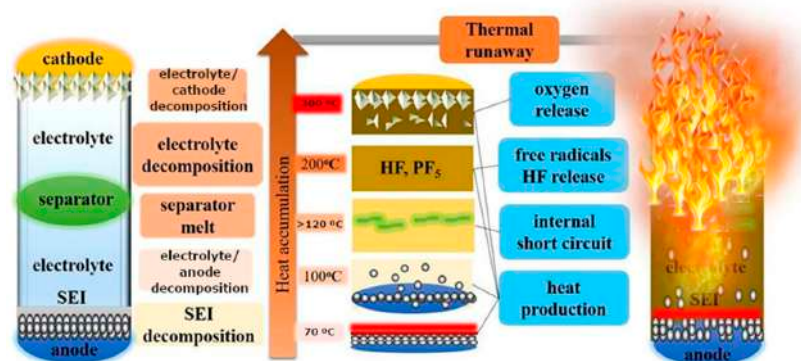
Figure 1. Schematic of the Thermal Runaway processes in a Lithium Cobalt Oxide (LCO)/graphite cell [29].

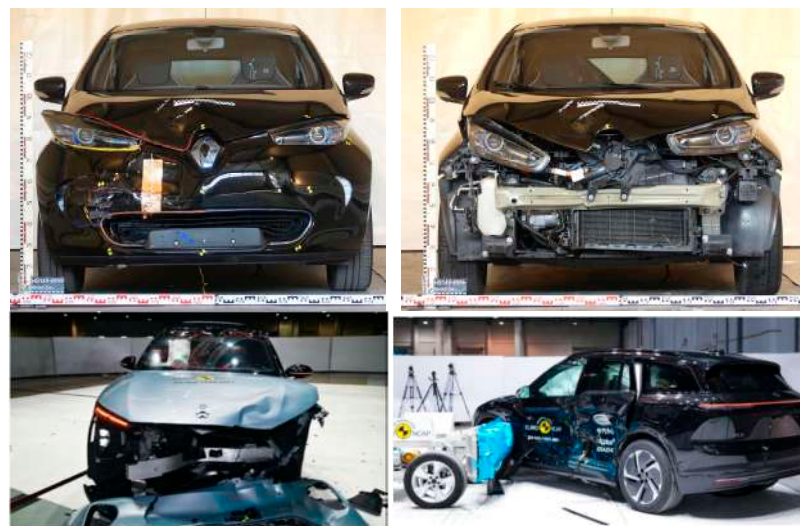
Figure 2. Images of various deformed electric vehicles in a crash test. Source: Renault Zoe (at the top) [70] and NIO EL6 (at the bottom) [71].

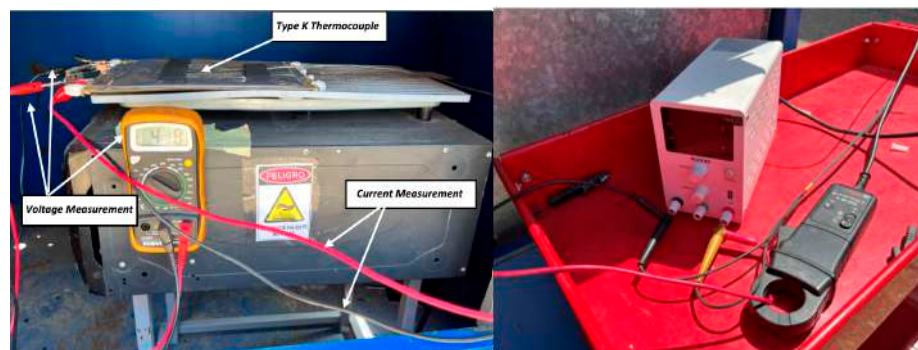
Figure 3. Images of the overcharge test set-up (left) and image of the charger used to supply 10 A (DC) (right).

The effect of the overcharge on the pouch cells tested will be analyzed by simulating their behavior in conditions where they can operate at ambient temperature and at a lower temperature. The aim is to analyze the behavior at room temperature of a pouch cell that fails due to overcharge since the behavior of lithium-ion batteries under adverse circumstances has been analyzed and is well known, but failures can also occur under normal conditions. For this reason, this test is performed while keeping the cell in its nominal operating temperature range. Figure 3 shows the set-up of the overcharge test carried out.

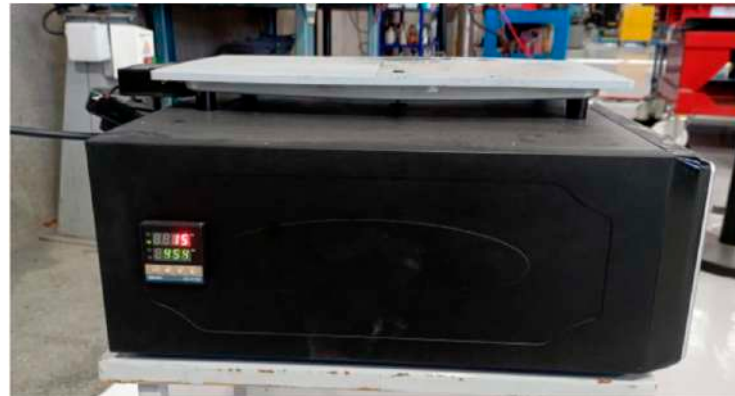
Figure 4. Images of the electric griddle instrumented with a PID-controlled thermostat, used for the heating tests.

The cells are heated using an electric iron instrumented with a PID (proportional integral derivative control) thermostat. A thermographic camera will also be used to monitor the T of the cells, as well as a voltmeter that will indicate when the cell voltage drops, indicating that the cell is no longer functioning properly and that the TR reaction may have begun. It should be borne in mind that, as the cells are joined together to carry out the test, they are not a purchased module and therefore do not have a BMS to manage the behavior of the group of cells. Below is an image (Figure 4) of the equipment used to heat the cells.

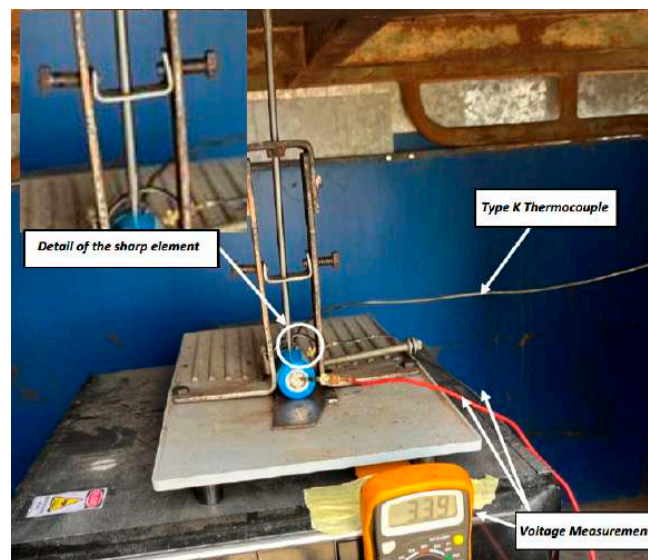
Figure 5. Image of the set-up of the perforation test with sharp element on the side of a cell with 100% SoC.

The test is carried out on a 32700 cylindrical cell in a horizontal arrangement with an SoC of 100%. A type K thermocouple is placed on the cell to measure its temperature, and a voltmeter is used to measure the voltage during the test. A tool has been prepared to pierce the cell horizontally (perpendicular to the longitudinal axis of the cylindrical cell) with a sharp tool; the Figure 5 shows the test set-up.

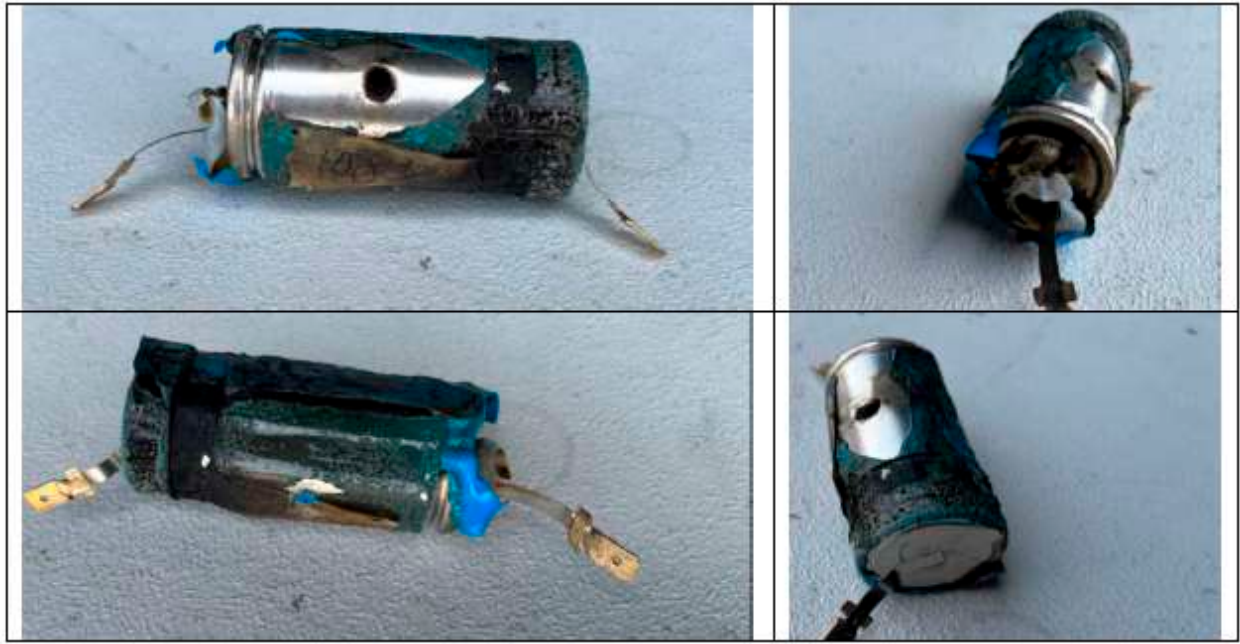
Figure 6. Images of the state of cell A after the test are shown, where the perforation it has undergone can be clearly seen.

Images of the state of cell A after the perforation test in the direction perpendicular to its longitudinal axis are shown below (Figure 6).

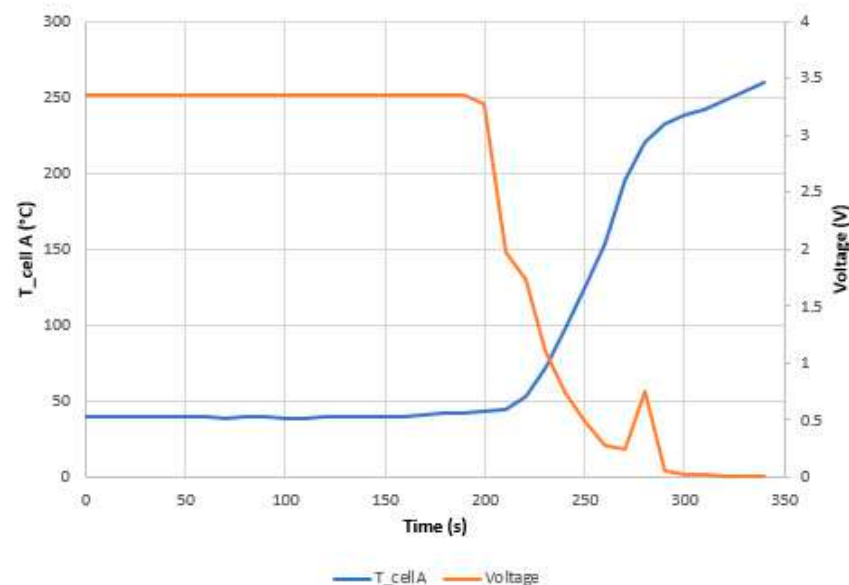
Figure 7. Temperature and voltage of cell A (SoC 100%) as a function of time during the mechanical abuse test, in which the cell is subjected to perforation in a direction perpendicular to the longitudinal axis of the cell until a short circuit occurs.

The cell reached a maximum temperature of 261 °C; when compared to other studies carried out on NMC cells [69], it is observed that the maximum temperature peak is lower in the case of LFP cells (tested) than in the case of NMC cells. In the following graph (Figure 7), the temperature reached by the A cell as well as the voltage behaviour is observed.

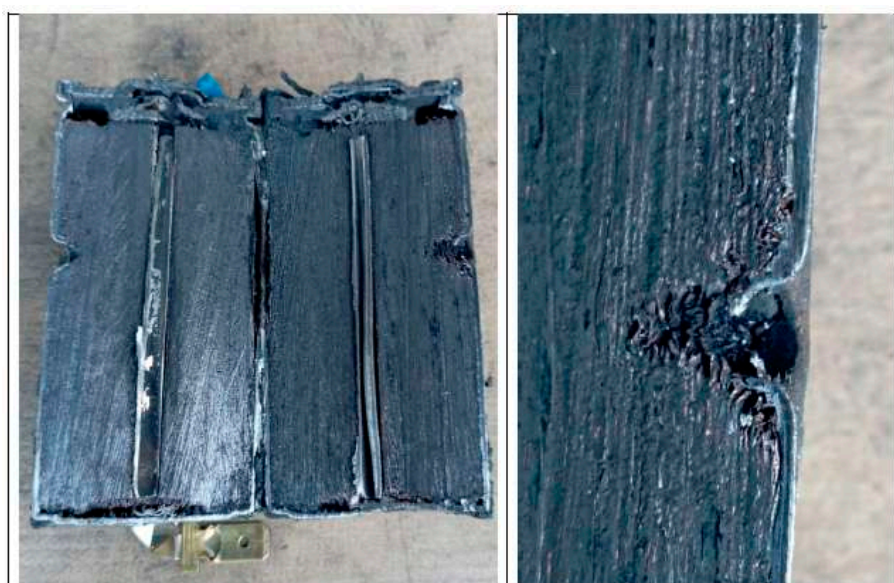
Figure 8. Image of damage to A cell tested for mechanical abuse by perforation in the direction perpendicular to the longitudinal axis of the cell.

Below is an image (Figure 8) of the sectioned cell after undergoing the test, in which a significant perforation of the cell can be seen before the short-circuit occurs, as well as considerable damage to the electrodes in the perforation. It can also be observed that the central part of this type of cell is solid; in other types of cells, such as LG 2200 mAh cells, model ICR18650 S3, this space is empty.

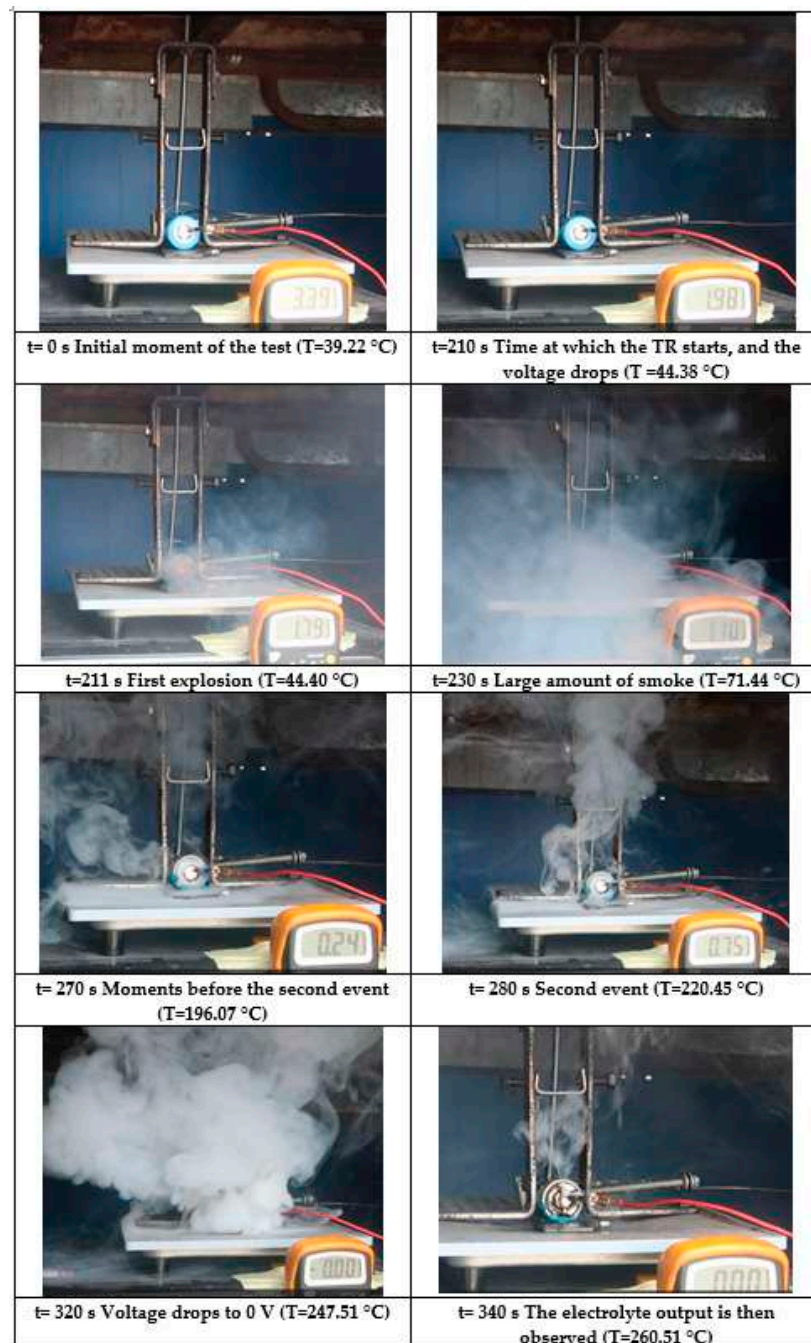
Figure 9. Images of the main events experienced by cell A (SoC 100%) during the mechanical abuse test (perforation in a direction perpendicular to the longitudinal axis of the cell).

Images of the test are shown in Figure 9, corresponding to the events identified as most significant during the mechanical abuse test carried out. Until the cell is perforated by a few millimeters, the effects of TR do not begin, even if the puncture is evident; it can be concluded that damage must take place of a certain level on the internal components of the cell (electrodes) for the short-circuit to occur. Venting of the cell gases takes place through the vent valve located on the positive pole. The generation of gases is due to reactions and evaporation of part of the electrolyte. After vapor venting, electrolyte venting is observed. In the case of the LFP cell analyzed, as the maximum temperature reached is lower than the melting temperature of the cathode aluminum, no traces of the cathode aluminum are observed.

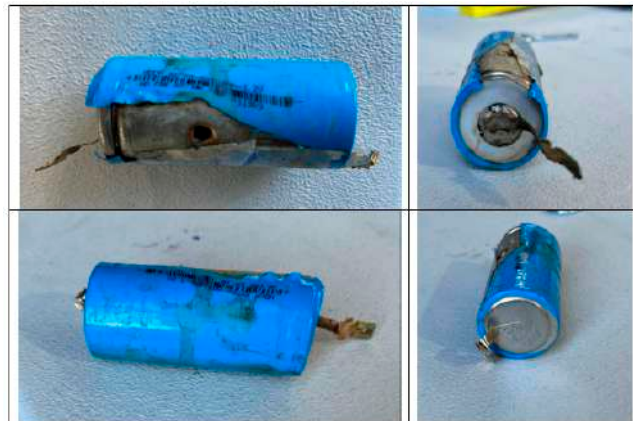
Figure 10. Images of the state of cell D after the test are shown, where the perforation it has undergone can be clearly seen.

Below are images of the state of cell D after the perforation test (Figure 10).

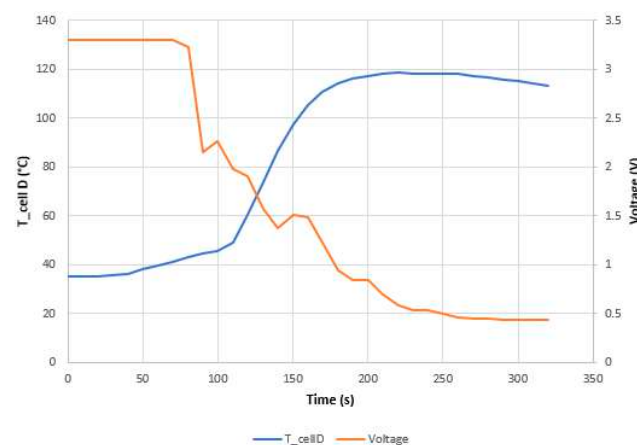
Figure 11. Temperature and voltage of cell D (SoC 50%) as a function of time during the mechanical abuse test, in which the cell is subjected to a perforation in a direction perpendicular to the longitudinal axis of the cell until a short circuit occurs.

Cell D (SoC 50%) reached a maximum temperature of 118.26 °C, well below the 261 °C reached in the case of cell A (SoC 100%). The following graph (Figure 11) shows the temperature reached by cell D as well as the voltage behavior.

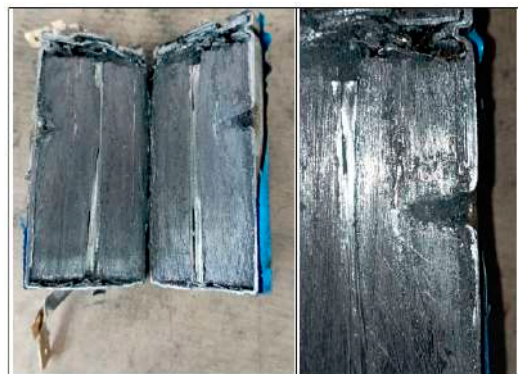
Figure 12. Image of damage to cell D (SoC 50%), which was tested for mechanical abuse by perforation in the direction perpendicular to the longitudinal axis of the cell.

Figure 12 shows the cell sectioned after the test, in which a significant perforation of the cell can be observed before the short circuit occurred. However, there is no major damage to the electrodes, and the cell is not burnt.

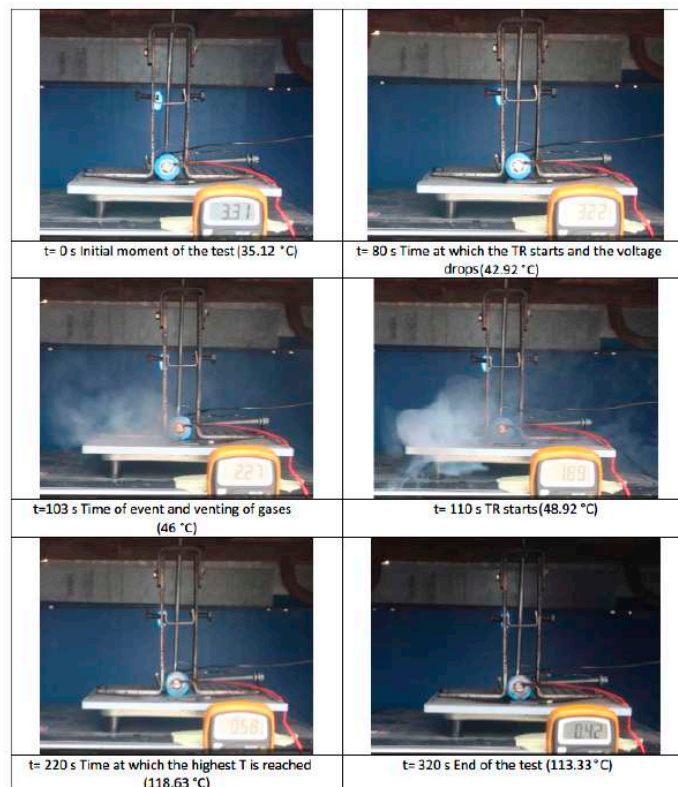
Figure 13. Images of the main events experienced by cell D (SoC 50%) during the mechanical abuse test (perforation in a direction perpendicular to the longitudinal axis of the cell).

In Figure 13, there are images from the test that correspond to the events identified as most significant during the mechanical abuse test carried out. Figure 13 shows that the events experienced by cell D are less intense than those experienced by cell A, and no electrolyte leakage occurred. It can therefore be concluded that cell D (SoC 50%) experiences milder exothermic reactions than those experienced by cell A (SoC 100%) when subjected to the same perforation test in a direction perpendicular to its longitudinal axis, so it can be stated that, given the same mechanical abuse by horizontal perforation, the behavior of the more heavily loaded cells will be more dangerous.

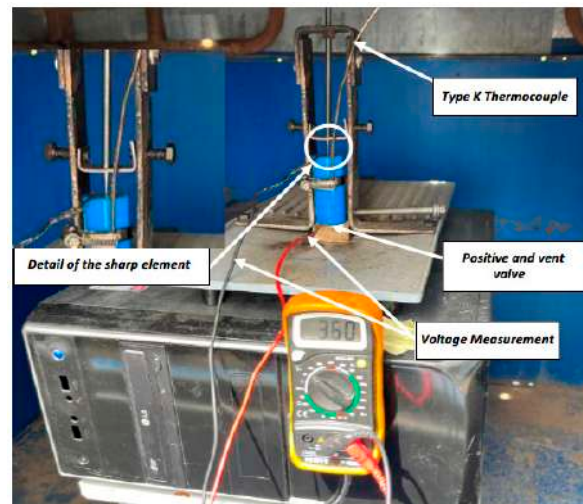
Figure 14. Image of the set-up of the perforation test, with the sharp element on the negative pole of a cell with an SoC of 100%.

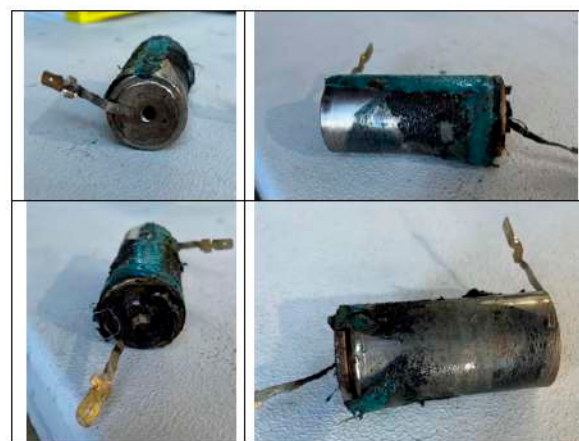
Figure 15. The state of cell C after the test, where the perforation it has undergone is clearly visible.

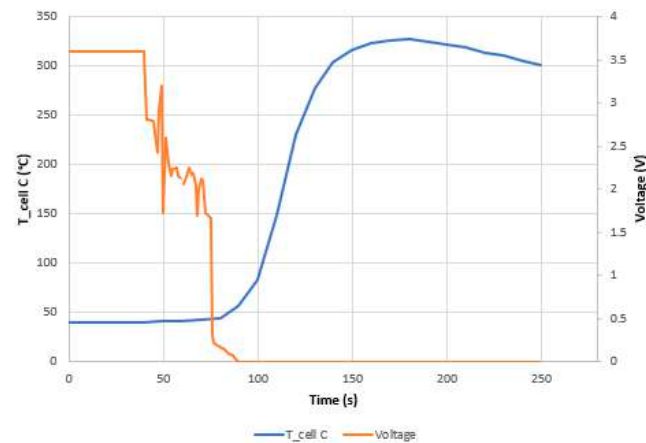
Figure 16. Temperature and voltage of cell C (SoC 0%) as a function of time, during the mechanical abuse test, in which it is subjected to a perforation in the direction of the longitudinal axis of the cell until a short circuit.

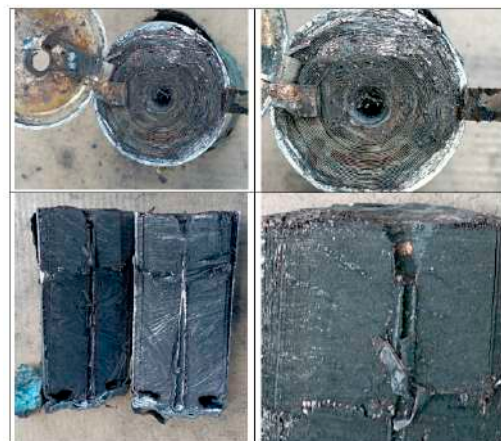
Figure 17. Image of the damage in cell C tested for mechanical abuse by perforation in the direction of the longitudinal axis of the cell.

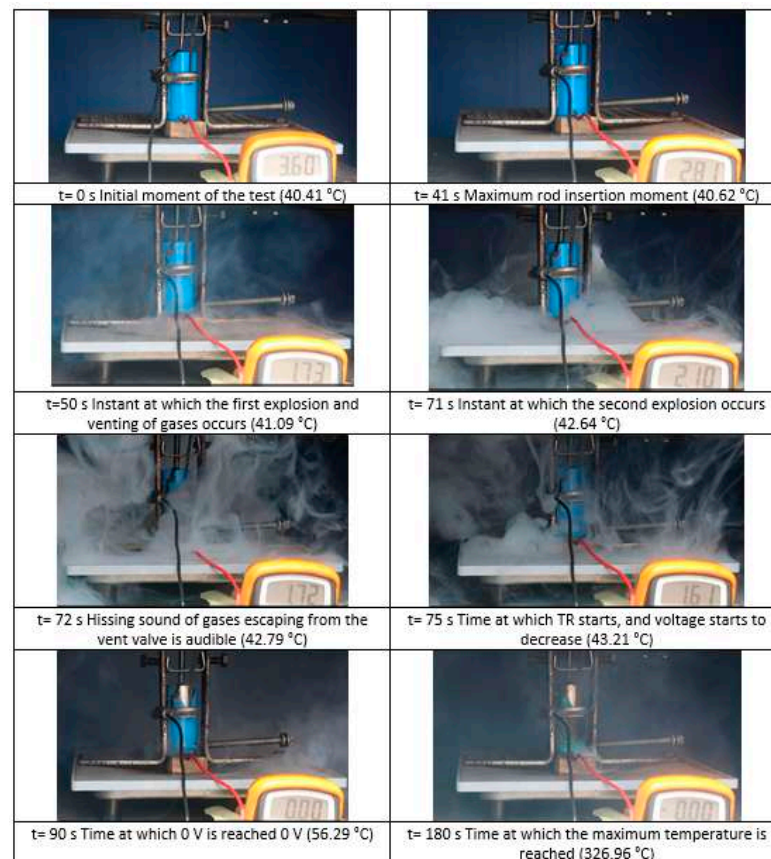
Figure 18. The main events experienced by cell C (SoC 100%) during the mechanical abuse test (perforation in the direction of the longitudinal axis of the cell).

Figure 18 shows the events identified as most significant during the mechanical abuse test.

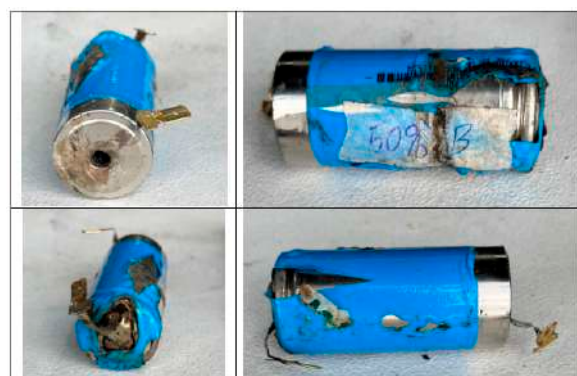
Figure 19. Image of the damage in cell B after the test; the perforation is clearly visible.

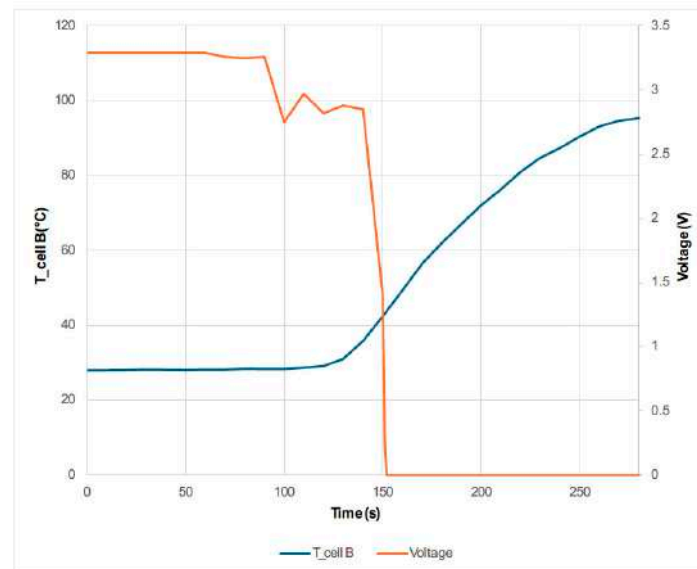
Figure 20. Temperature and voltage of cell B (SoC 50%) as a function of time during the mechanical abuse test, in which it is subjected to a perforation in a direction of the longitudinal axis of the cell until a short circuit occurs.

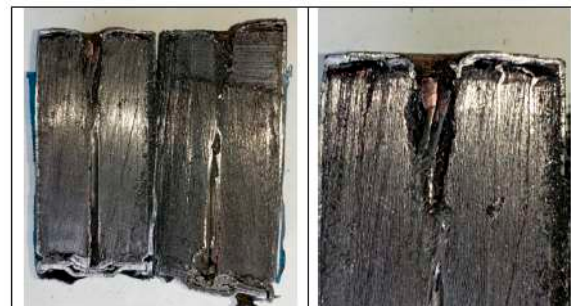
Figure 21. Image of the damage in cell B tested (SoC 50%) for mechanical abuse by perforation in the direction of the longitudinal axis of the cell.

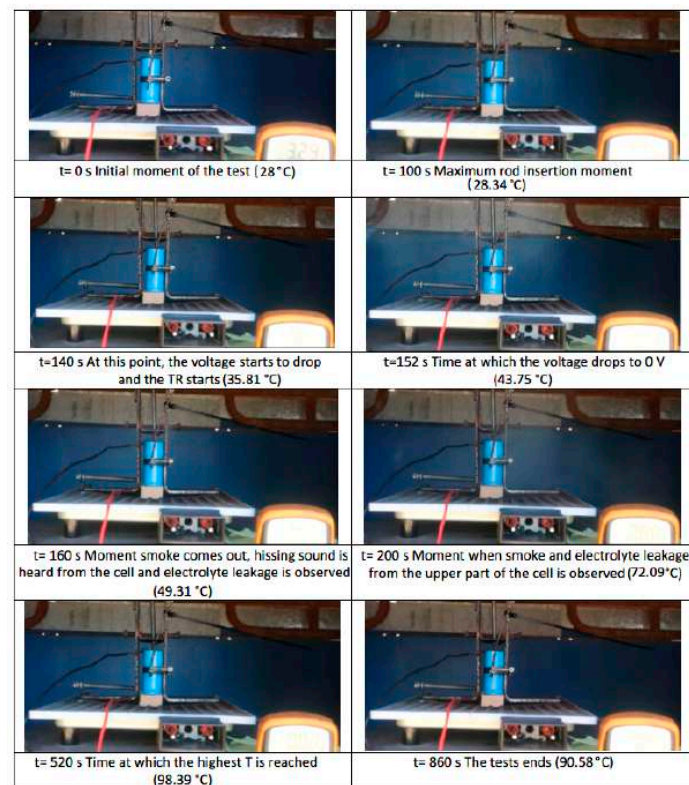
Figure 22. Images of the main events experienced by cell B (SoC 50%) during the mechanical abuse test (perforation in the direction of the longitudinal axis of the cell).

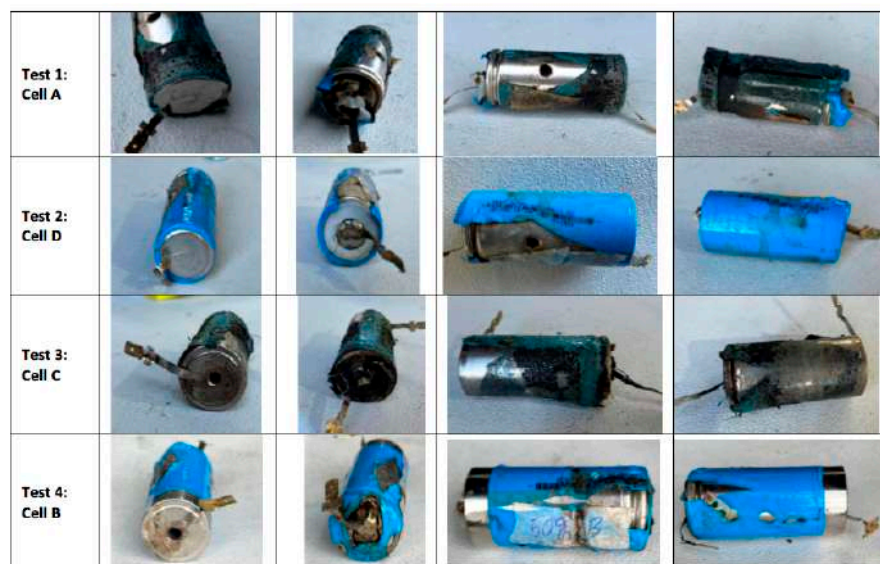
Figure 23. Qualitative comparison of the final state of the tested cells (analyzing their exterior).

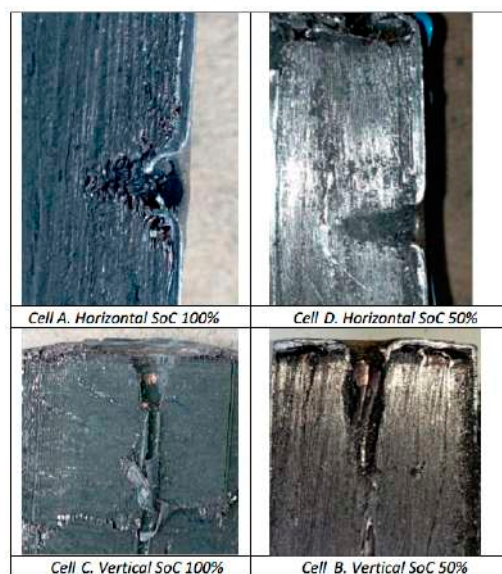
Figure 24. Qualitative comparison of the final state of the tested cells (analyzing their interior).

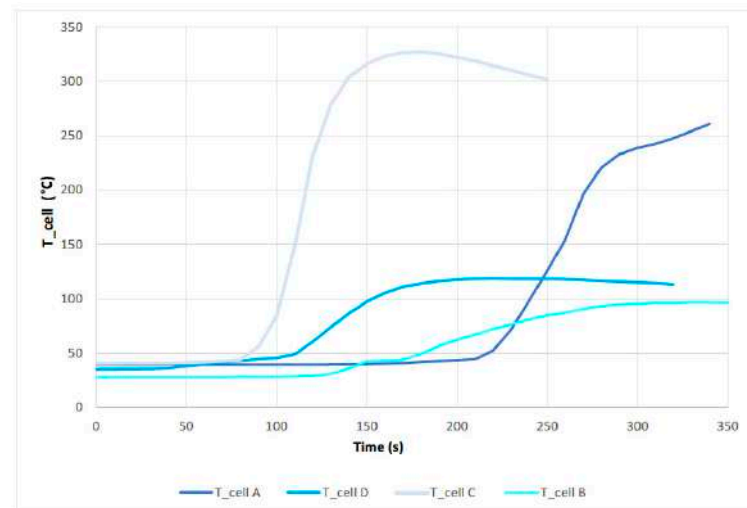
Figure 25. Comparison of the temperature reached by the cells during the tests to which they have been subjected.

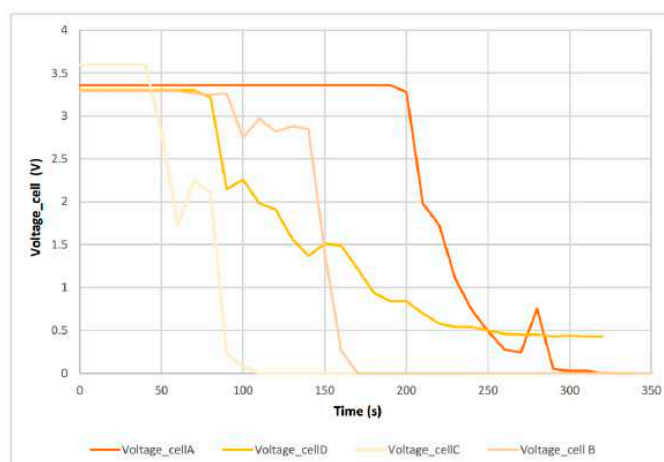
Figure 26. Comparison of the voltage behavior of the cells during the tests to which they have been subjected.

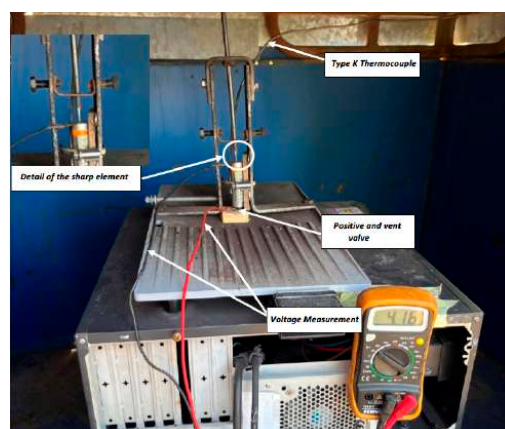
Figure 27. Image of the set-up of the perforation test with sharp element on the negative pole of a cell NMC with an SoC of 100%.

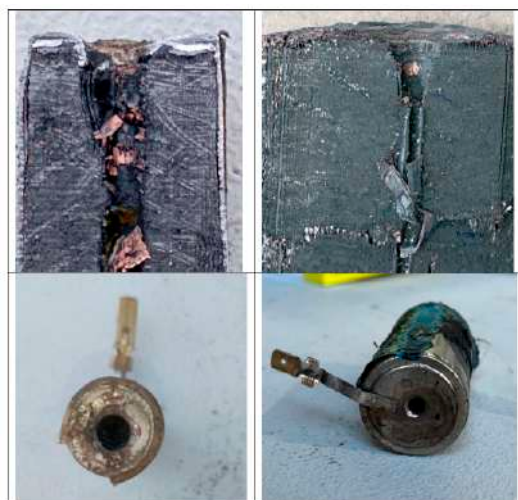
Figure 28. Qualitative comparison of the damage in the NMC cell (**left**) with the damage in the LFP cell (cell C) (**right**), tested by mechanical abuse by perforation in the direction of the longitudinal axis of the cell.

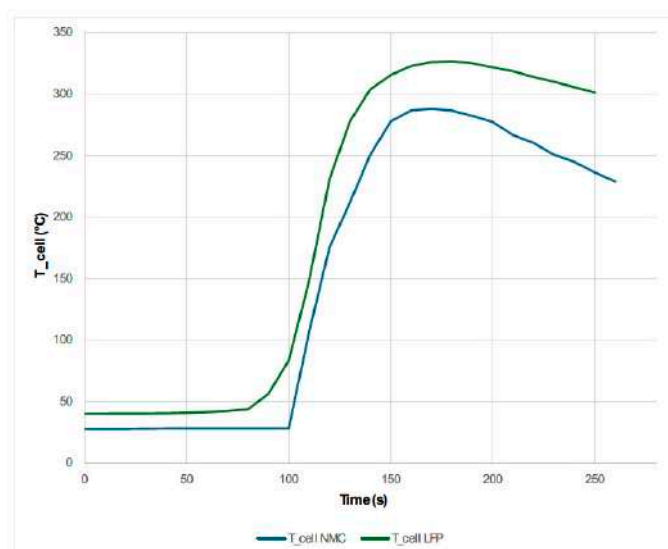
Figure 30. Temperature of NMC cell (SoC 100%) and cell C (LFP, SoC 100%) perforated in the direction of the longitudinal axis of the cell to the short-circuit.

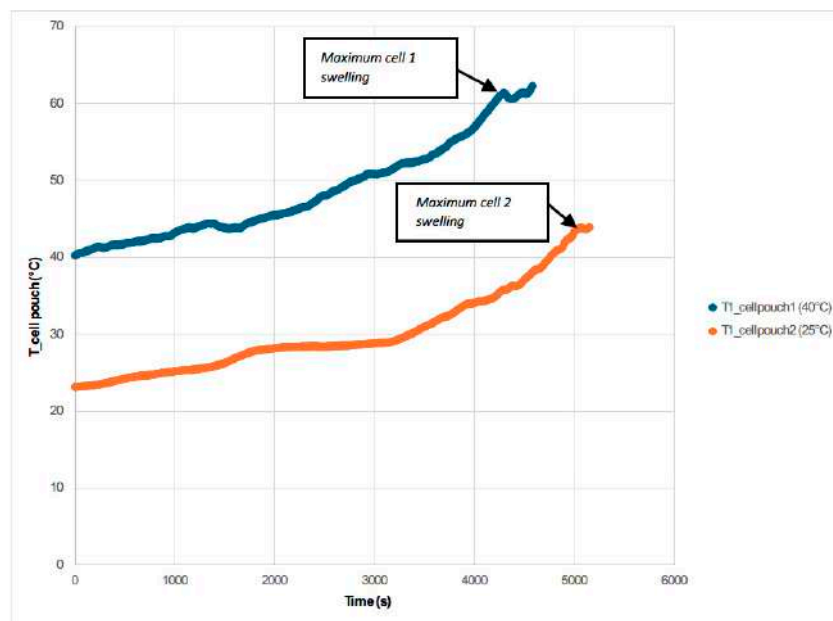
Figure 31. Temperature profile reached by the pouch cells subjected to the overcharge test, for ambient temperature of 40 °C and 25 °C.

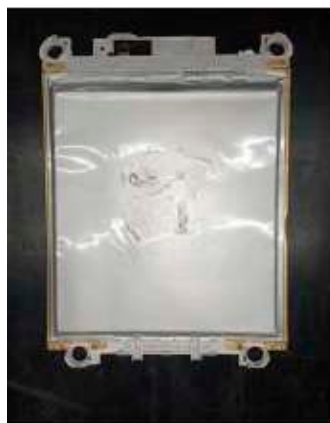
Figure 32. Image of the pouch cell in its original state to be used in the overcharge tests.

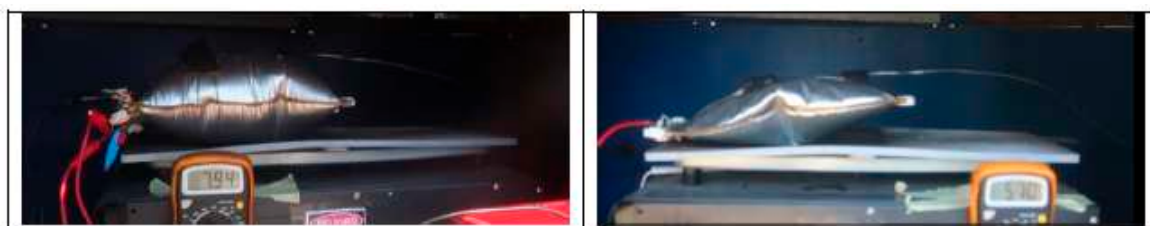
Figure 33. State of pouch cell 1 (left) and pouch cell 2 (right) at the instant of maximum swelling, when the power supply is switched off.

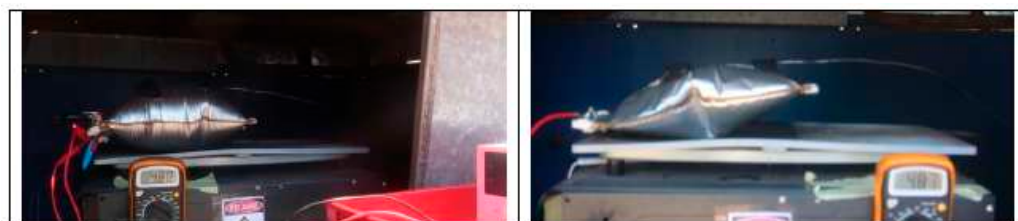
Figure 34. State of pouch cell 1 (left) and pouch cell 2 (right) at the instant of maximum swelling, after switching off the power supply.

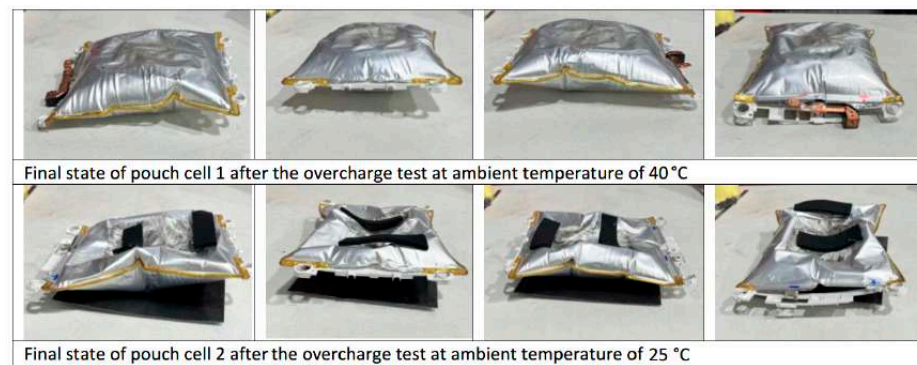
Figure 35. Final steady state of the pouch 1 and pouch 2 cell one day after the overcharge test.

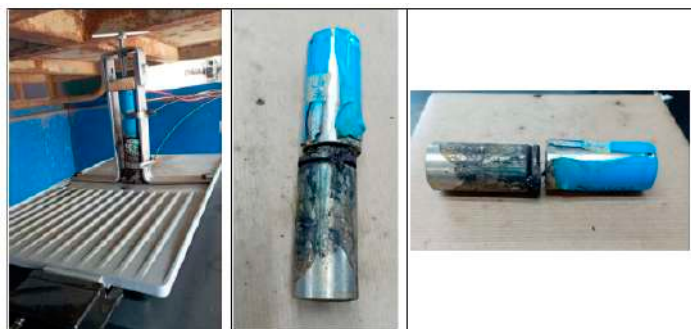
Figure 36. The first image shows the two cells with the tooling used to prevent them from moving during the test. The second and third images show the condition of the cells after test 1.

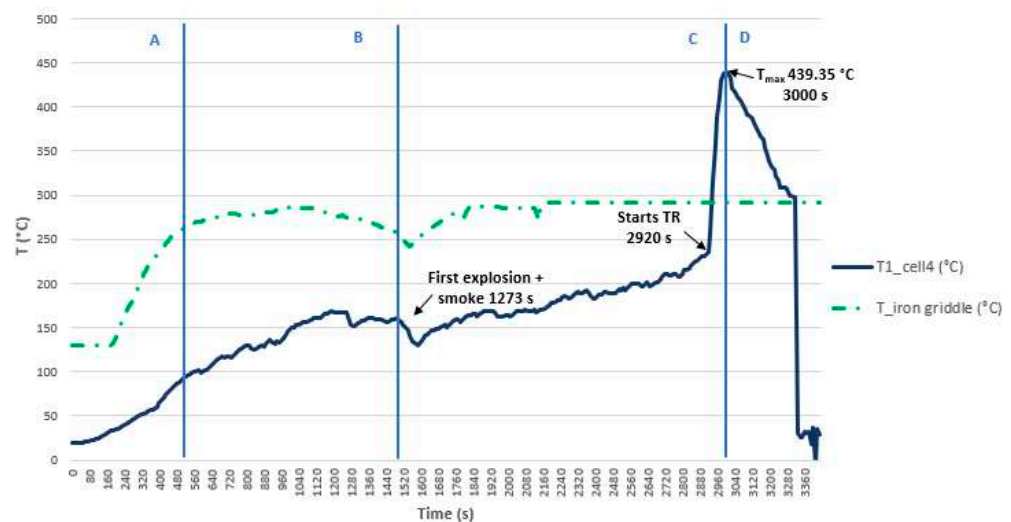
Figure 37. Cell 4 temperature (solid line) because of heating when placed on the electric griddle.

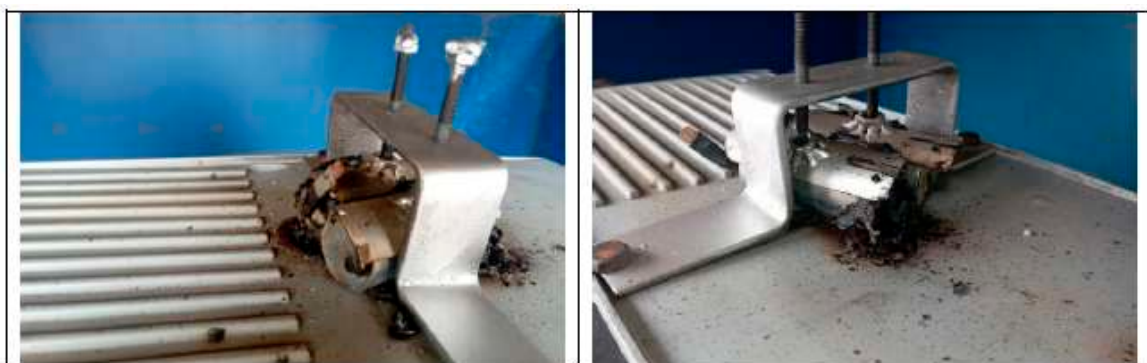
Figure 38. Images of the state of the cells after test 2, positioned with a fixture so that it does not move during test.

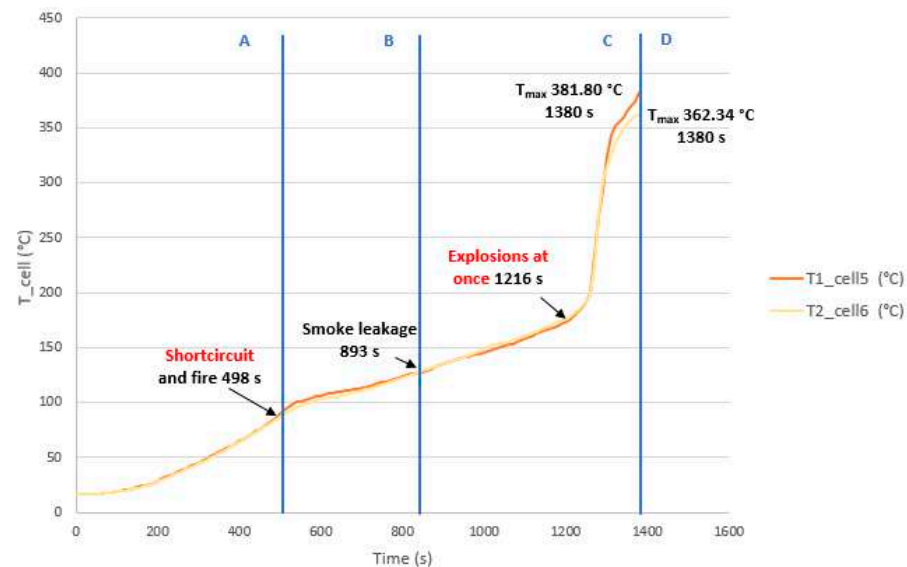
Figure 39. Temperature of cell 5 and cell 6 (solid lines) because of heating when placed on the electric griddle (Test 2).

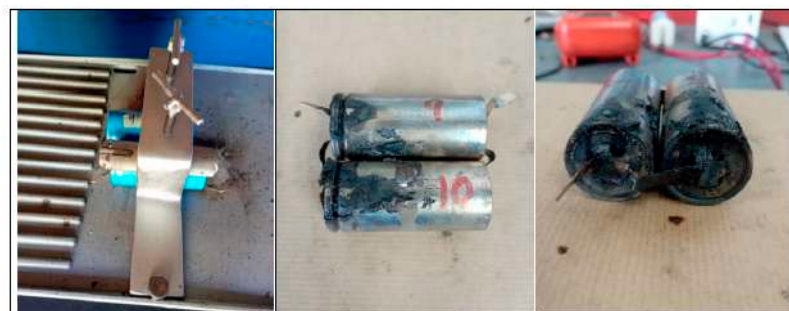
Figure 40. The first image shows the two cells before the test with the tooling used to prevent the cells from moving during the test. The second and third images show the condition of the cells after test 3.

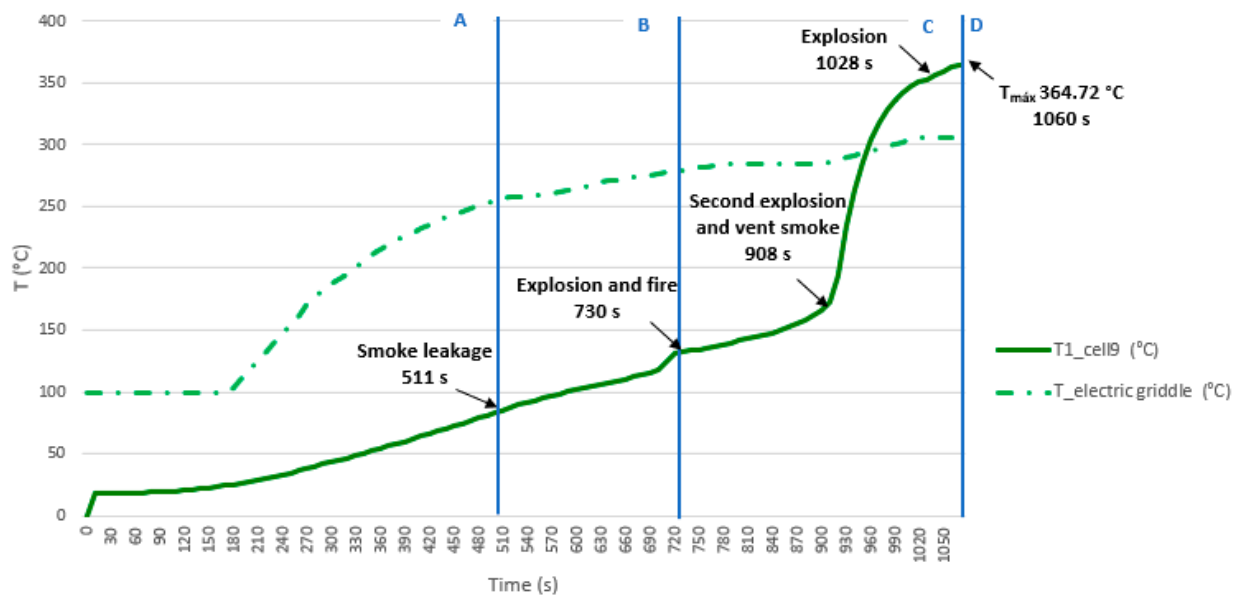
Figure 41. Temperature of cell 9 (solid line) because of heating when placed on the electric griddle (Test 3).

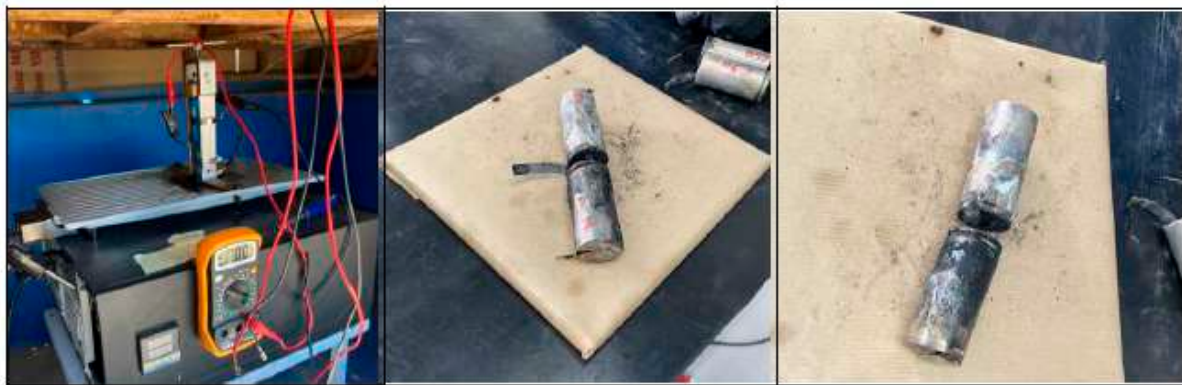
Figure 42. The first image shows the two cells on the electric griddle with the tooling used to prevent the cells from moving during the test. The second and third images show the condition of the cells after test 4.

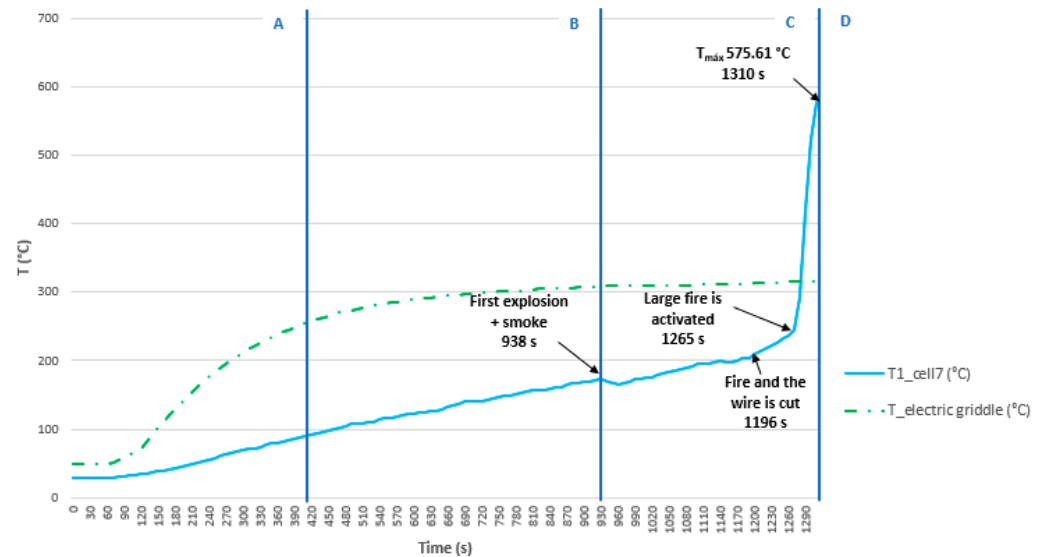
Figure 43. Temperature of cell 7 (solid line) because of heating when placed on the electric griddle (Test 4).

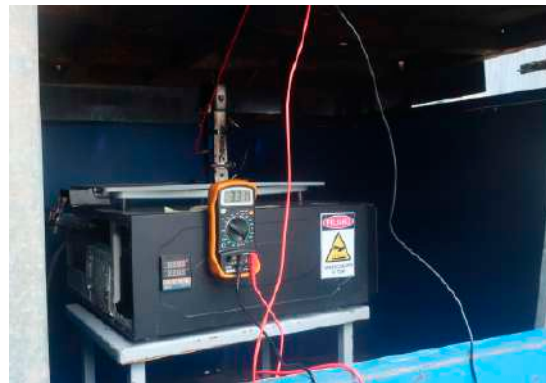
Figure 44. Image of the cells with an SoC of 50%, placed with a tool in a vertical arrangement and connected in parallel on the electric griddle, before the starting the heating test.

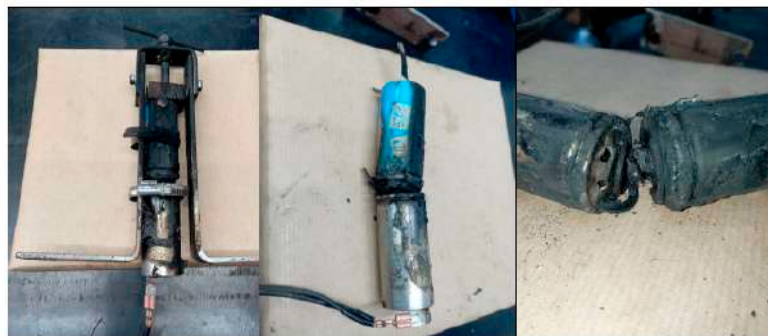
Figure 45. The first image shows the two cells with the tooling used to prevent the cells from moving during the test. The second and third images show the state of the cells after test 5.

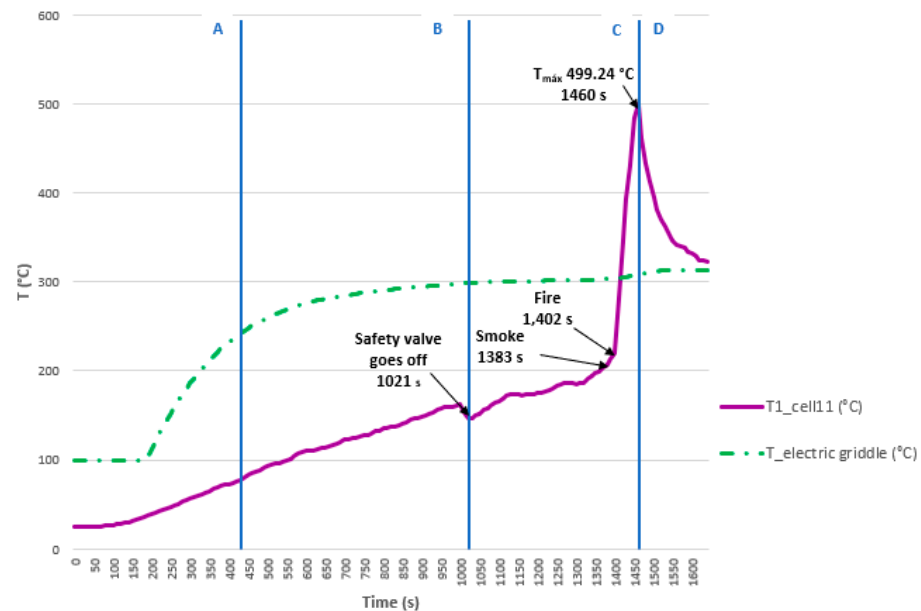
Figure 46. Temperature of cell 11 (solid line) because of heating when placed on the electric griddle (Test 5).

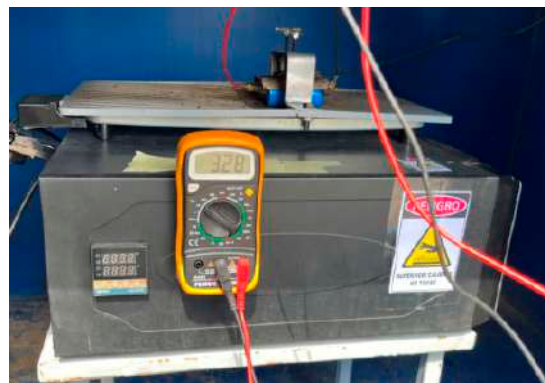
Figure 47. Image of the cells with an SoC of 50%, placed with a tool in a horizontal arrangement and connected in parallel on the electric griddle before the starting the heating test.

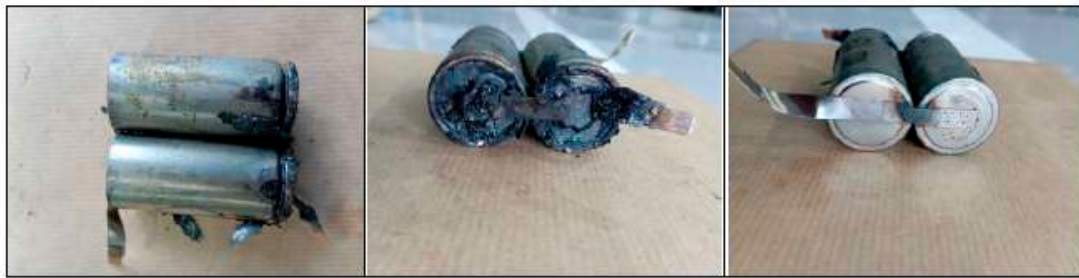
Figure 48. The first image shows the two cells seen from above, the second image shows the upper part of the cells (where the vent valve is located), and the third image shows the lower part of the cells.

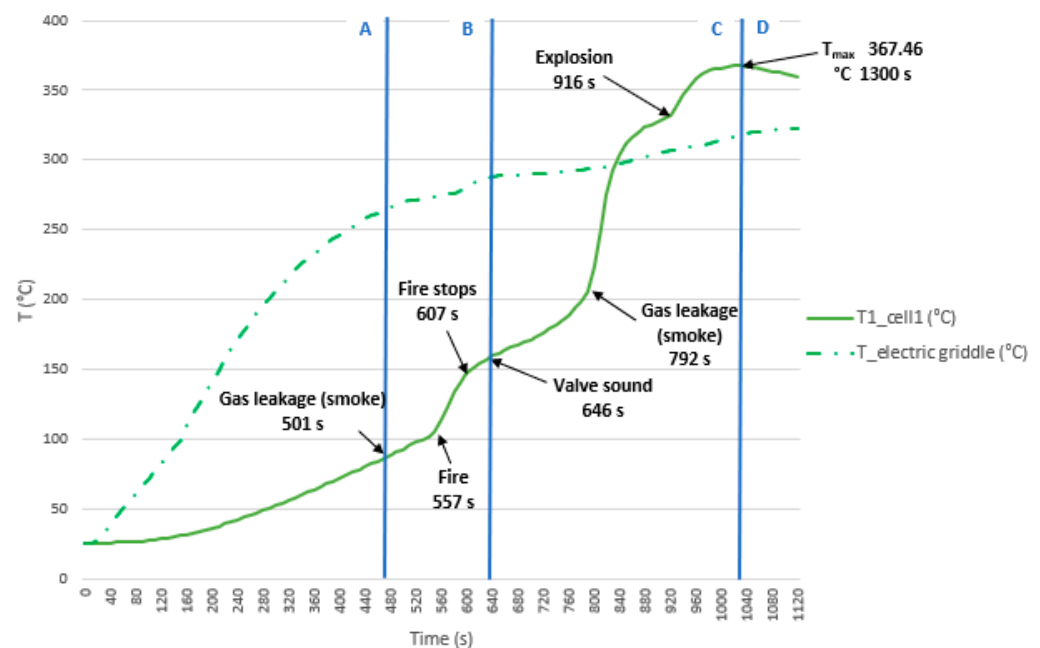
Figure 49. Temperature of cell 1 (solid line) because of heating when placed on the electric griddle (Test 6).

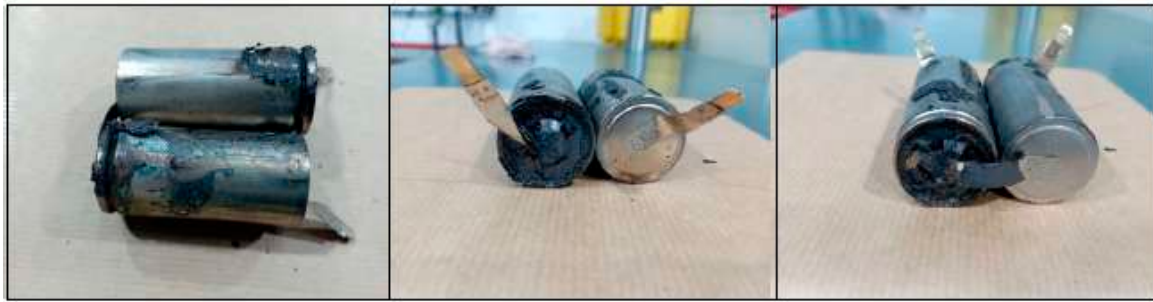
Figure 50. The first image shows the two cells seen from above, the second image shows the upper part of one of the cells (where the vent valve is located), and the third image shows the upper part of another of the cells.

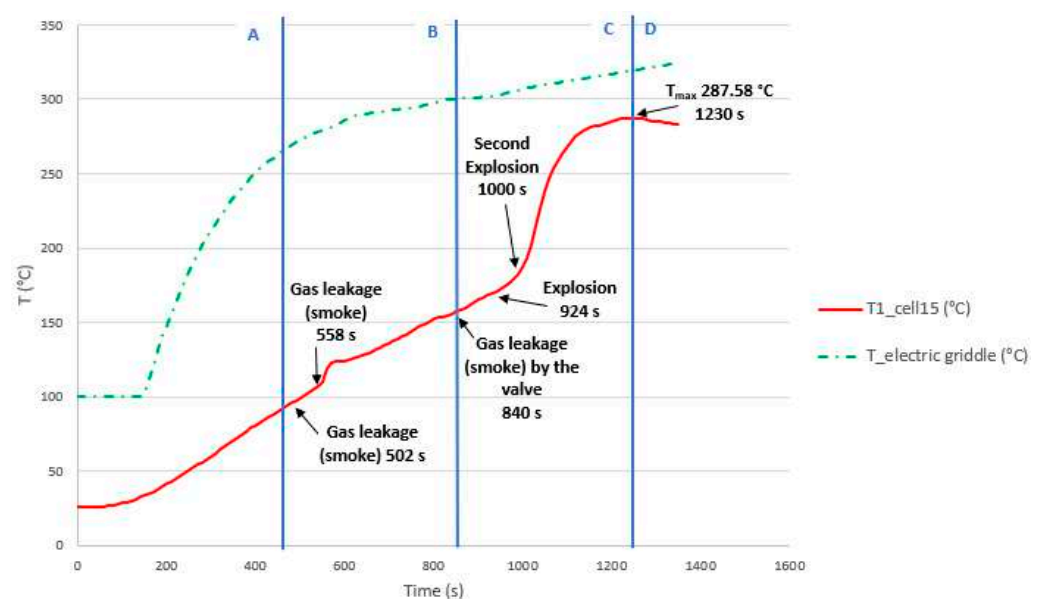
Figure 51. Temperature of cell 15 (solid line) because of heating when placed on the electric griddle (Test 7).
