Article

Influence of the Layout of Cells in a Traction Battery on the Evolution of a Fire in the Event of a Failure

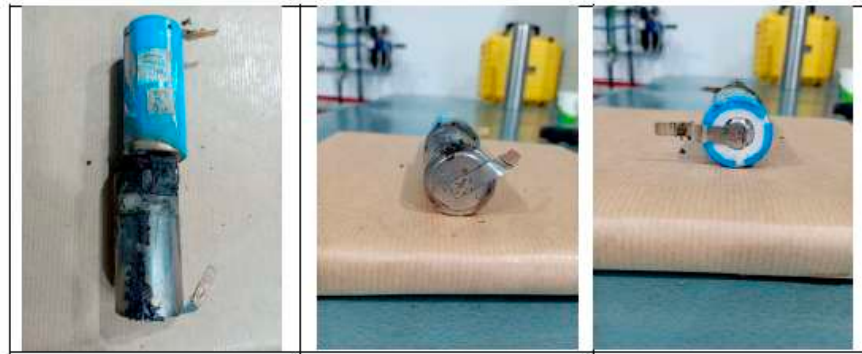
Figure 52. The first image shows the two cells seen from above, the second image shows the lower part of the cell 13, and the third image shows the upper part of cell 17 (where the vent valve is located).

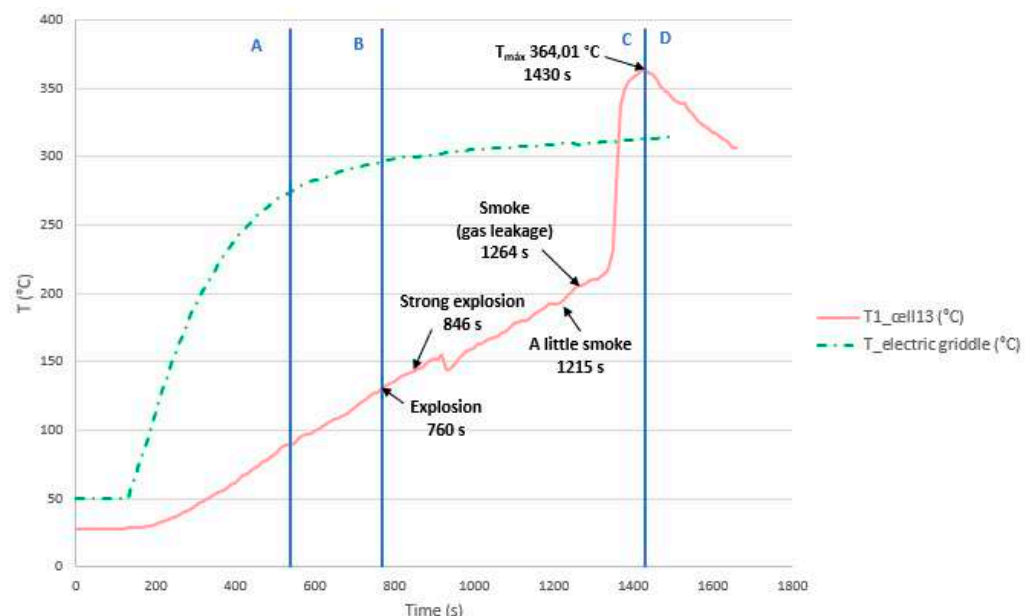
Figure 53. Temperature of cell 13 (solid line) because of heating when placed on the electric griddle (Test 8).

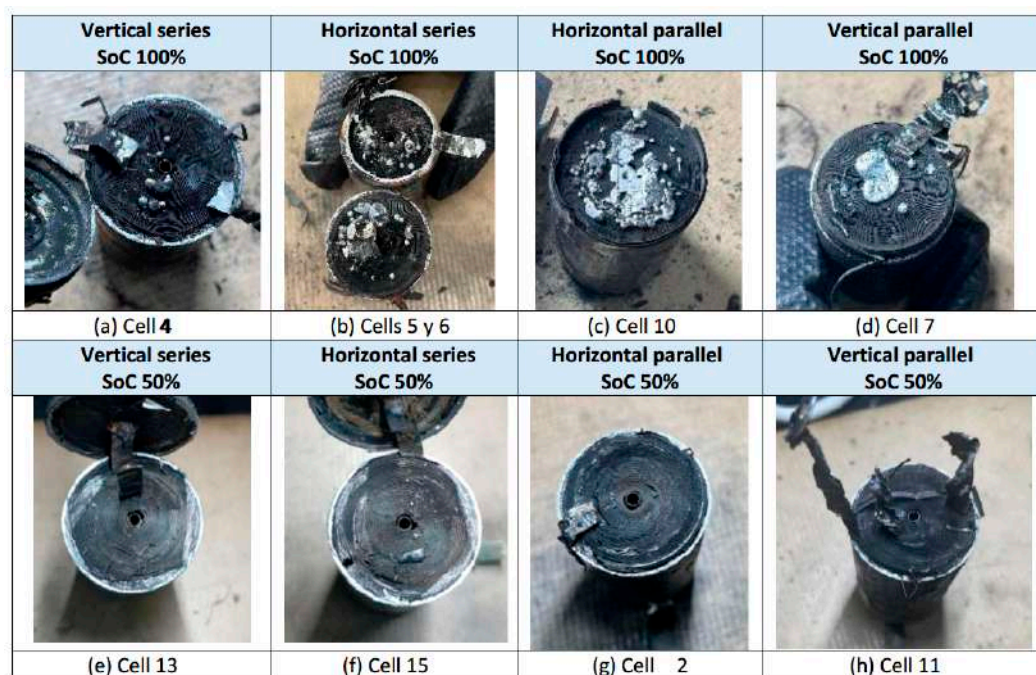
Figure 54. Final state of the cells after thermal abuse tests by heating, after removal of the top cover.

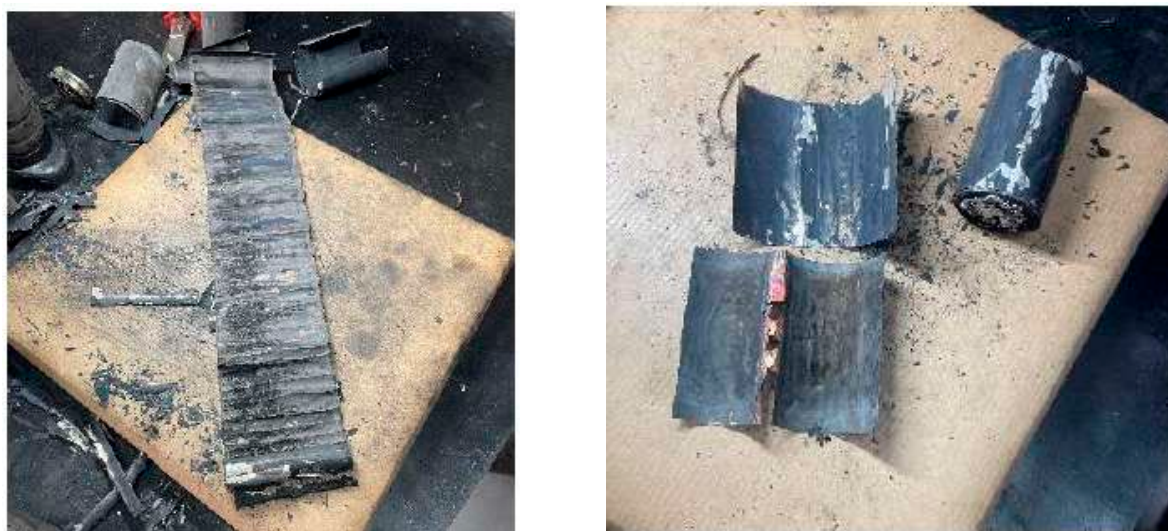
Figure 55. Final state of tested cell 7 (Test 4: vertical arrangement parallel connection SoC 100%) (left) and final estate of tested cell 10 (Test 3: horizontal arrangement parallel connection SoC 100%) (right).
