## Flooding, channel dynamics and transverse infrastructure: a challenge for Middle Ebro river management

This study documents the impacts of engineering works on flood risk and channel dynamics of the maximum geomorphic flow reach of the Middle Ebro River (Spain) over the last ninety years. The map reveals how the construction of transversal transport lines and their ineffective design and maintenance has contributed to an elevated risk of flooding and channel avulsion at this location. In addition, the development of flood protection structures has restricted the natural dynamics of the river. These modifications have restricted the passage of flood waters, ultimately increasing flood hazards, by changing the area and depth of inundation and extending the flood hydrograph. The map allows for the interpretation of key processes, forecasting of flood hazards, and the evaluation of possible mitigating actions. These findings reconfirm that reducing space for the mobility of a river is not a good management solution and further aggravates the current situation.

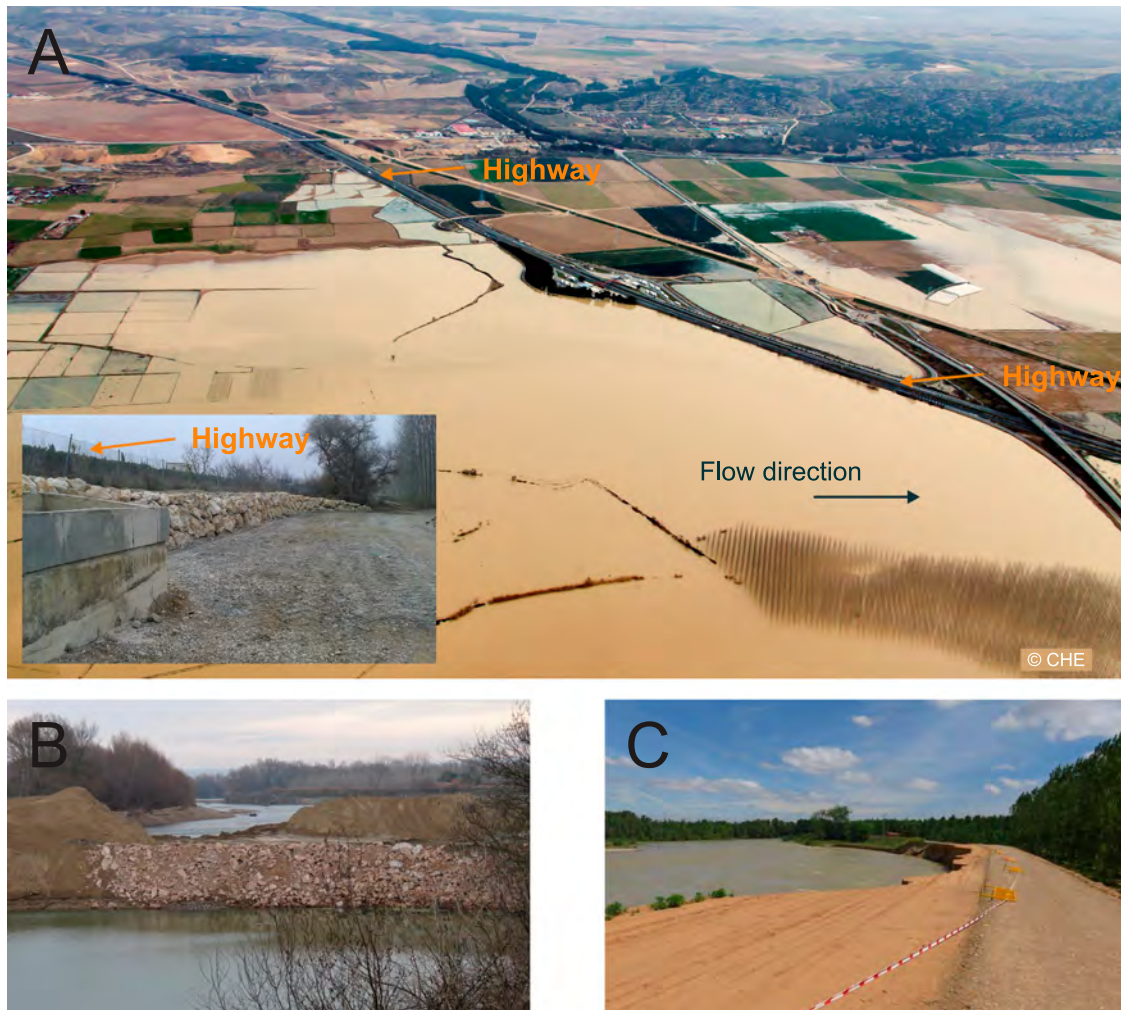
**Figure 5.** Dam effect of the AP-15 highway and drainage siphon plugged up with the works of 2015 (© CHE, 2015. Aerial flight tracking the Ebro flood in February 2015); the image can be located in the main map in the overflow of the Soto de Alfaro meander (see also Figure 4) (5A). Works in the relief channel in 2015; the image can be located in the main map (downstream section of the relief channel) (5B). Erosion of a stopbank in 2018, which was made to protect the riverbank a few months before (© Diario La Rioja); the image can be located in the main map seeing the Estajao stopbank (5C).

The blocked drains of the AP-15 highway (Figure 5A), added to the dam effect they exert and to the effect that the railway has upstream, have caused a dangerous increase of the risk situation due to: (i) the alteration of the normal flooding processes, (ii) the prolongation of its times and the flooding downstream, (iii) the distortion of the flow data and (iv) the consequential problems in decision-making. This situation will be equally serious in future floods especially if these are extraordinary, as has been observed in the events of April 2018.

In autumn of 2015 the CHE also began working on a relief channel (Figure 5B) to improve the water circulation in flooding and reduce the pressure on the water intake in the village of Alfaro. This channel was already operative in 2016 and constitutes the first use of this type of mitigation in the Middle Ebro River, but with an experimental character. At the same time, CHE has also been working, with the support of several groups, in the application of a LIFE project, ‘Ebro Resilience’ (LIFE17 TAE/ES/000003). The project proposes the repositioning of three stopbanks: Chorro de la Nava, Estajao and La Roza. Besides, the relief channel has shown an irregular operation in the recent flood of April 2018, driving the flow against the left bank and generating some breaks in the structure. Therefore,
