1 **Diagnostic imaging techniques of the respiratory tract of sheep**

17 This article shows more than 40 images of thermograms, X-ray, ultrasonography and computed tomography
18 of the most significant respiratory diseases in sheep.

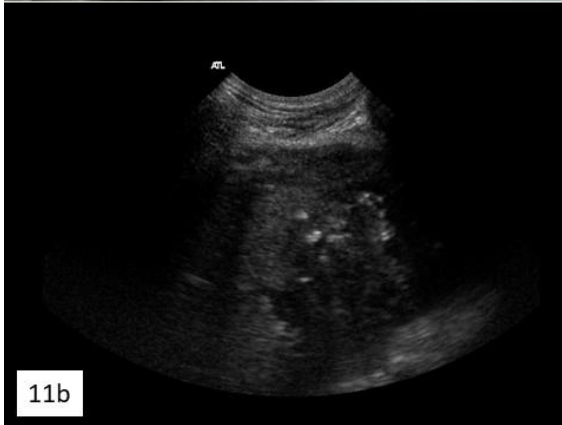
492 **Figure 11. 11a.** Thorax radiography of a ewe with ovine pulmonary adenocarcinoma. Nodular
493 pattern with different-sized nodules is observed. 11b. Thorax ultrasonography of a ewe with ovine
494 pulmonary adenocarcinoma. Echogenic nodules with different sizes and shapes are shown. 11c.
495 CT axial view of the thorax of a ewe with ovine pulmonary adenocarcinoma (soft tissue filter).
496 Ventral lobes with consolidated areas and metastatic nodules in the rest of the lung are shown.

267 In the **X-ray**, a nodular pattern can be observed at the beginning of the process with small
268 and diffused nodules (Fig. 11a). Once tumour nodules converge and form larger lesions, they are
269 more easily detected.

270 **Ultrasonographic examination** of ovine pulmonary adenocarcinoma involving the lung
271 surface/visceral pleura reveals hypoechoic areas representing a tumour mass, defined dorsally by
272 a broad hyperechoic line (Scott, 2017). Ultrasound displays echogenic areas that correspond with
273 different-sized neoplastic nodules associated with OPA (Fig. 11b).

274 **Computed tomography** provides a clear picture of the tumour nodules inside the lung
275 and their different sizes and locations. This technique also allows serial CTs to evaluate the
276 progression of the disease. At first, it can be observed a nodular pattern with small and diffused
277 dotted that converge in different-sized masses (Fig. 11c).
