Internal characterization of embankment dams using ground penetrating radar (GPR) and thermographic analysis: A case study of the Medau Zirimilis Dam (Sardinia, Italy)

Internal characterization of embankment dams using ground penetrating radar (GPR) and thermographic analysis: A case study of the Medau Zirimilis Dam (Sardinia, Italy).

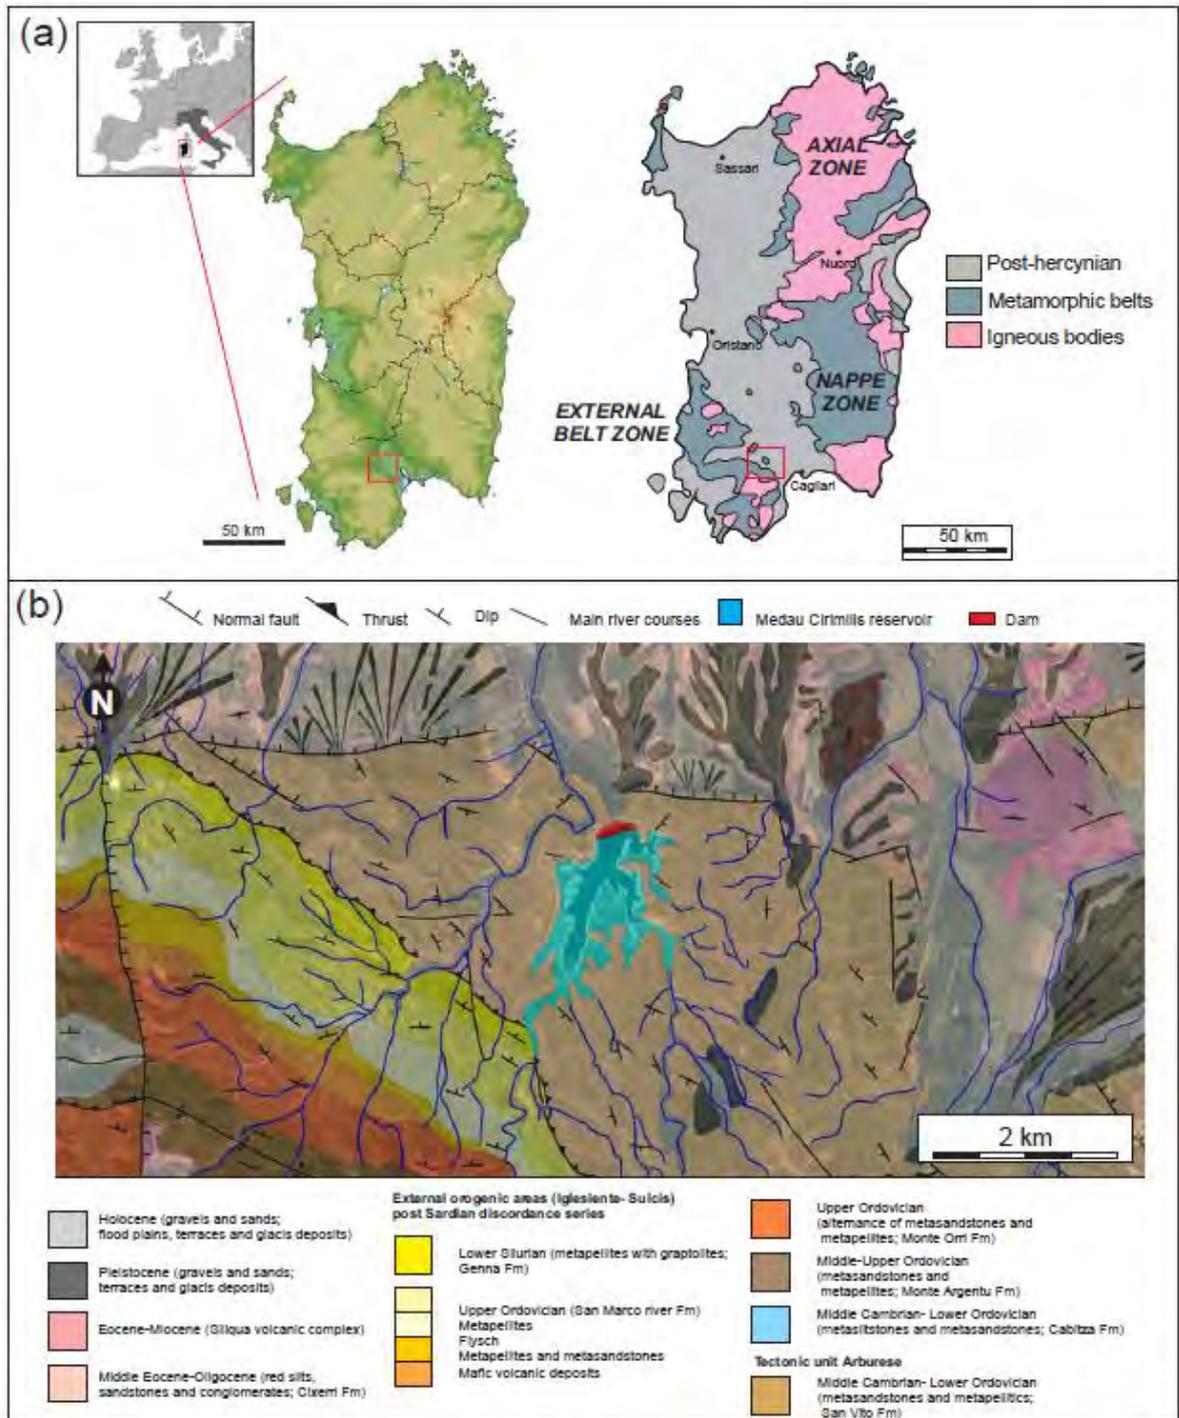
Figure 1

Figure 1. (a) Location of the Medau Zirimilis Dam and reservoir in Sardinia. (b) Geological map from the studied zone (modified from Funeda et al., 2009).

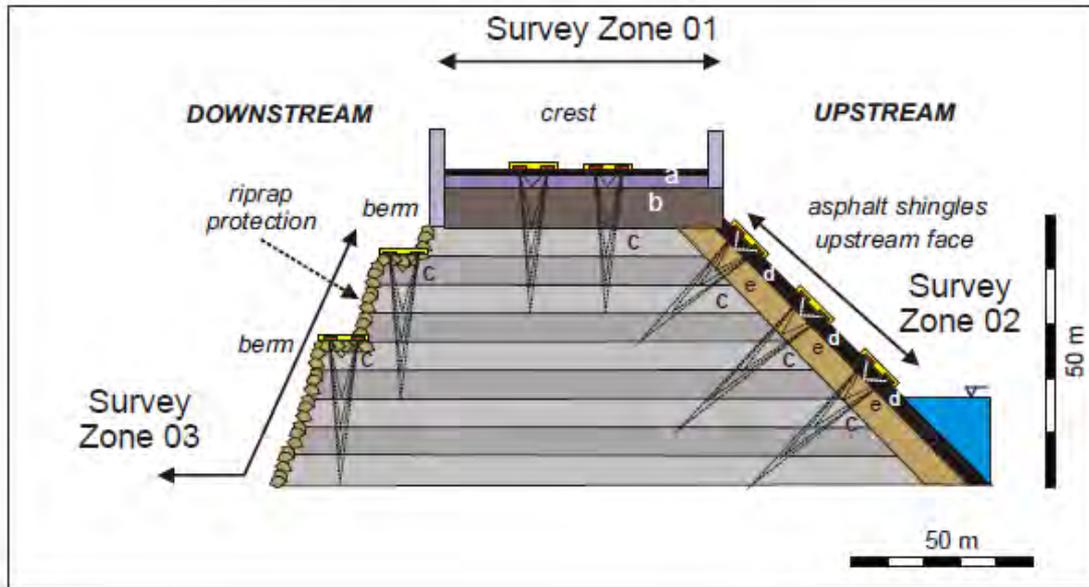
Figure 3

GPR was conducted along three accessible sectors (Fig. 3): the crest of the dam, its upstream slope covered by asphalt shingles and its downstream slope at three different berms. The survey was completed with profiles along different near sectors including lateral dam zones and over the roads to the west and southwest of the dam. In the constructive sectors and following the expected technique of dam construction, GPR profiles should permit one to identify homogeneous, subhorizontal disposition or shallow dipping reflectors in the subsoil. In this sense, the survey was defined to identify non-horizontal or sharp lateral changes of reflectors underground. Because of the topography of the survey zone, zones 1 and 3 were surveyed along horizontal surfaces with a vertical propagation of GPR waves into the dam structure (Figs. 3 and 4). In the case of the upstream face, the survey was conducted along constant-elevation profiles (Fig. 4c) but the GPR wave propagation is normal to the survey surface, and the record shows an image of the dam structure at an angle with the vertical (Figs. 3 and 4c). Similar approaches have been previously employed in structures of this type (e.g., Di Prinzio et al., 2010). In this manner, topographical correction of the profiles was not necessary, and the objectives were focused on the identification of structural changes different from that expected given the dam's construction characteristics.

Figure 3. Conceptual sketch of the analyzed dam. The different survey zones, the used terminology and the theoretical GPR rays are included. Note that vertical scale has been exaggerated for illustration.

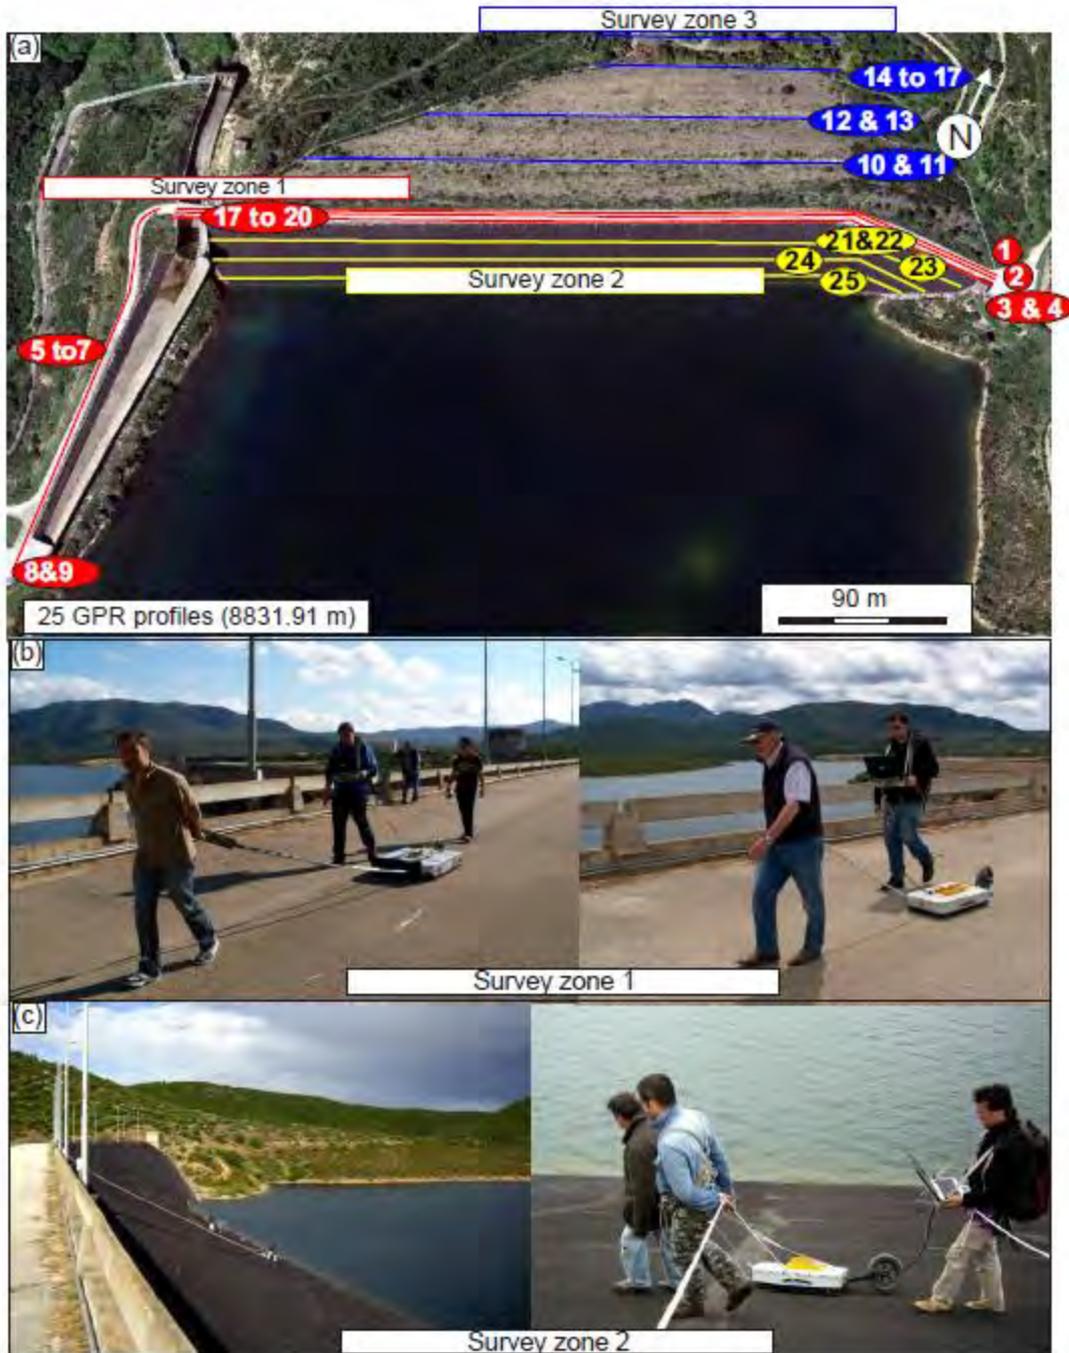
Figure 4

Because of the surficial characteristics of the surveyed zones and the objectives of the survey, three different groups of GPR antennas were used as follows: (i) 100-, 250-, and 500-MHz shielded antennas from RAMAC and a CUI-2 central unit along zone 1, (ii) 250 MHz in zone 2, (iii) 100 MHz in zone 3, and (iv) 100 MHz surrounding the dam and along the adjacent roads and lateral dams. Survey objectives were defined to evaluate non-horizontal reflectors or progressive changes that could denote post-constructive modifications or irregular trends that could suggest a subsidence process during or following the different construction phases. The surveyed zones were defined according to their accessibility and potential to evaluate the structure and dam characteristics. Zone 1 was used as a survey pilot zone (Fig. 4a and b) to evaluate the depth penetration of the GPR waves and the configuration. The homogeneous distribution of reflectors at the 100-MHz radargrams suggested focusing the analysis in the 250-MHz frequency for subsequent survey in the upstream sector where survey conditions were more difficult for low-frequency antennas. In the case of the downstream sector and the lateral

profiles (Fig. 4c and d), a survey was performed using the 100-MHz antenna to identify accommodation features related to syn- and post-construction modifications.

Figure 4. (a) Location of the GPR profiles (see Table 1 for characteristics); b) photographs from the studied zone during the geophysical survey for survey zone 1 over the dam, and b) at survey zone 2 along the upstream slope.
