EXPERIMENTAL STUDY ON THE INFLUENCE OF MANUFACTURING PROCESS DEFECTS IN BLISTERING IN GEL-COAT PROTECTED LAMINATES UTILIZED IN MARINE ENVIRONMENTS

Jesús Cuartero Salafranca ¹, David Ranz ², Hugo Malon Litago ¹

ABSTRACT:

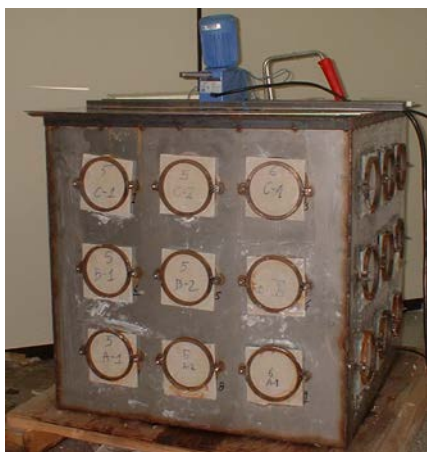
Fig. 1. Laboratory testing equipment

The laboratory testing equipment made for this study has a cube shape. The four lateral faces and the bottom face of the equipment were manufactured in rust-proof stainless steel and subsequently these sheets were joined by welding. The thickness of these sheets is 2mm. In the lateral faces have been mechanized nine holes. The top section of the equipment is closed by another plate. This plate was designed with a hole in the centre thereof. The purpose of this hole is to allow input a resistor and a stirrer in the equipment, as well as refill the equipment with water when it's necessary. In addition, the laboratory testing equipment is equipped with a thermostat which allows to control the water temperature in the equipment. Figure 2 shows the thermostat located into the turtle box. It is located somehow in a representative location in order to get mean temperature measures.

The experimental tests have been carried out in a laboratory testing equipment, produced by the Mechanical Department of the University of Zaragoza, based in the commercial system named "Turtle box" of the AMOCO Company.

Thus each of the 36 produced samples was placed in one of the 36 holes on the sidewalls of the laboratory testing equipment. These samples were placed in the equipment with the gel coat layer inwards and were attached to the laboratory testing equipment with washers. These washers were of non-rustproof steel, and were attached to the equipment by means of two screws. In order to obtain a watertight seals, a natural rubber gasket was placed between the samples and the sidewalls of the equipment. The attachment system of the panels is shown in figures 1 and 4. Also Figure 2 shows the gel coat part of the laminate exposed to water.

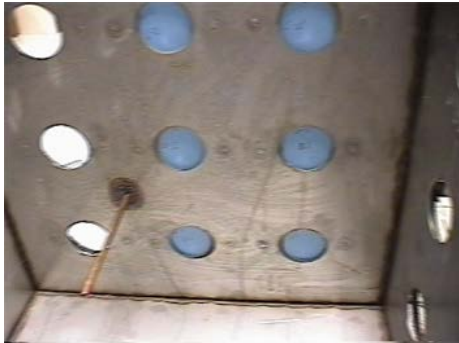
Fig. 2. Location of the thermostat

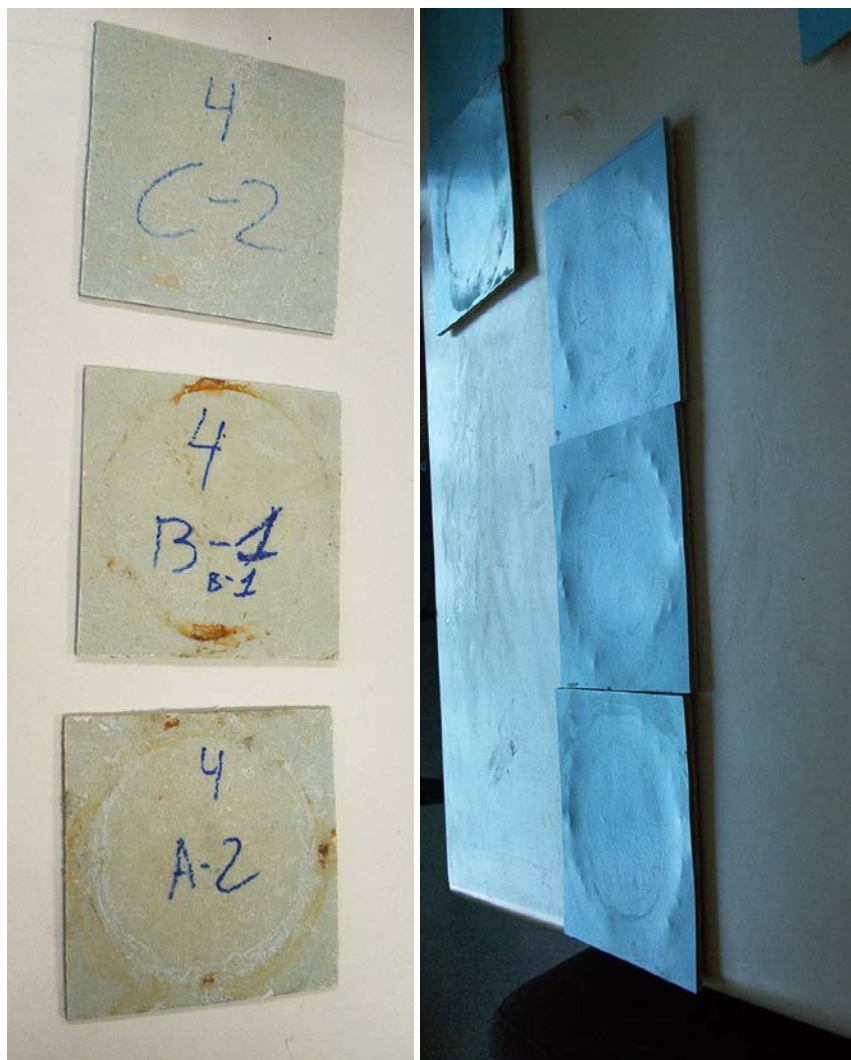
Fig. 8. Test num. 2, massive blisters on slightly corroded areas, and massive blisters on highly corroded areas

These blisters affect all samples with corroded washers. Besides, these blisters increase in both number and area depending on the type of Laminate. In Laminates 4 and 5 with the same corrosion on washer, blisters were greater and were showed in greater amount than in Laminates 2, 3 or 6 for the same amount of corrosion on washer. This is not a quantitative conclusion as much as a rather qualitative appreciation. Fig 8 shows this phenomena.

These results indicate that blistering phenomena in gel-coat protected laminates are not only produced in the side in contact with the water. In the side without contact with the water, the blistering phenomena are generated by the corrosion on washers.

In the examination of the tested samples have been detected blisters on the surface not exposed to hot water. These blisters were due to the corrosion of the washers. The samples with greater corrosion of the washers are the samples with greater blisters. This
